# Aging concrete on our dams

Frank Denys - 22 February 2024

CONCRETE WORKING FOR WATER – FEBRUARY 2024

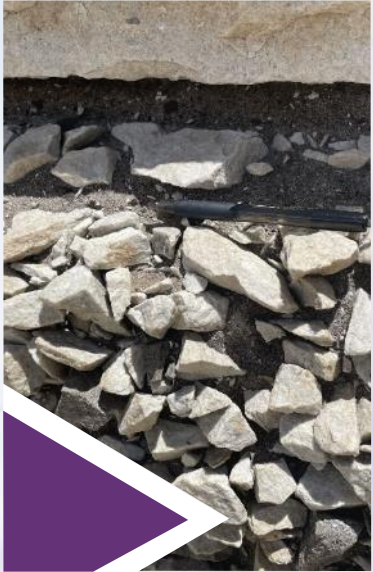
Mortar loss – exposed aggregate

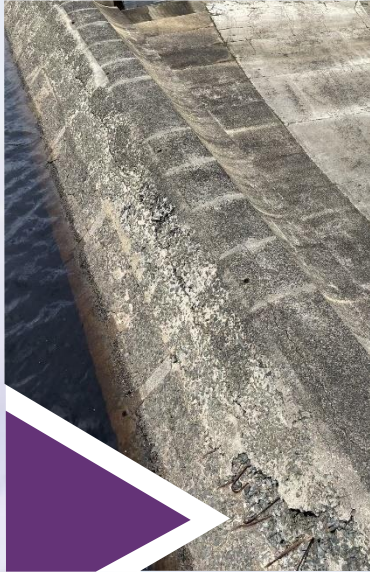
Reinforcement corrosion

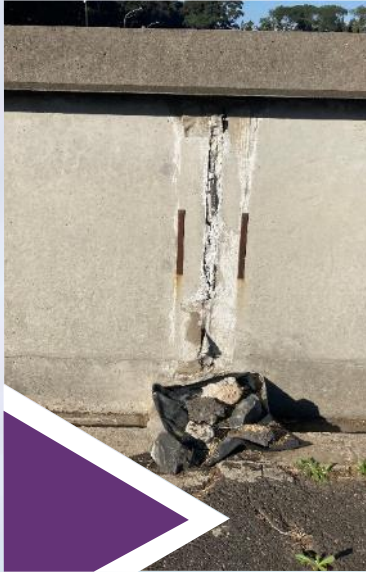
Joint damage / movement

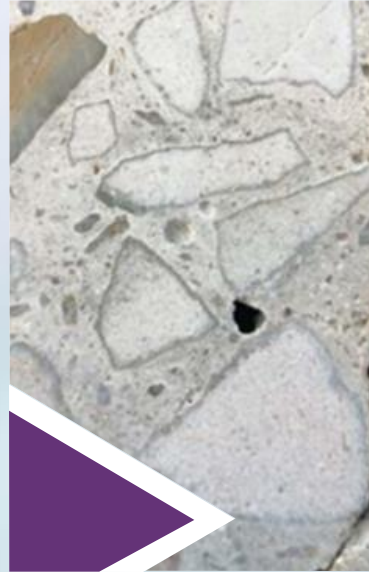
AAR / ASR

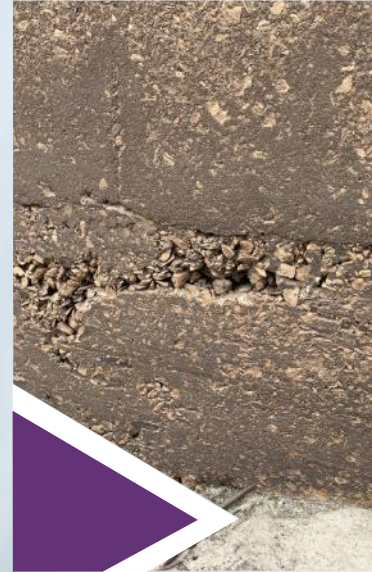
Construction defects

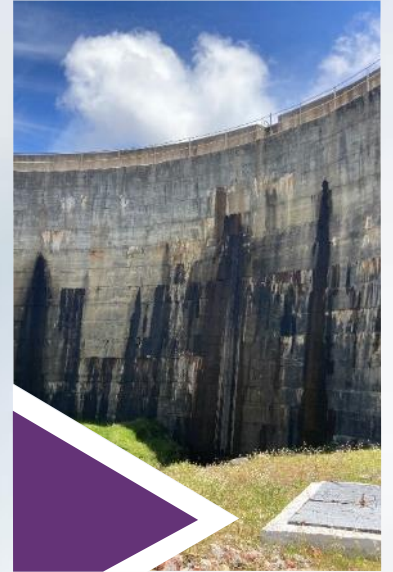
Cracking / leakage

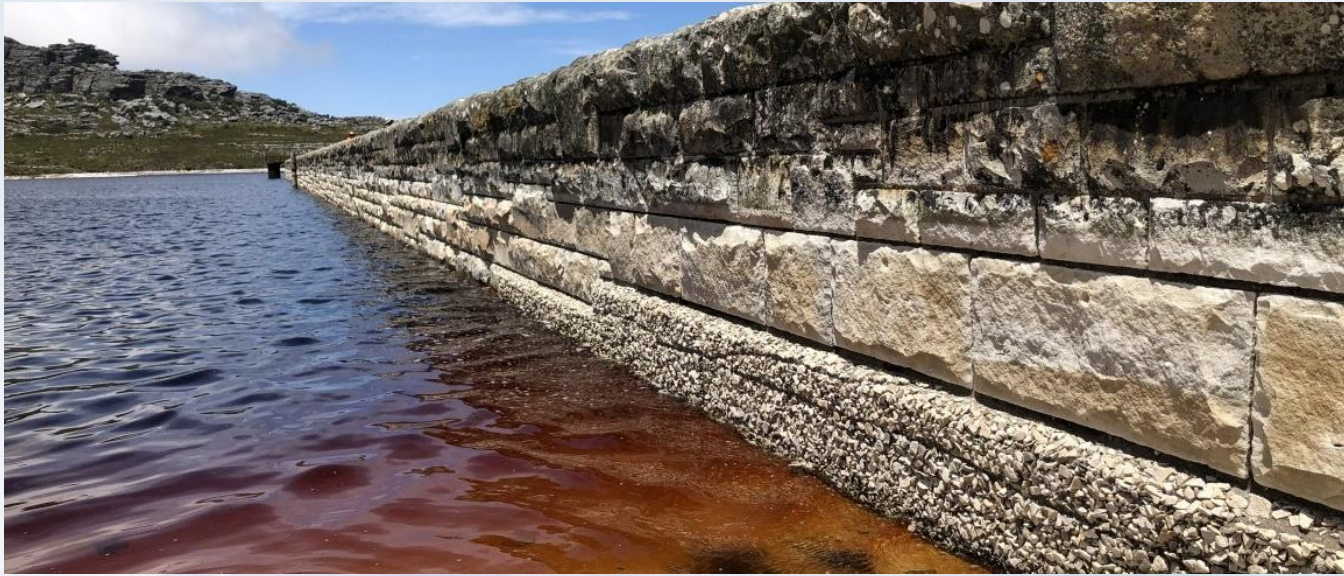
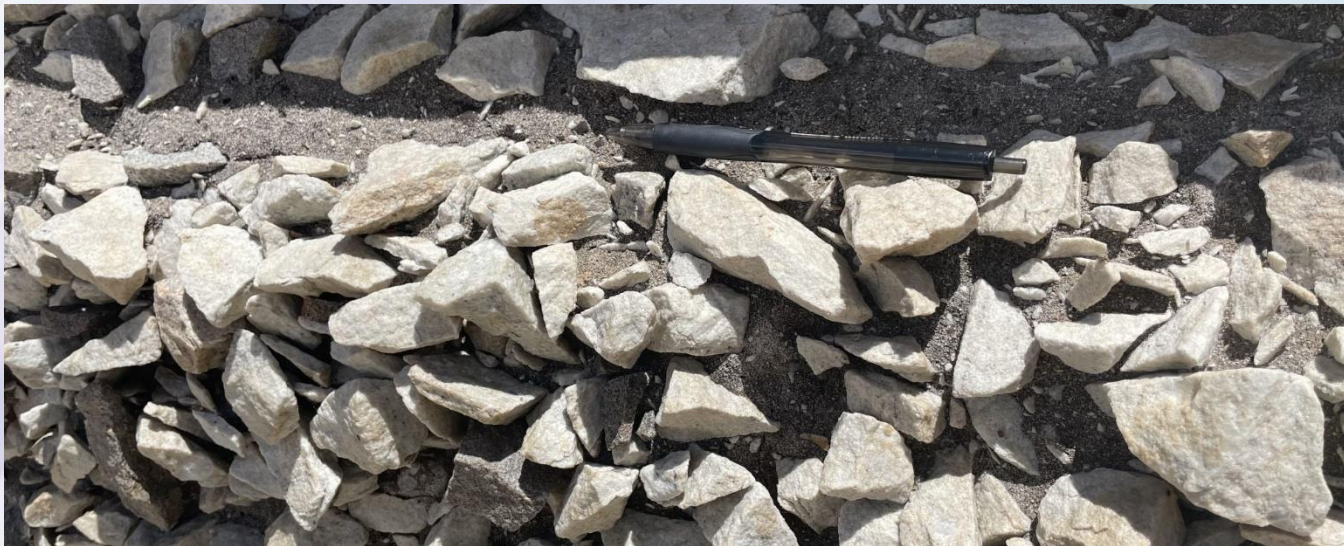
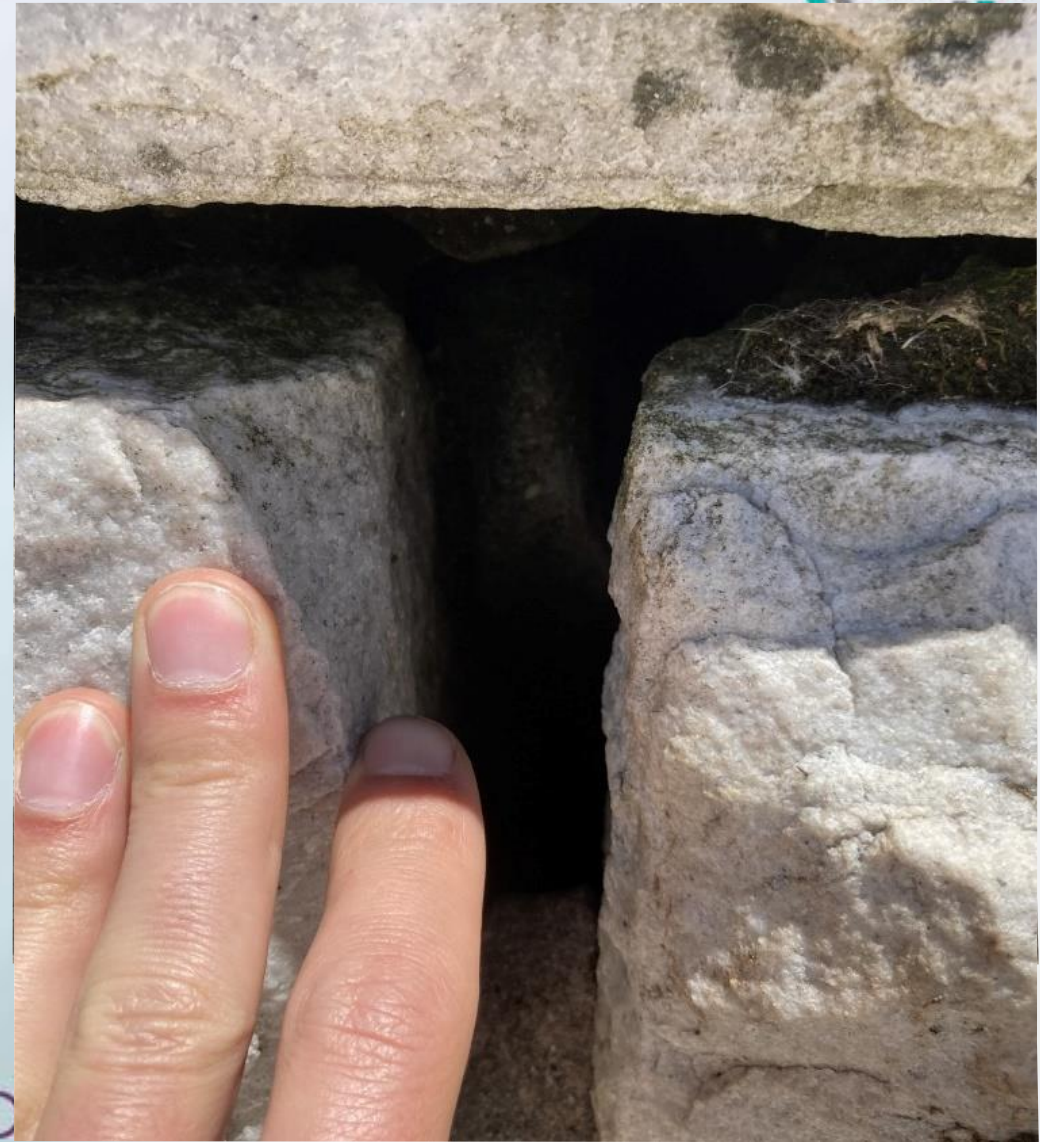
# Mortar loss

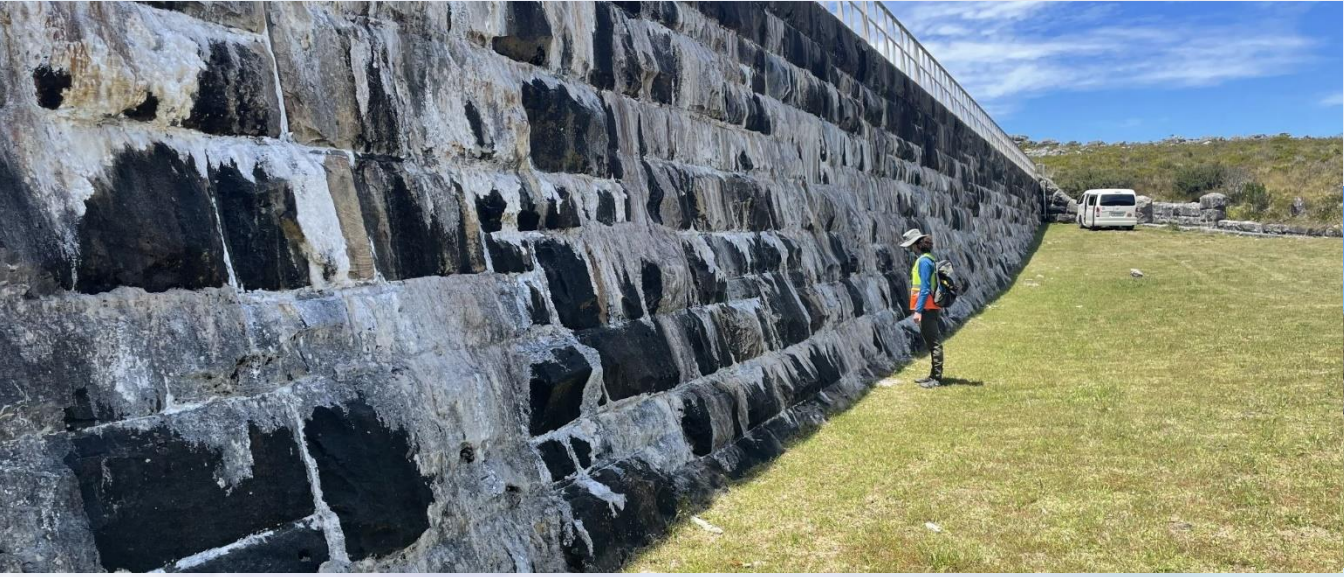
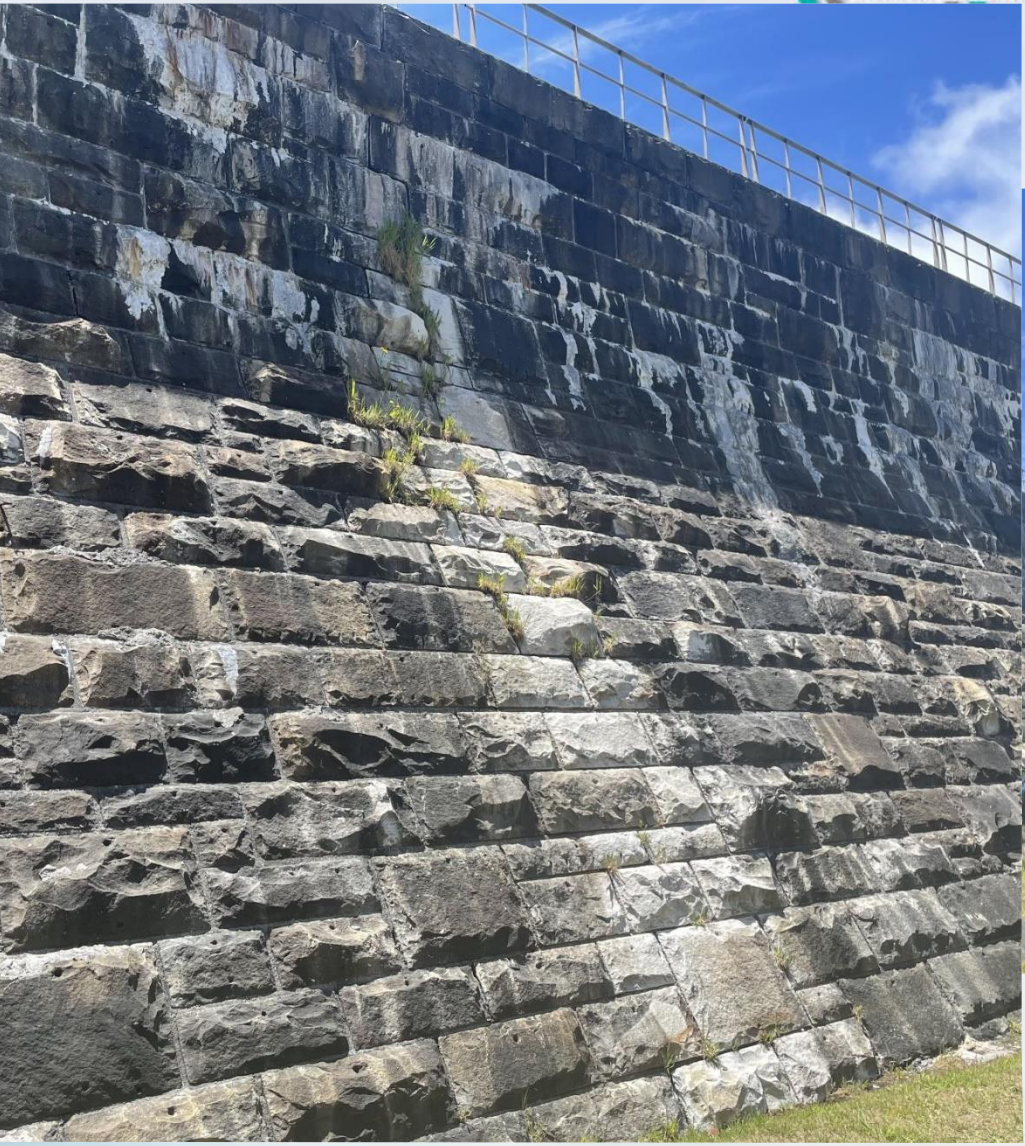
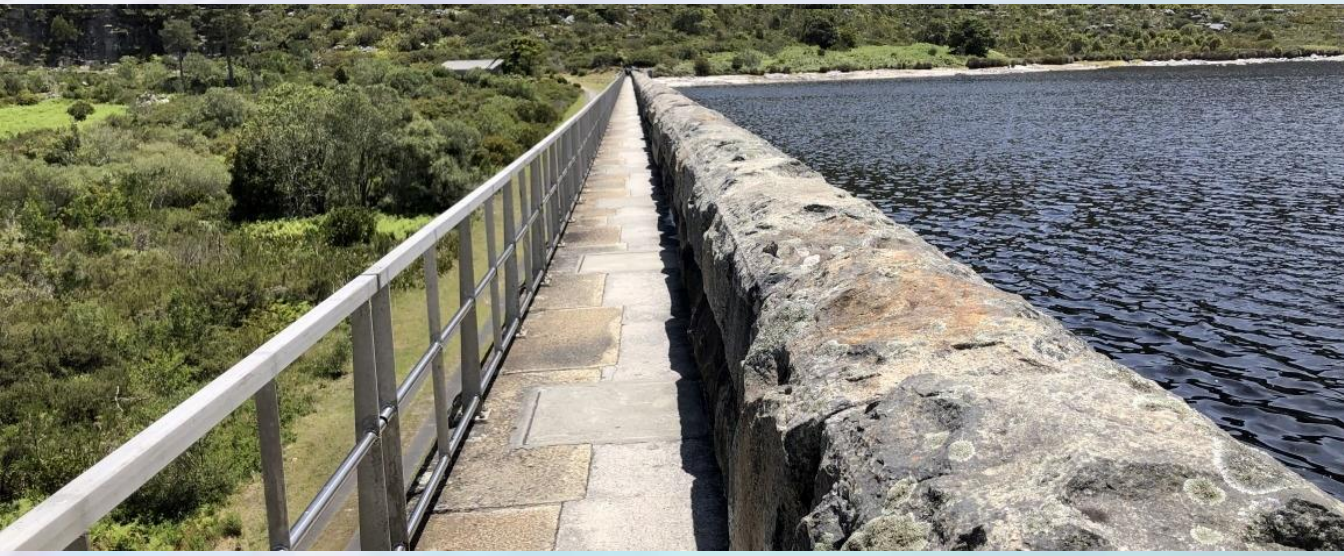
# Leakage and seepage

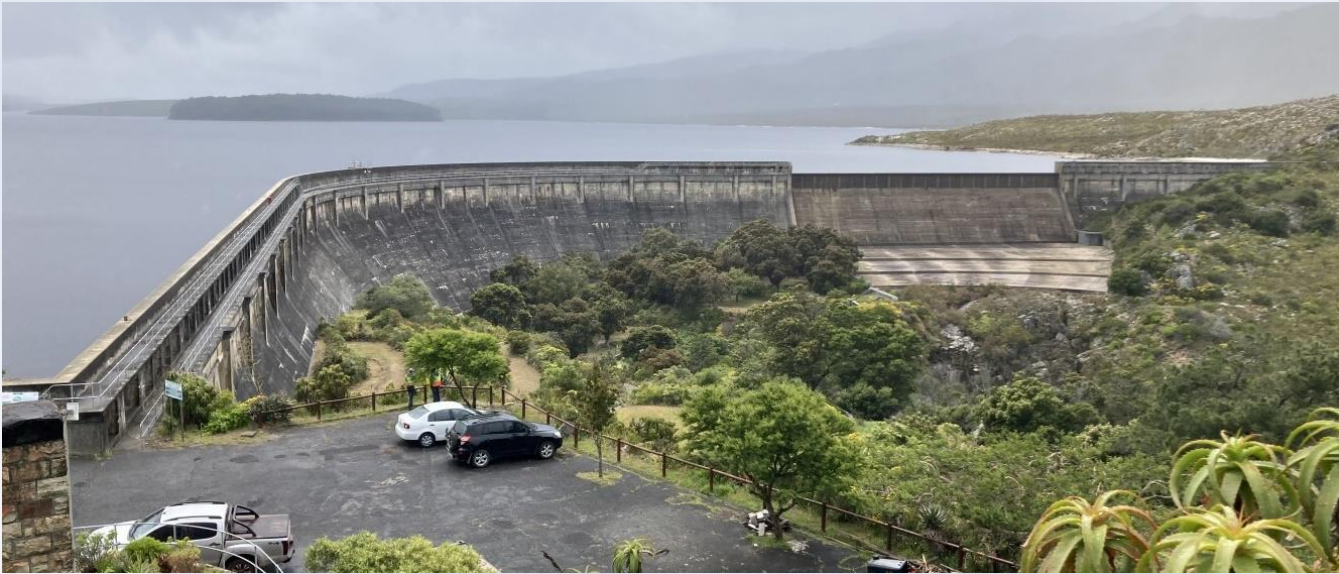
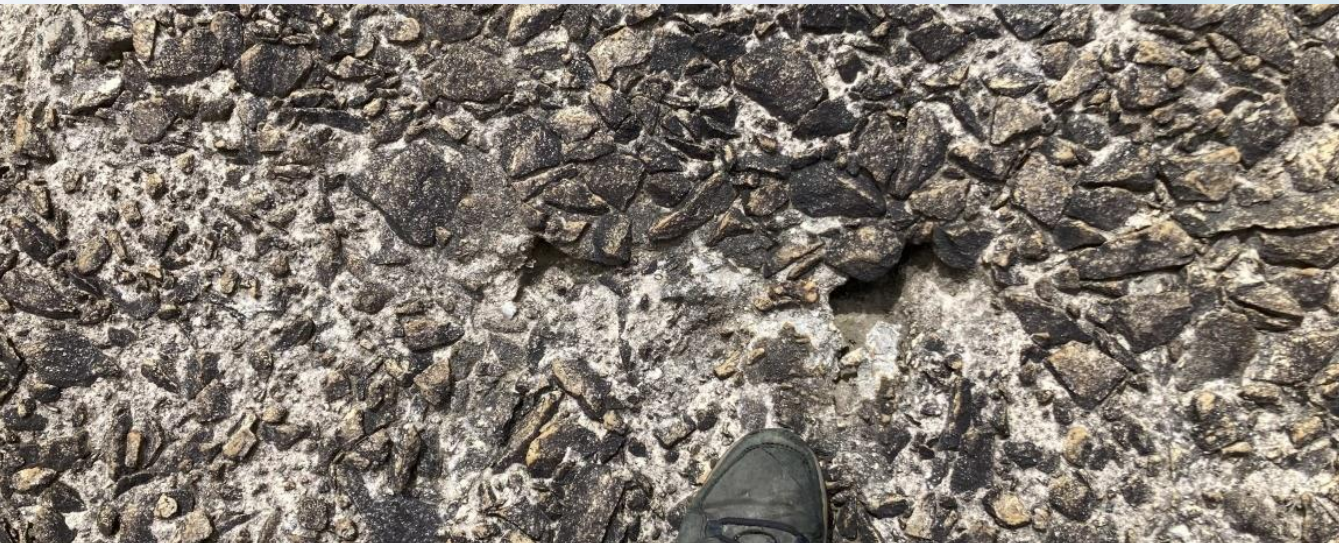
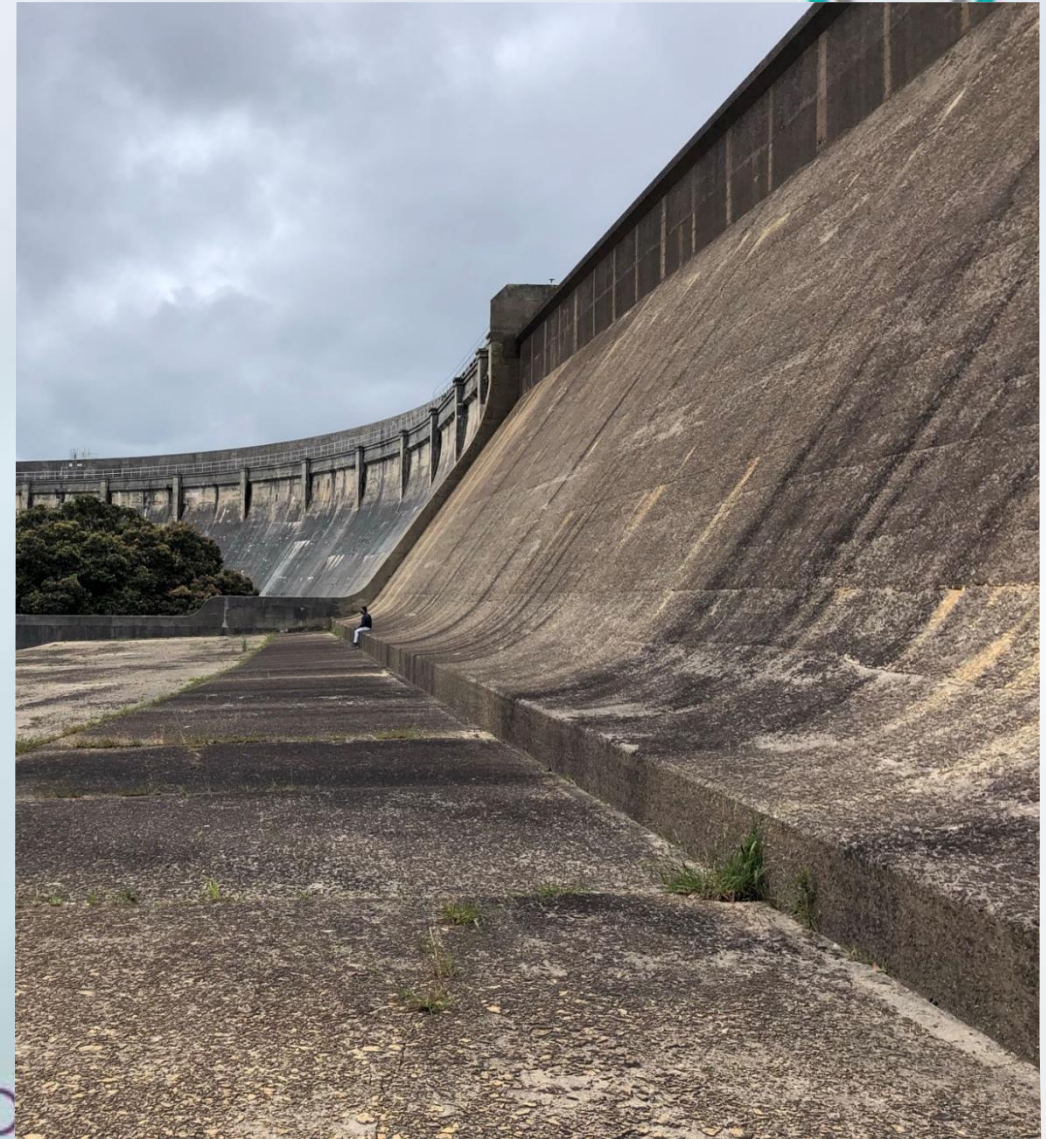
# Mortar and aggregate loss on spillway

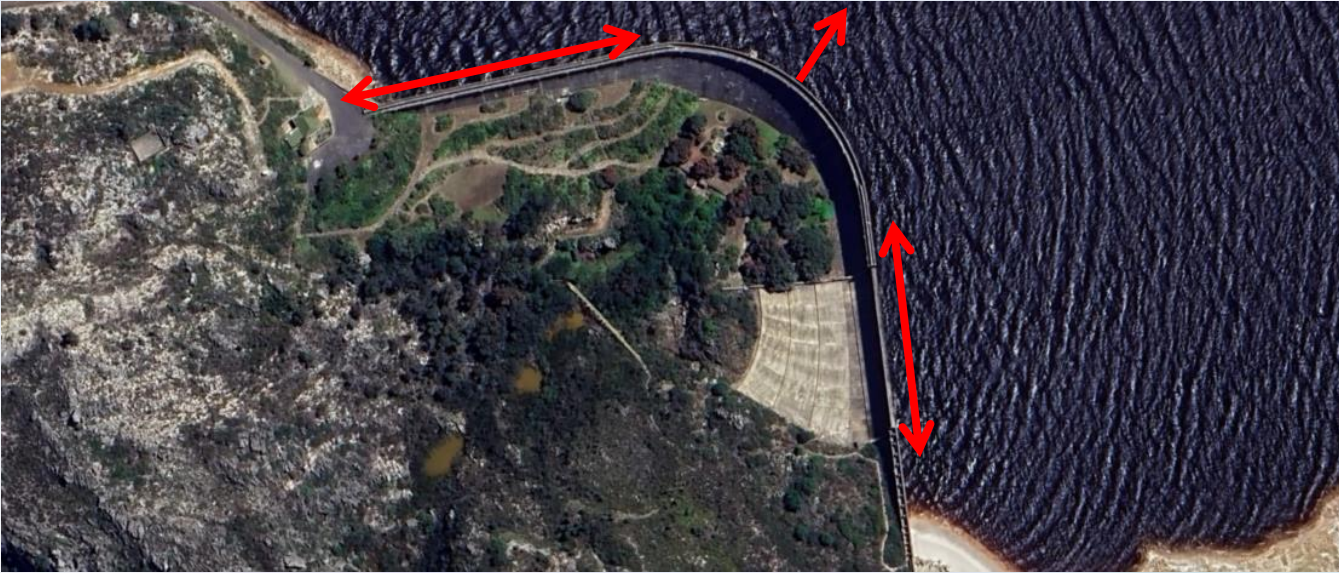
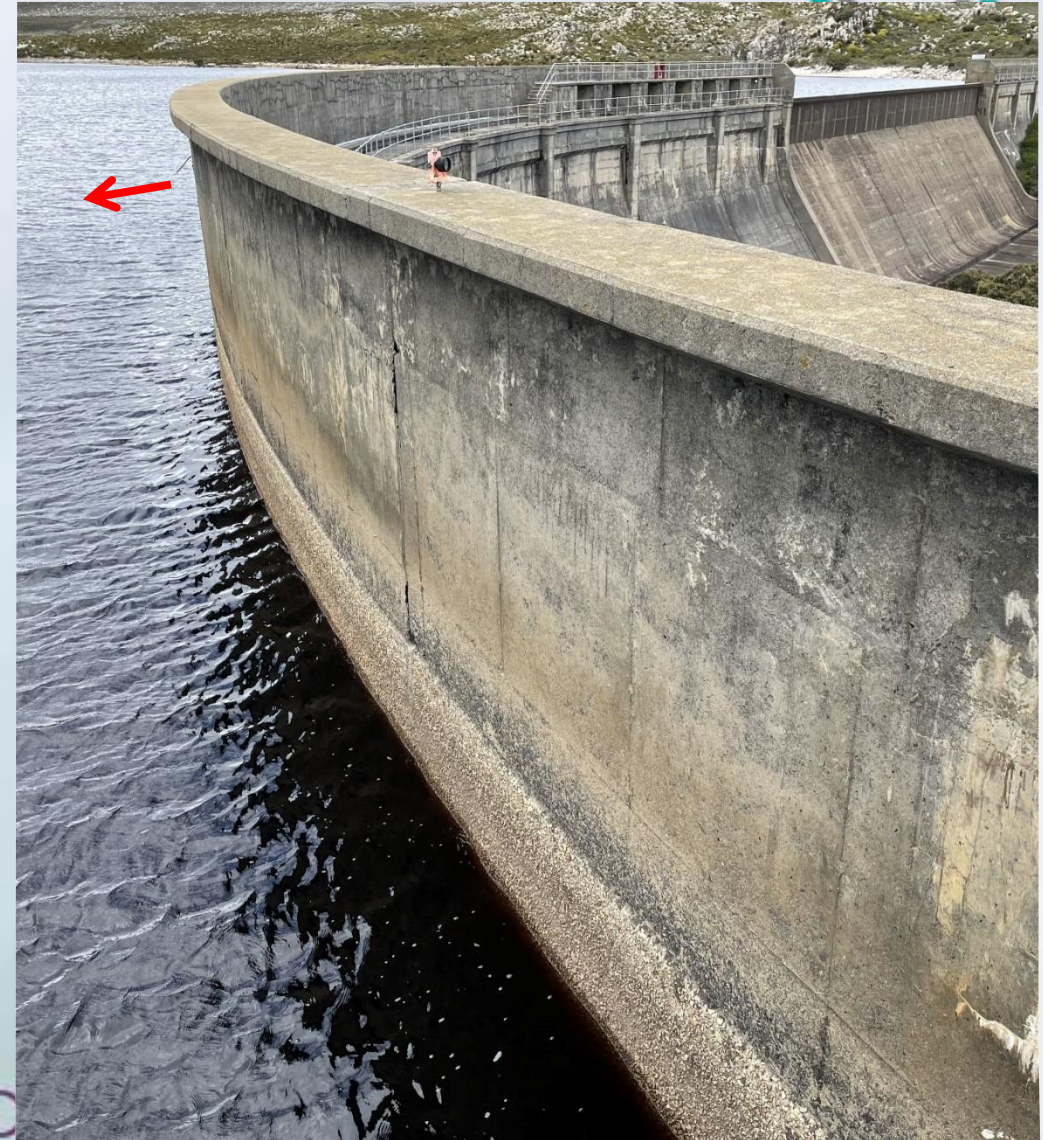
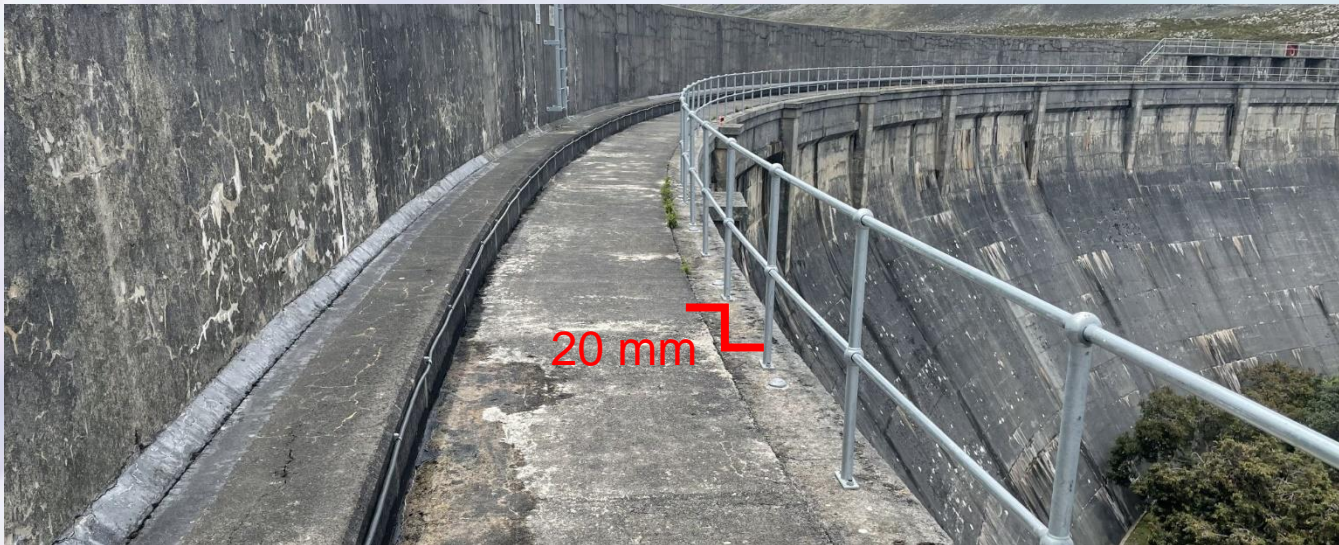
- Originally built in 1921
- Raised in 1927 and again in 1954
- Concrete gravity structure with outdated design
- Strengthened in 1954 with post-tensioned steel cables
- Significant AAR concerns

# Concrete swelling

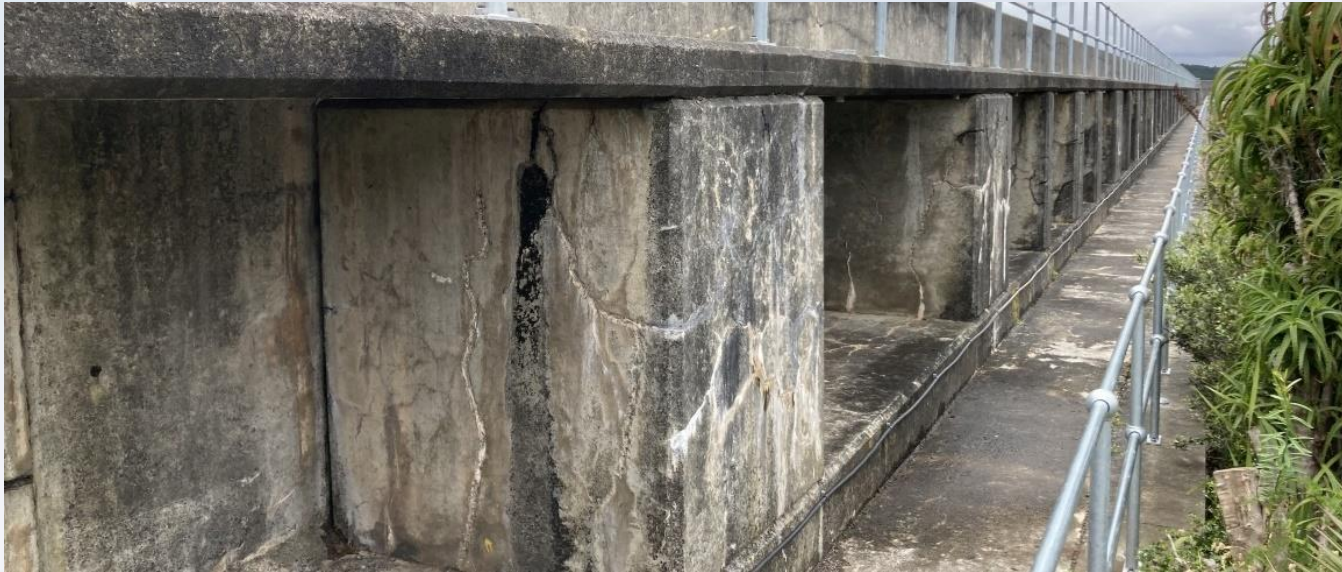
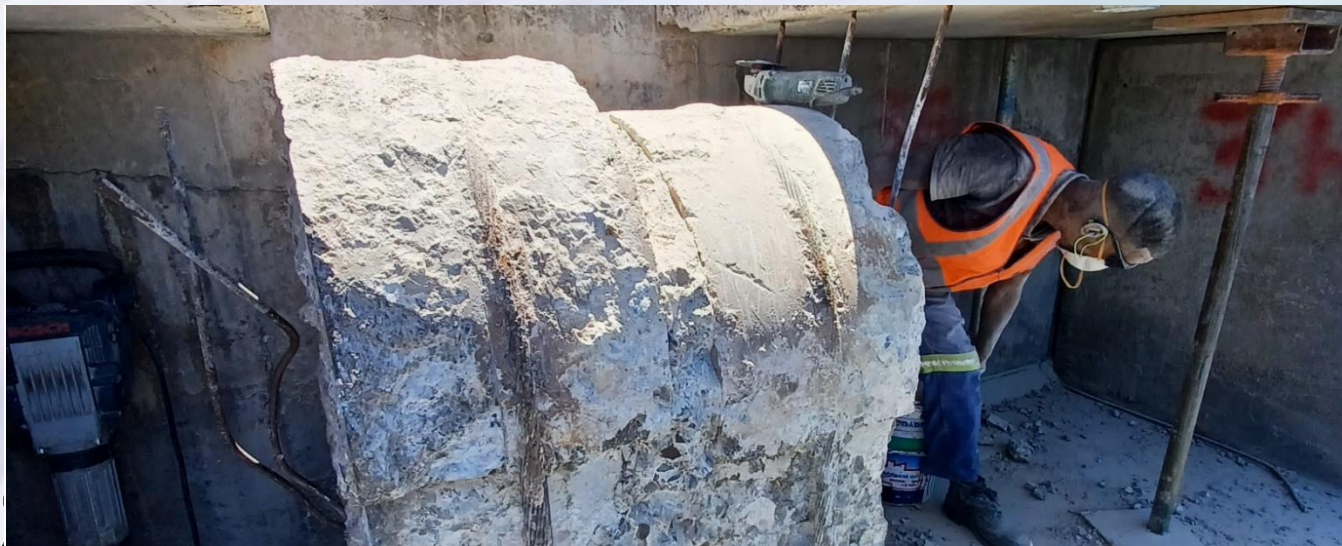
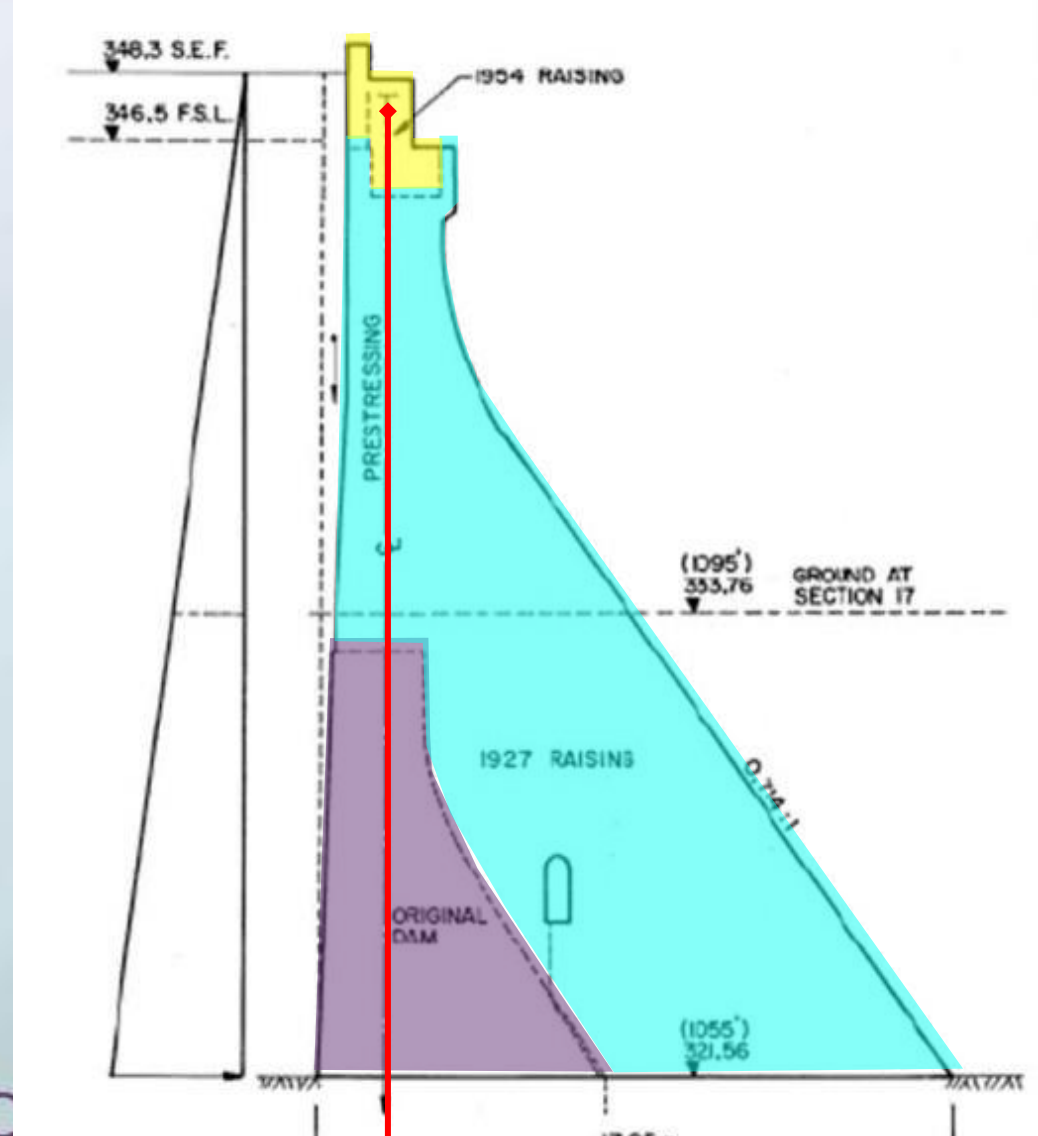
# Anchor cables

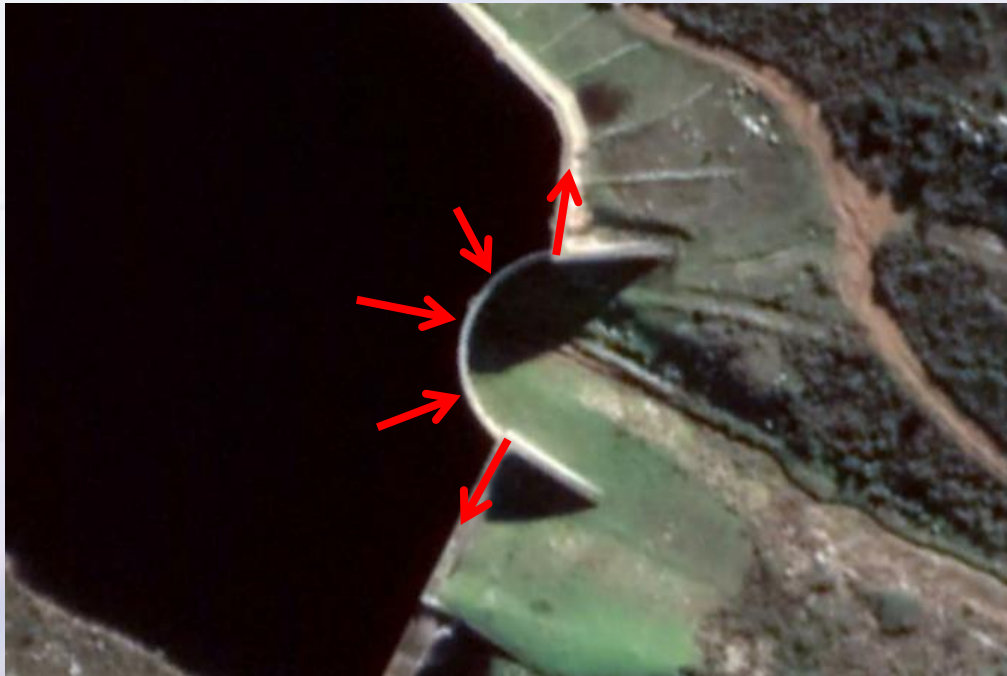
## WINTER

- Dam full
- Colder temperatures
- Downstream movement of the arch
- Limited by sand in cracks

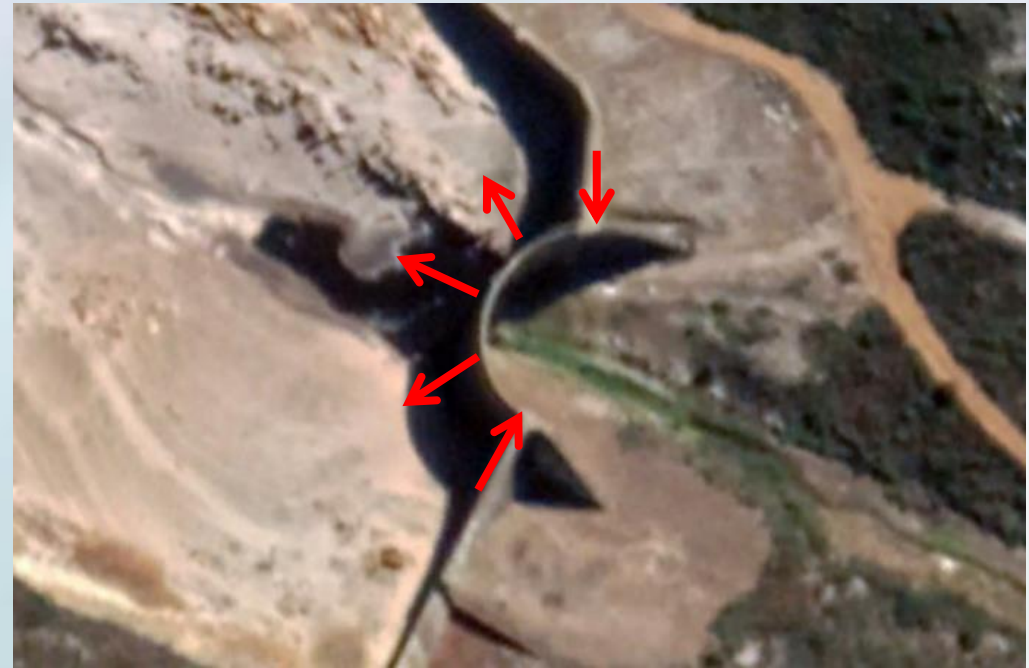
## SUMMER

- Dam empty
- Hot temperatures
- Expansion of gravity flanks causes pinching of the buttresses
- Large upstream movement of the arch

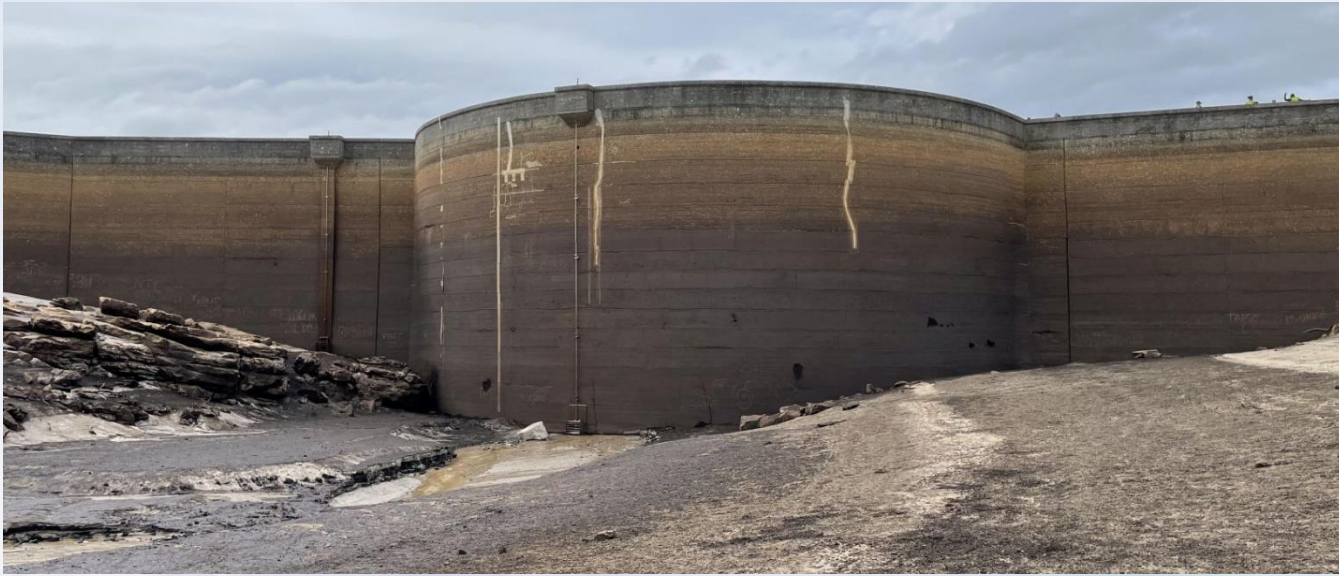
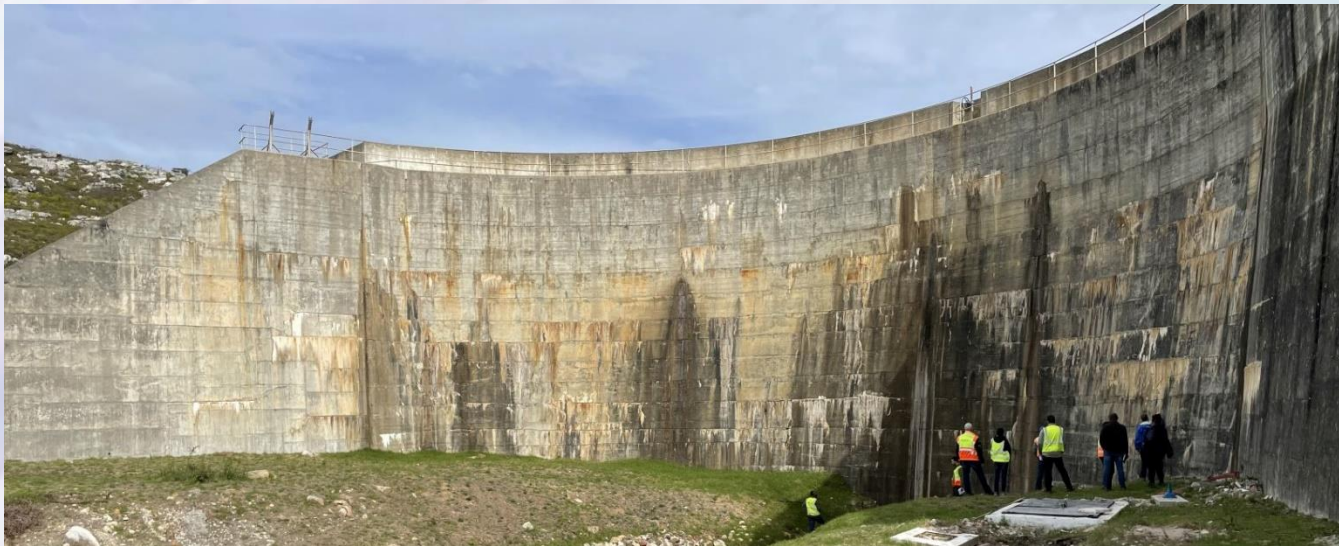
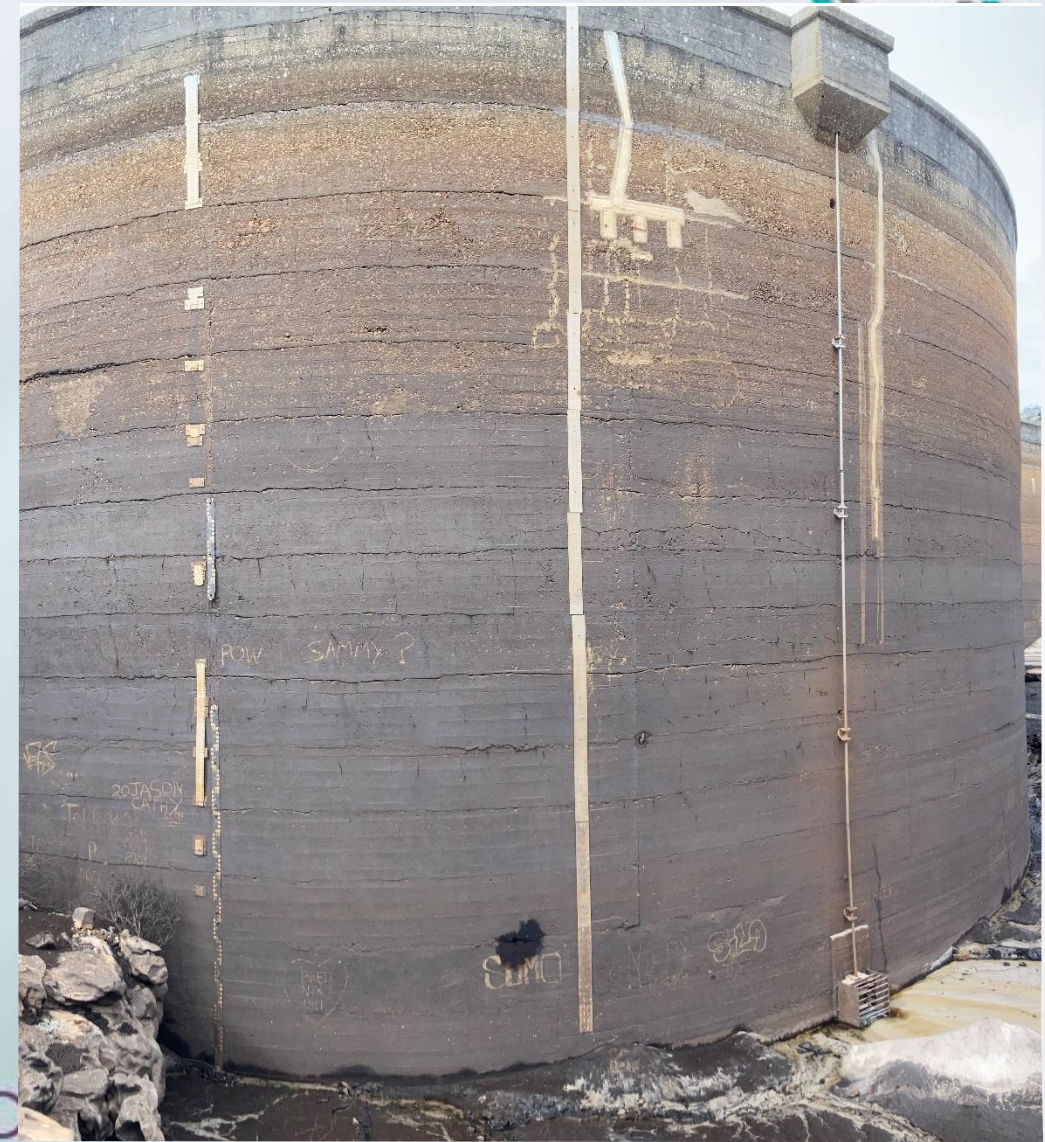
- Built in 1951
- Concrete arch dam supported by two buttresses
- Flanked by concrete gravity walls
- No expansion joints in arch section
- Only movement joints at buttress supports
- Severe vertical cracking and leakage in the arch

# Cracking and leakage

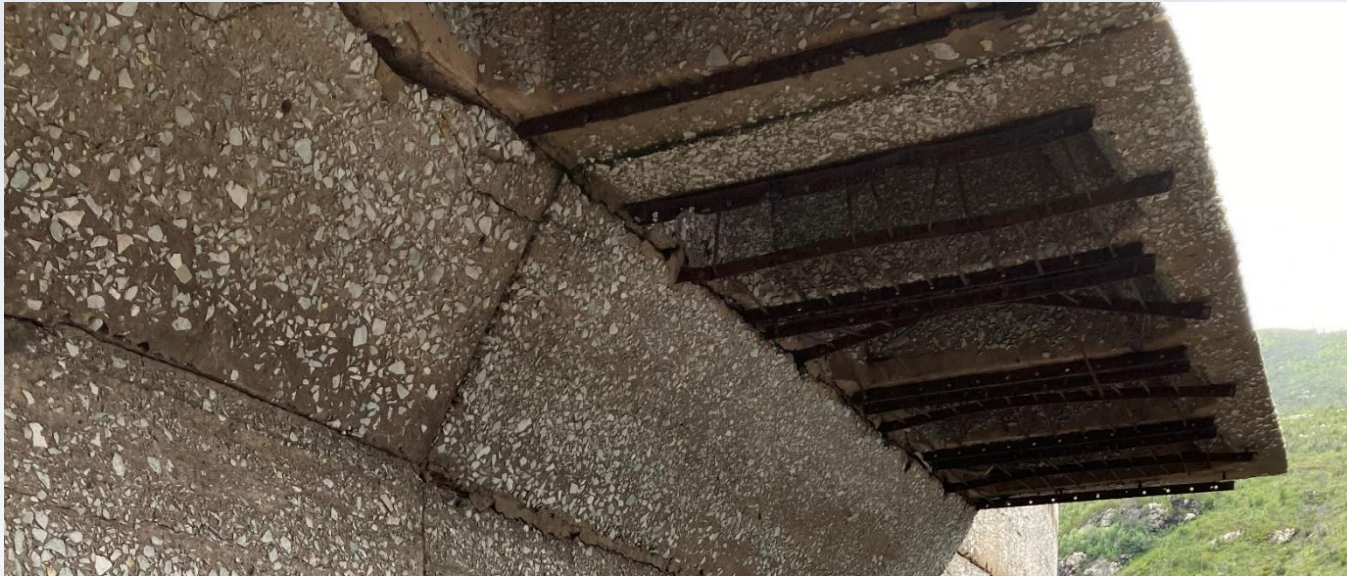
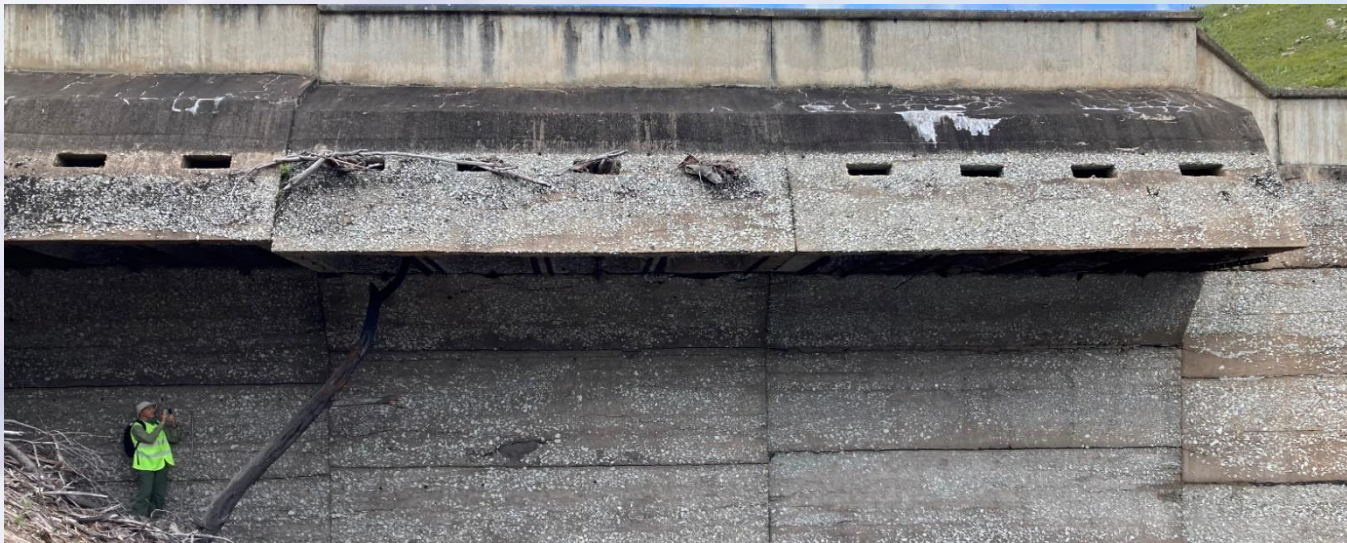
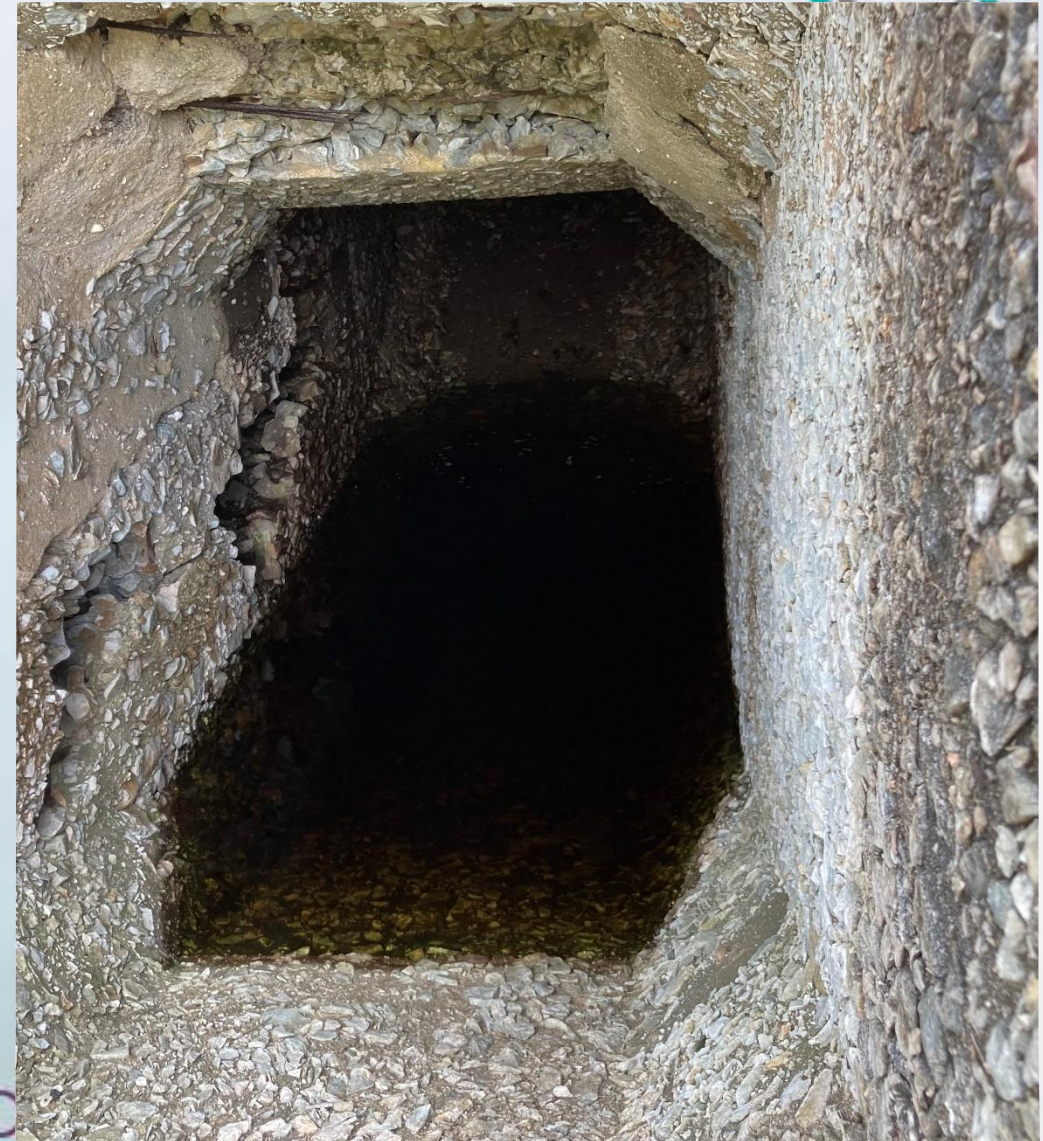
# Siphon up close
