CONCRETE REPAIRS & JOINT SEALING ON NATIONAL ROUTE N1-19 FROM KLEIN RIETSPRUIT TO N12/POTCH

John W Hodgson

BVi Consulting Engineers Western Cape (Pty) Ltd

29 August 2023

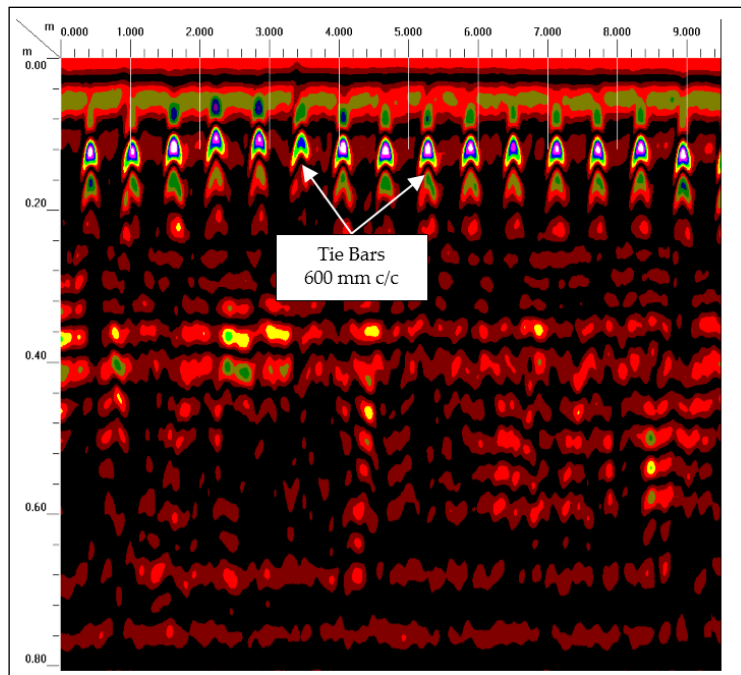
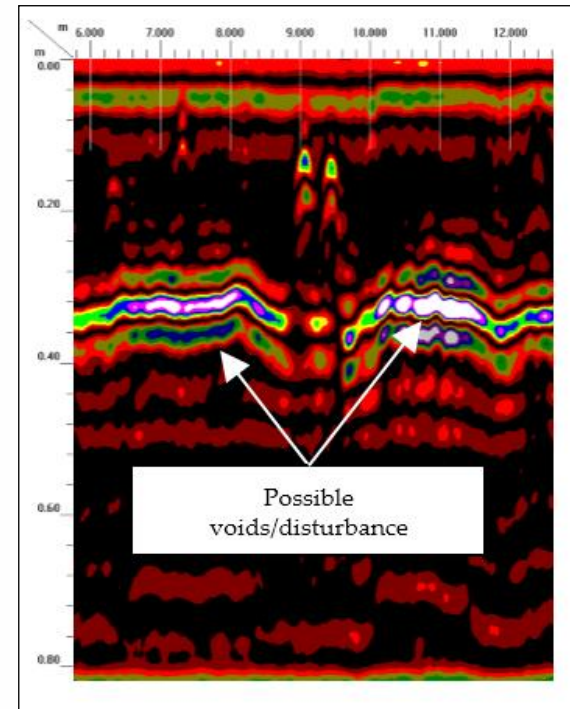
- Materials Investigation – GPR Survey

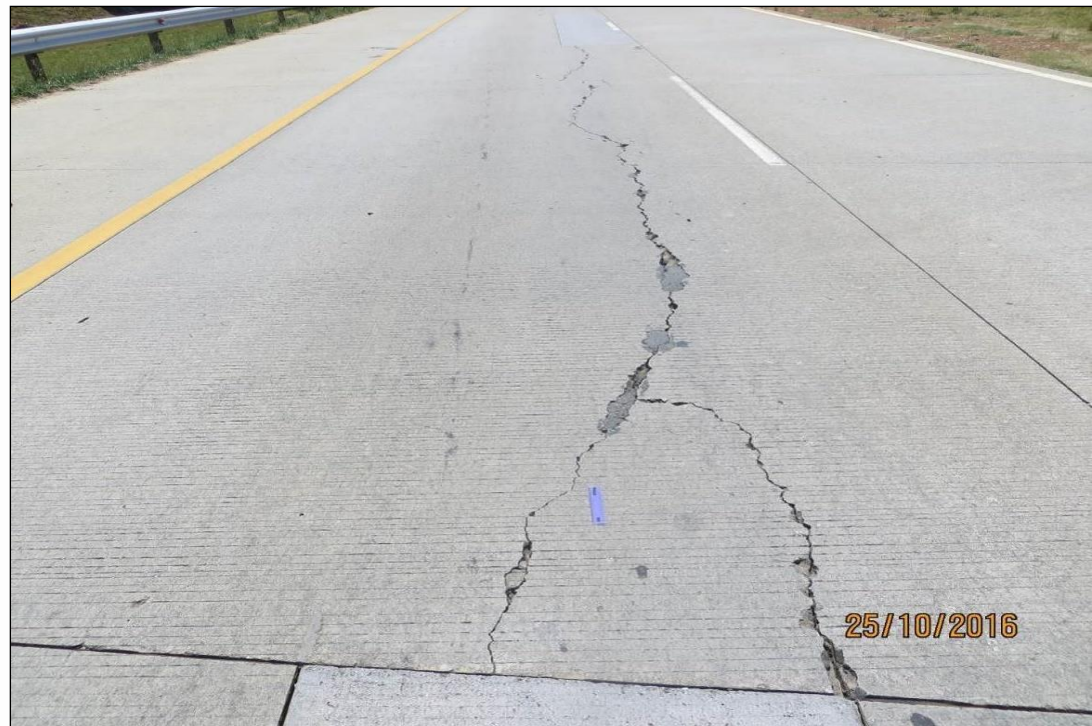
- Pavement History
 - Visual Condition:
 - Spalled longitudinal cracks

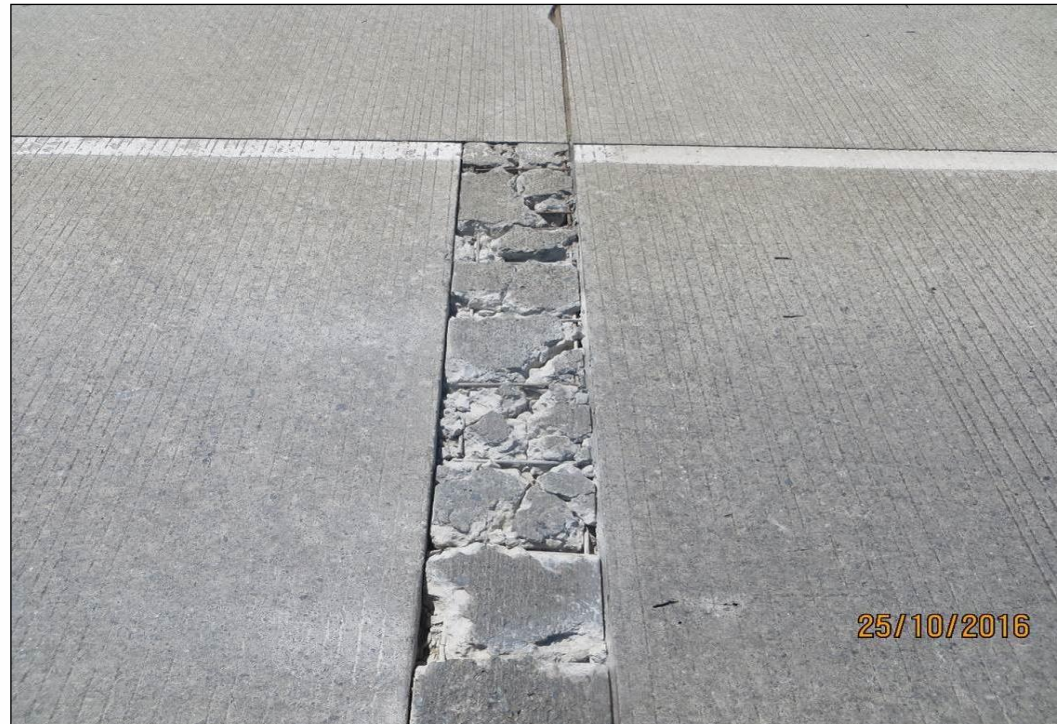
- Pavement History
 - Visual Condition:
 - Failed concrete patch with rebar exposed (previous strip repair)

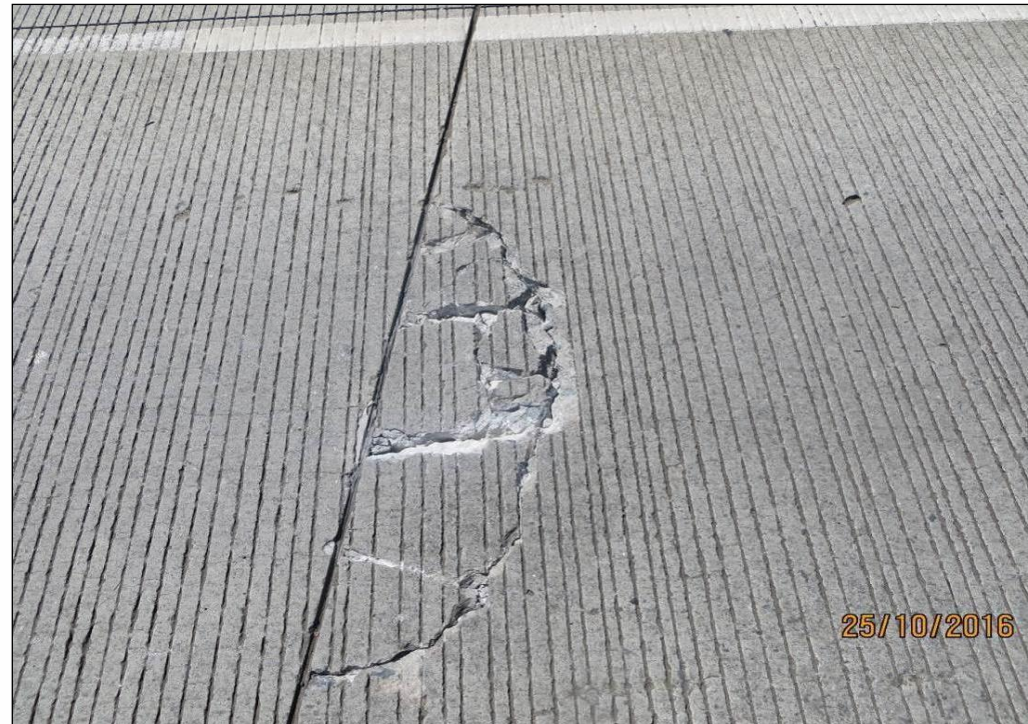
- Pavement History
 - Visual Condition:
 - Typical D-shaped edge break along transverse joint

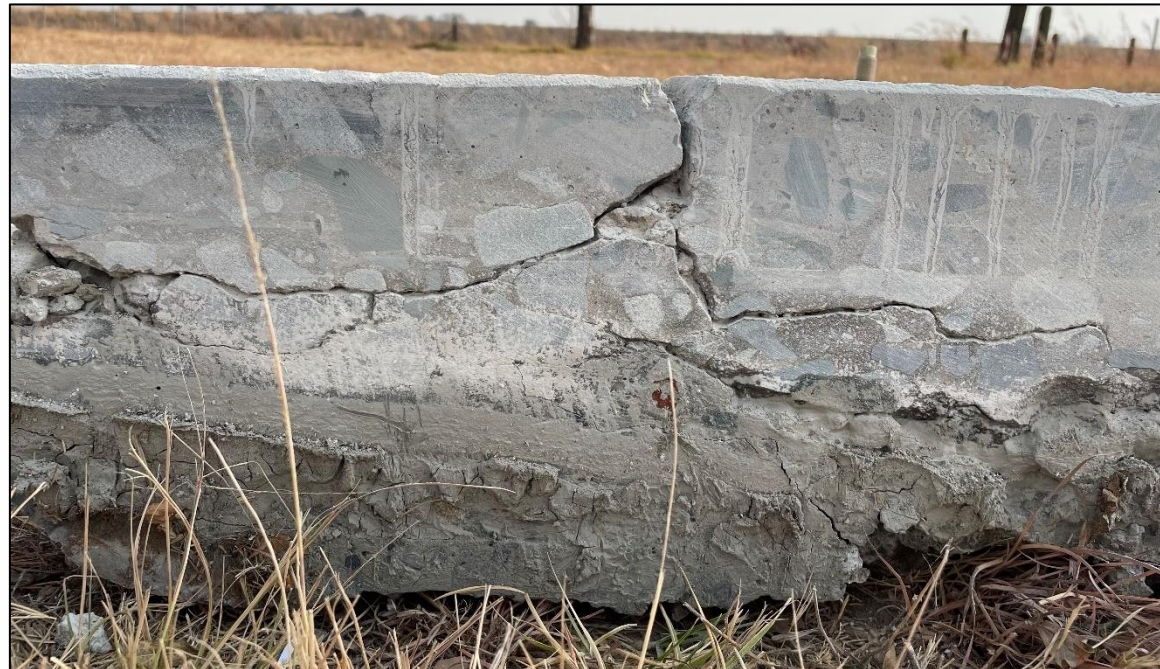
- Horizontal cracks
 - Developed \pm one third to half-depth within the concrete slab.

- Horizontal cracks
 - Transverse cracks develop $\pm 300\text{mm}$ to 500mm from transverse joint;
 - Possibility that this can be related to the shallow cut depth of transverse joints;
 - Slabs in compression leading to the development of horizontal cracks, progressing horizontally and upwards.

- Actual failure mechanism different to that identified during design.
- Longitudinal cracking probably due to excessive tie bar thickness.
- Horizontal cracking at transverse joints probably due to shallow saw cuts.

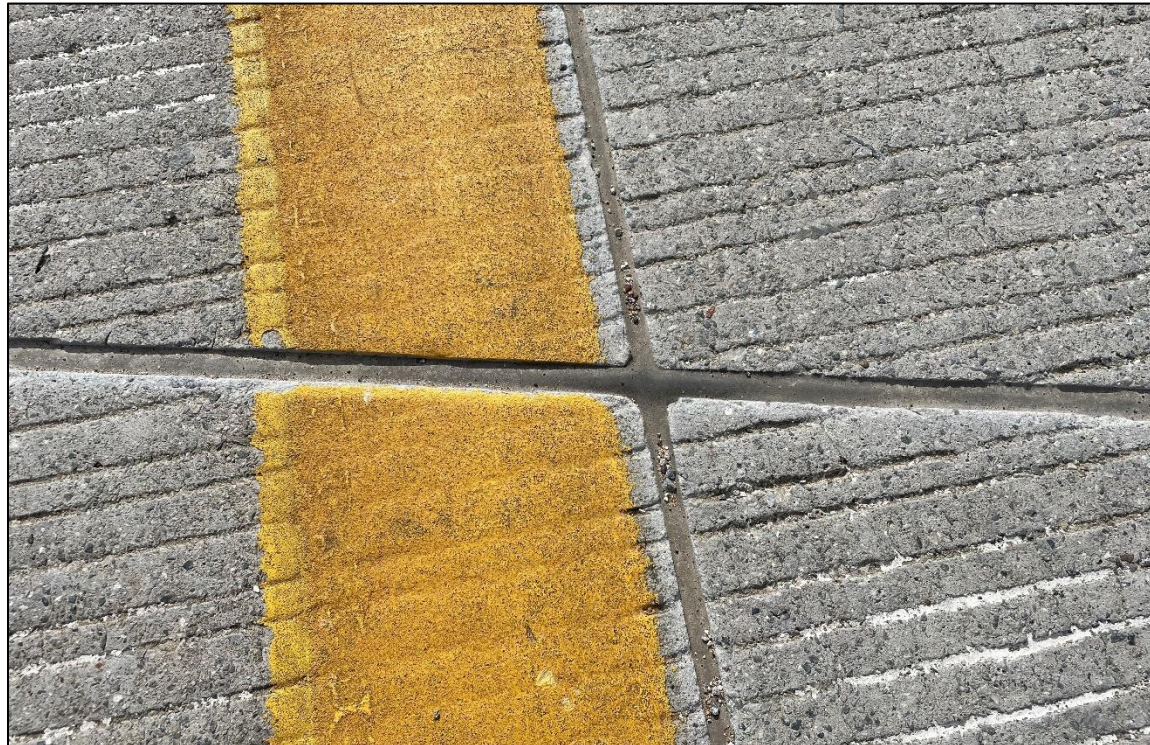
- Horizontal cracks
