# Case Study – Fire Damage Repair of the Sarnia Road Bridge

Thobekile Ngcobo Graduate Engineer and  
Kevin Volmink Pr Eng

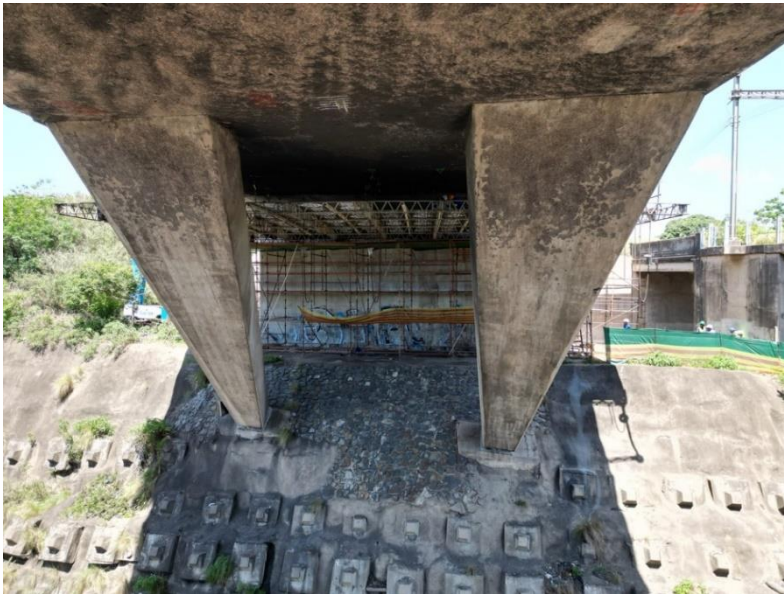
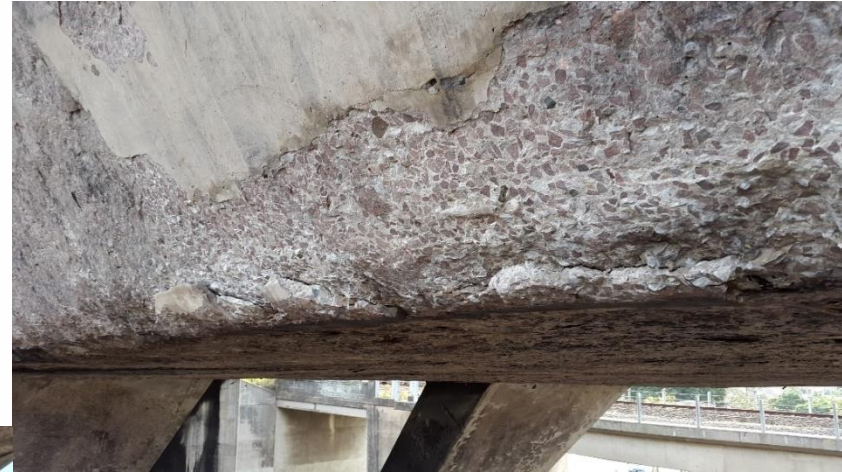
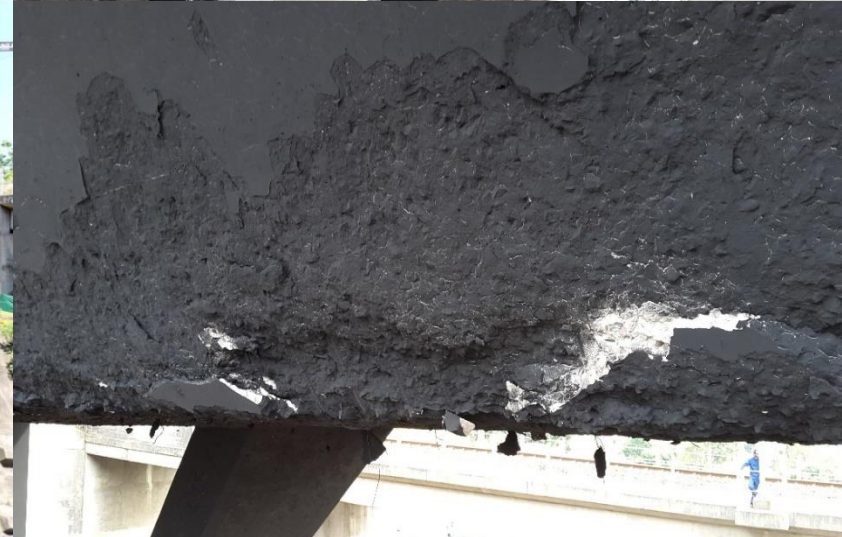
- Petrol and diesel tanker collision in August 2015
- Type of fire and location
- Response and Details of damage

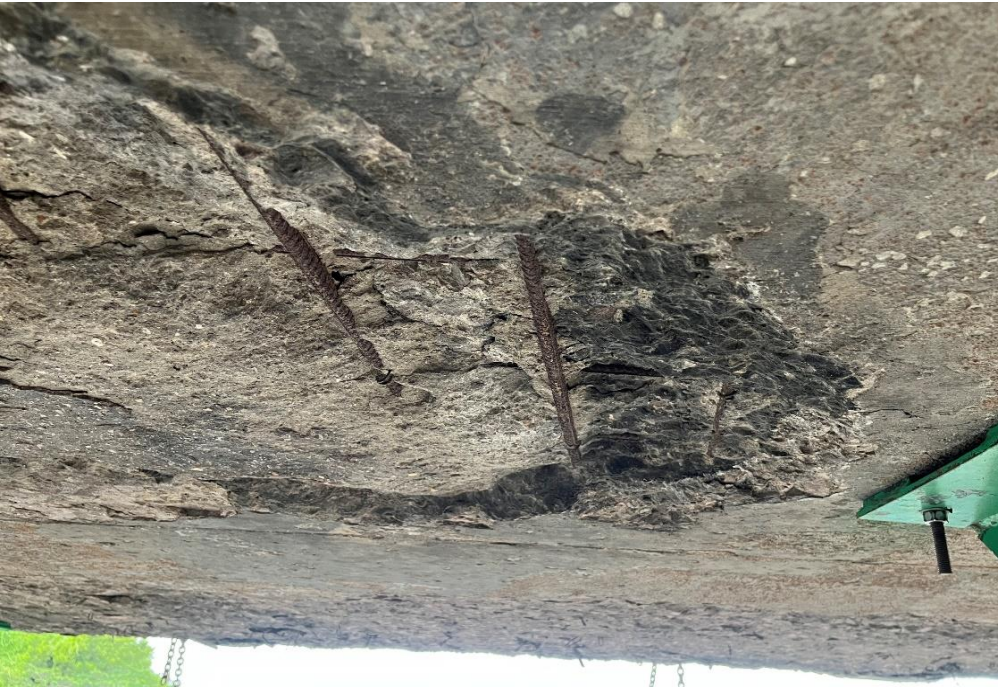
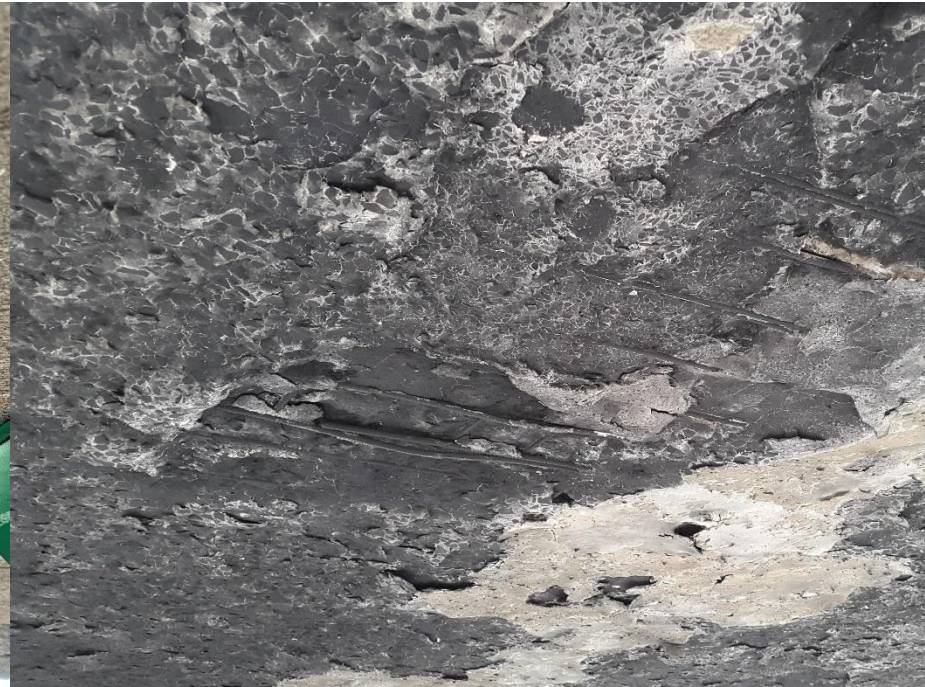
- Spalling identified on soffit and sides of the concrete box girder
- Exposure of reinforcement

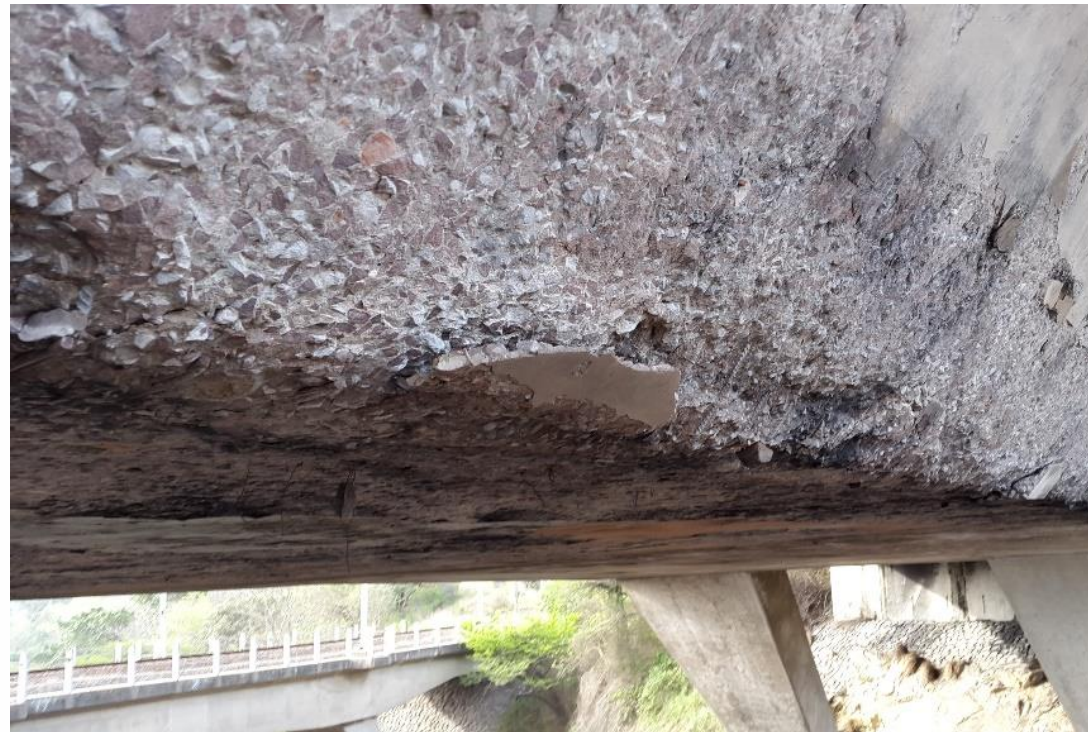
- Change in colour due to chemical and physical changes when exposed to high temperatures.
- Quartz-containing concrete turns pink/red between 300°-600°C.
- Discolouration near fire's location suggests exposure above 300°C.

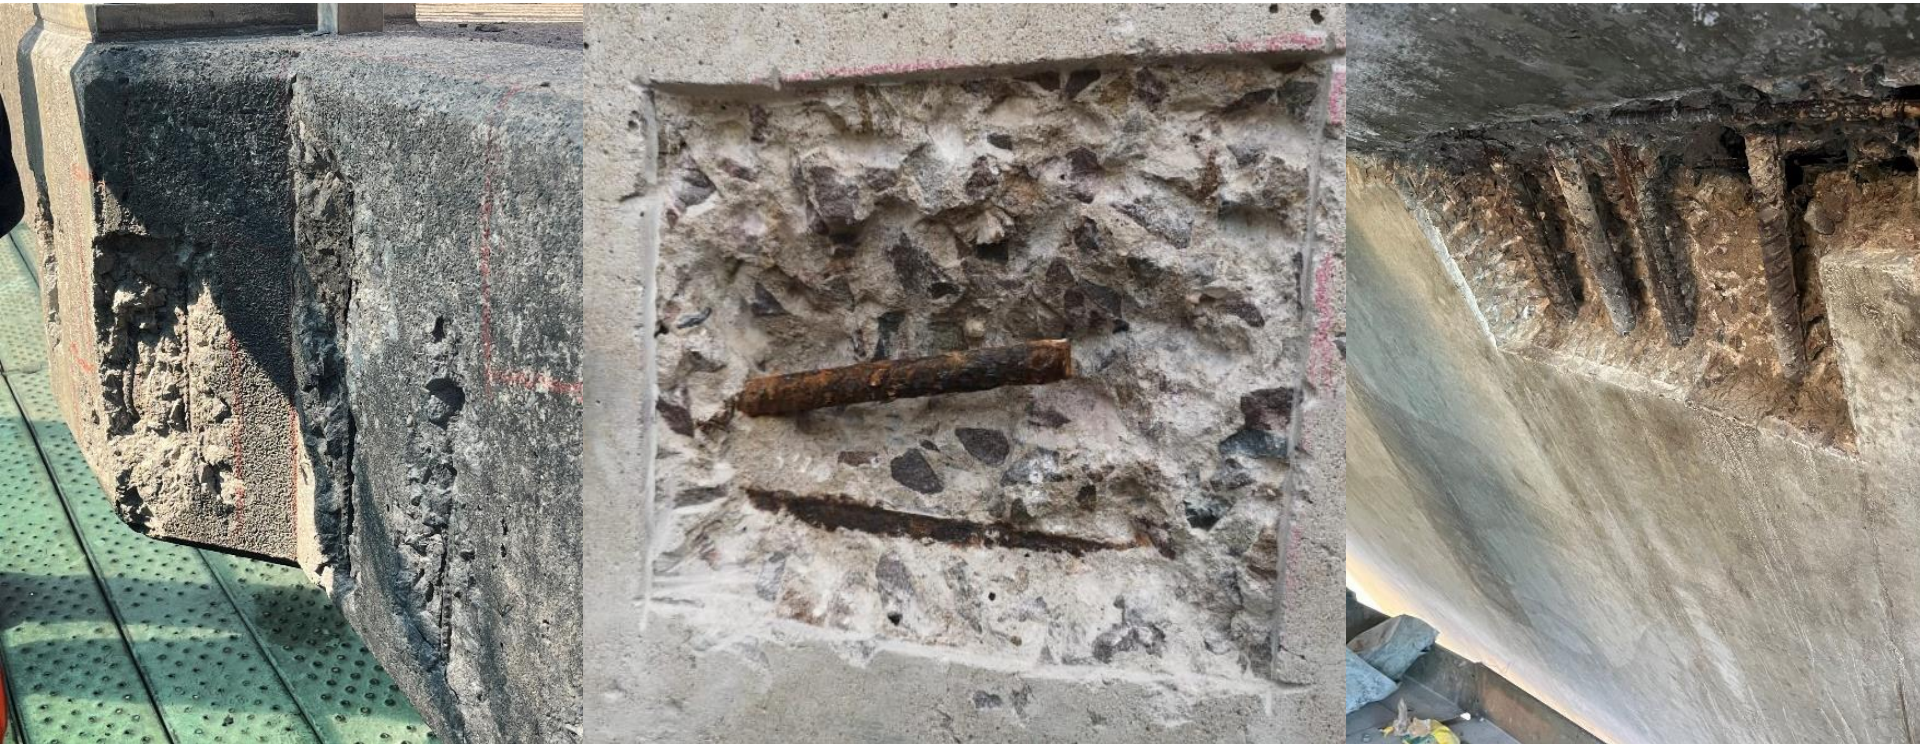
- More than 120m<sup>2</sup> of the surface area of the bridge was spalled off due to carbonation and chloride induced corrosion.

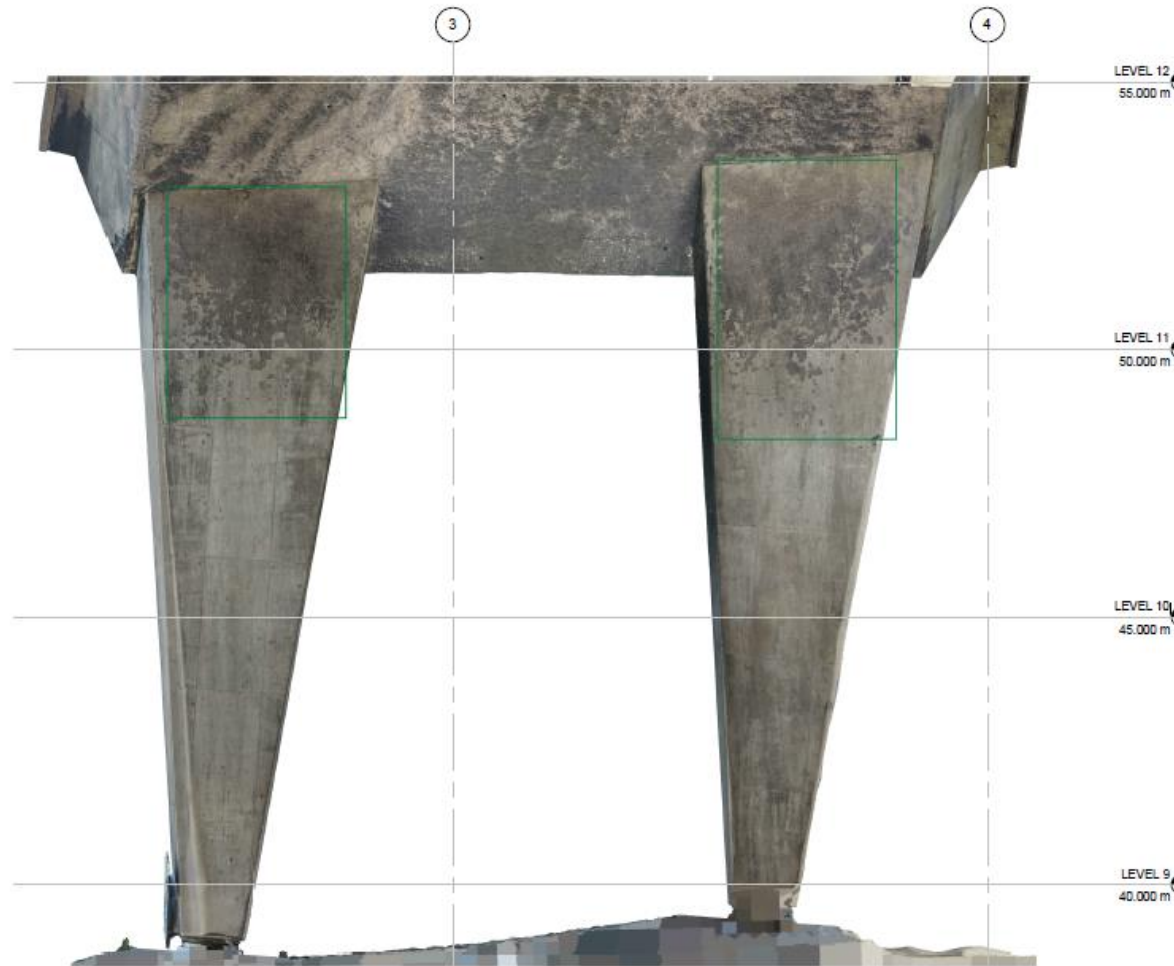
- Digital twinning
- Other defects: concrete spalling/exposed rebar, potential delamination, cracking and failure of existing repairs were identified.

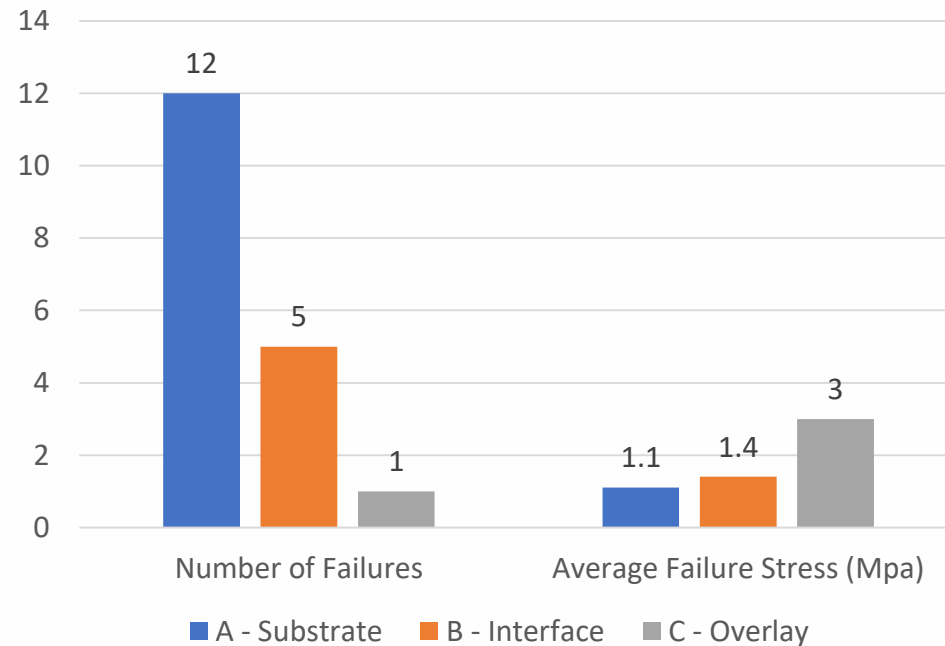
Bond Strength of Repairs (Pull Off Test)

- Sprayed concrete Class D32/40-  
XC4
- Compressive Strength (56,5 Mpa)
- Bond Strength
