## Evaluation and rectification of concrete defects in hydraulic structures during DLP-case of Isimba Hydro Power Plant (183mw) in Uganda

**Godfrey Rwakafunjo (1), Chad S. Akita (2) Muzafalu Kayondo (3)**

(1) Civil Engineer, Uganda Electricity Generation Company Limited (UEGCL)

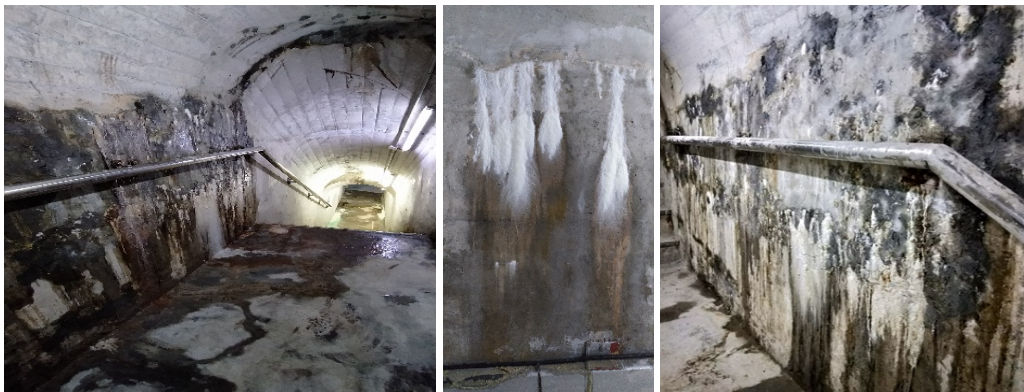
The seepage was through the walls, floor and joints that were more evident in lower galleries that included EL1017 (drainage gallery) EL1024masl (grouting gallery) EL1025masl (spiral case floor) EL 1030masl (cooling water floor) and EL1037masl (turbine pit floor).

With the dam crest at EL 1057masl a hydrostatic pressure head of 20-40meters largely influenced the magnitude of the leakages in the galleries (see Figure 2).

Figure 2: Concrete leakages along staircase from EL1025 and at EL1017

In other areas under hydrostatic pressure with numerous leaking points, curtain grouting was recommended that involved use of Sika 201 Injection while drilling grouting holes perpendicular to the wall at a spacing of 300mm from each other as shown in Figure 6.

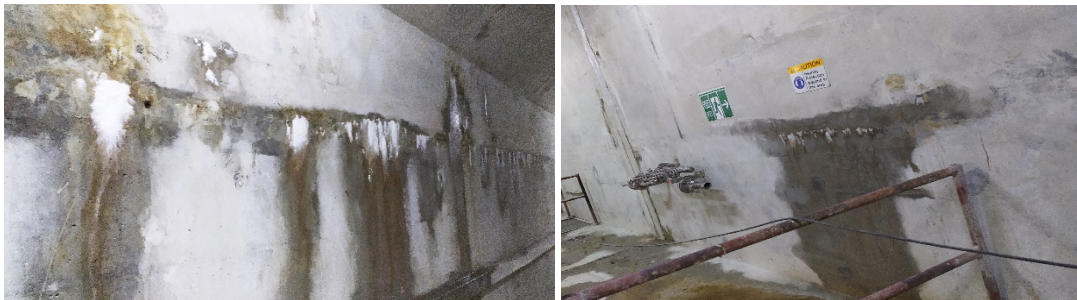
These were distributed across all the elevations more evident in the lower galleries (Figure 3).

Figure 3: Damp spots and leakage along lift joints at EL1024 and EL1017

The methodology was onsite based, with different defects having different methodology. Leakages along construction joints were injected with Sika 201 (polyurethane based material) at a spacing of 300mm, 400mm depth with pressure in the pump at 8-10MPa and holes drilled at an angle of 45° to the wall.

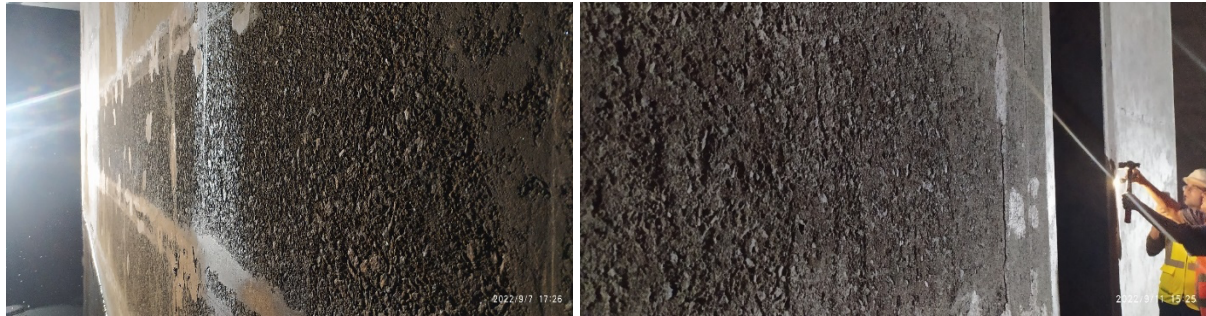
These were the most critical concrete defects experienced at Isimba HPP having been observed just after 2 years of commercial operation. They included; severe washout (Figure 4) and abrasion damage, exposed reinforcement, concrete spalling, long transverse concrete cracks, concrete pop outs at some sections of the ceiling slab, joint leakages and damp spots along the spiral case wall, leakage through crack seals and cavities in 2<sup>nd</sup> stage concrete.

Figure 4: Severe abrasion in Unit 3 draft tube (left) and abrasion in Unit 3 spiral case(right)

Soft water attack was suspected after the first inspection of the spiral case owing to the uniform abrasion on the walls. Whereas during the preliminary stage soft water attack was ruled out by calculating Lingerie index, the recent developed Basson Index carried out in September 2022 confirmed the soft water attack of River Nile water on concrete. All the total calculated corrosion values from the samples obtained were greater than 1100 indicating a very high aggressiveness of the water [8].

Concrete repair for damaged surfaces, and lift joints in unit #1 #2, #3, and #4 spiral cases was undertaken using;

- i. Sika Monotop 412S; a fiber reinforced low shrinkage repair mortar, then
- ii. Sikagard 720 Epocem; an epoxy modified mortar to act as a moisture barrier and
- iii. Sikagard PW; an epoxy coating with outstanding mechanical and chemical properties as a final sealing protective coating.

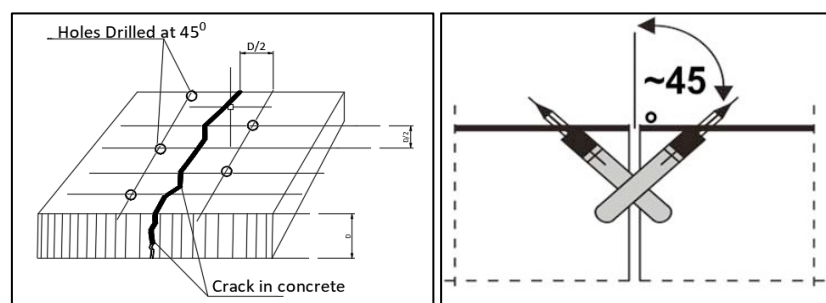
Figure 5: Schematic diagram showing spacing of grouting packers

Along a dry or wet crack, packers were installed at an offset of 300mm from crack- packer and packer- packer which was equivalent to  $\frac{1}{2}D$  as shown in Figure 5 where  $D$  is the thickness of the structure. A depth of 400mm was adopted which was within the acceptable range (200-600mm). The alternating pattern was used to ensure that the crack was intercepted, since the location of the crack underneath the surface is usually unknown.

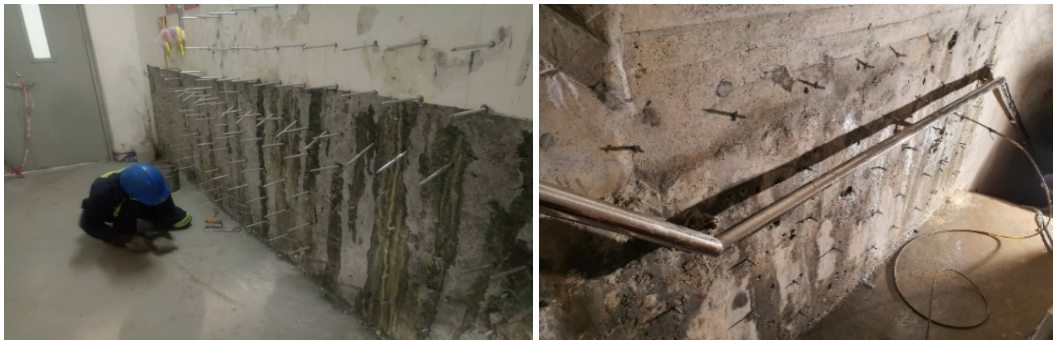
Figure 6: Curtain grouting at EL1037 and stairs to EL1017

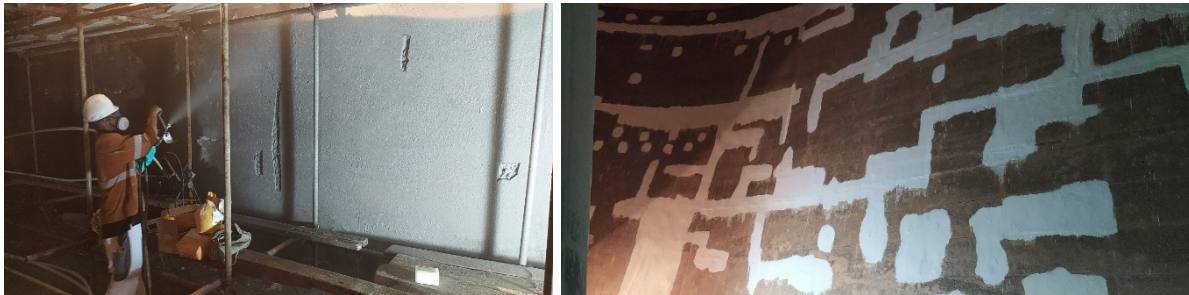
Figure 7: Final coating of Sikagard PW in Unit 3 spiral case

These products were applied independently or combined depending on the concrete defect as guided by the Sika technical personnel. Therefore, the coatings applied were designed to provide an improved concrete surface, for increased resistance or performance against specific external influences both mechanically and chemically. With only defective areas repaired instead of the whole area (Figure 7). Recommendations have been made to line the

entire spiral case walls with the same material in future. The same defects were observed in the draft tubes hence a similar procedure shall be adopted before expiry of the DLP.
