A STIFFNESS DAMAGE ASSESSMENT OF CONCRETE FROM A REINFORCED CONCRETE RAILWAY BRIDGE SUBJECT TO ALKALI SILICA REACTION (ASR) DETERIORATION IN JOHANNESBURG

Janina P Kanjee¹, Yash Thakurdin² & Yunus Ballim¹

¹ School of Civil and Environmental Engineering, University of the Witwatersrand, Johannesburg

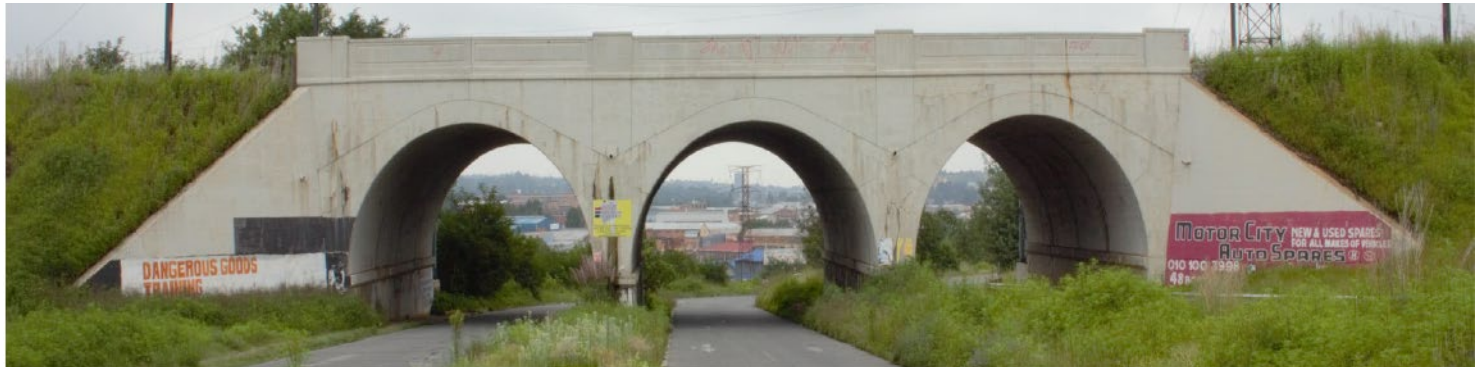
- A RC Railway bridge located in central Johannesburg which displayed signs of distress in the form of severe map-cracking, was selected as the field structure that was likely prone to ASR deterioration.

Fig. 3 : North facing view of Railway Bridge on Treu Road and Crown Mines Spur

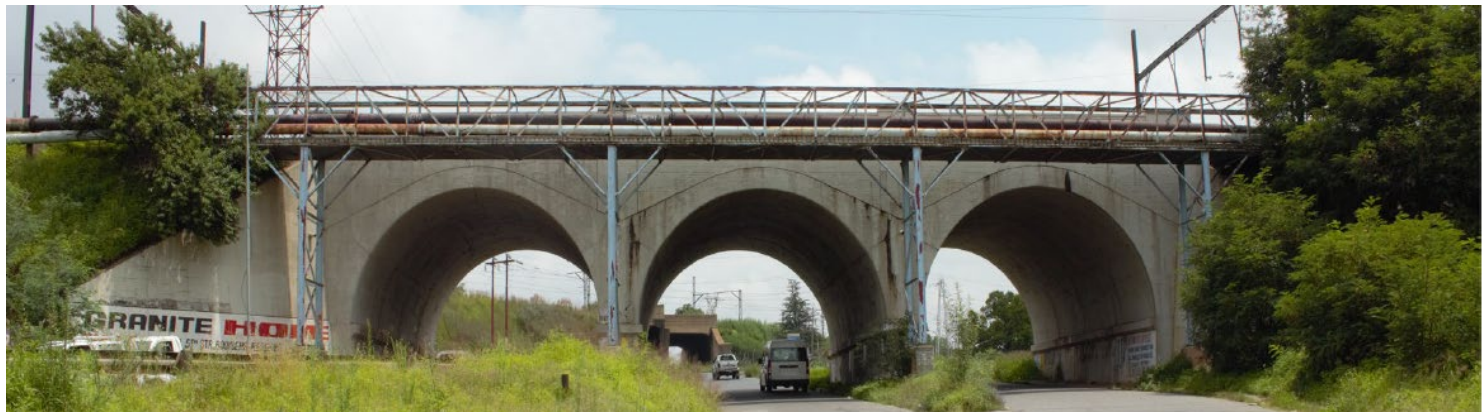
Fig. 4 : South facing view of Railway Bridge on Treu Road and Crown Mines Spur

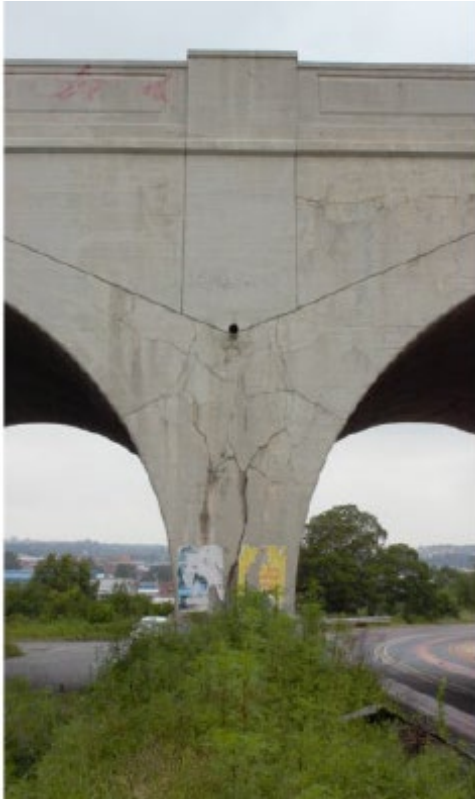
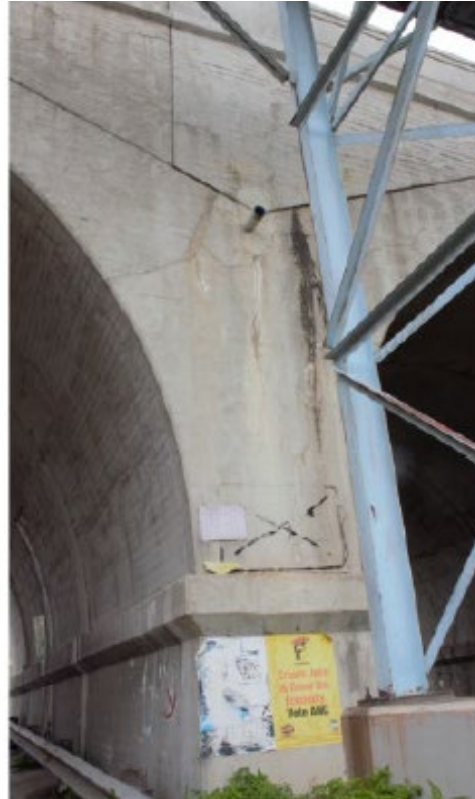
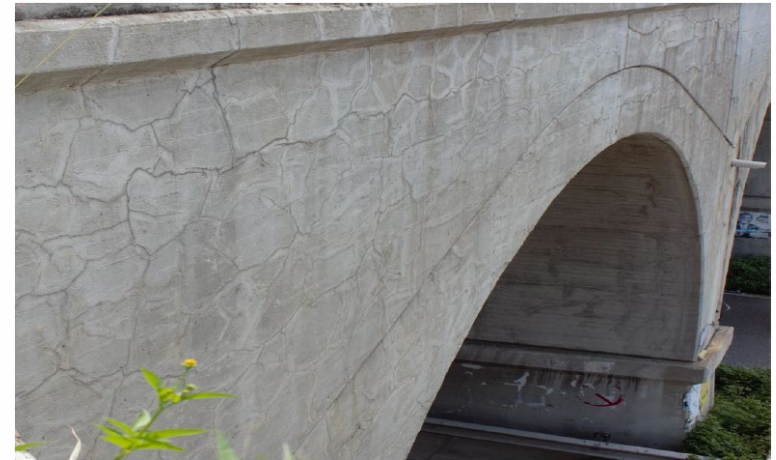
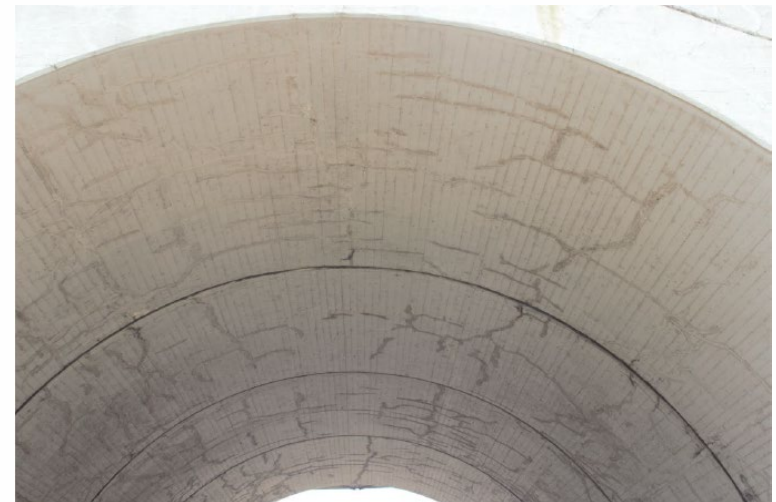
Fig. 5, 6, 7, 8 : Evidence of map-cracking on various bridge elements

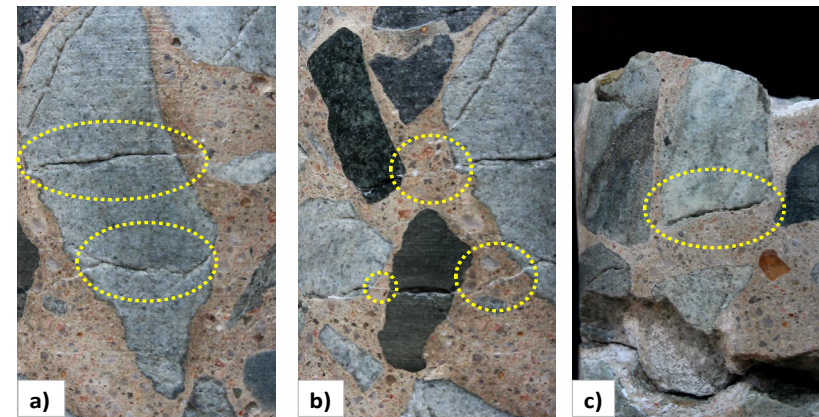
Fig. 10: Petrographic features observed in as-received cores

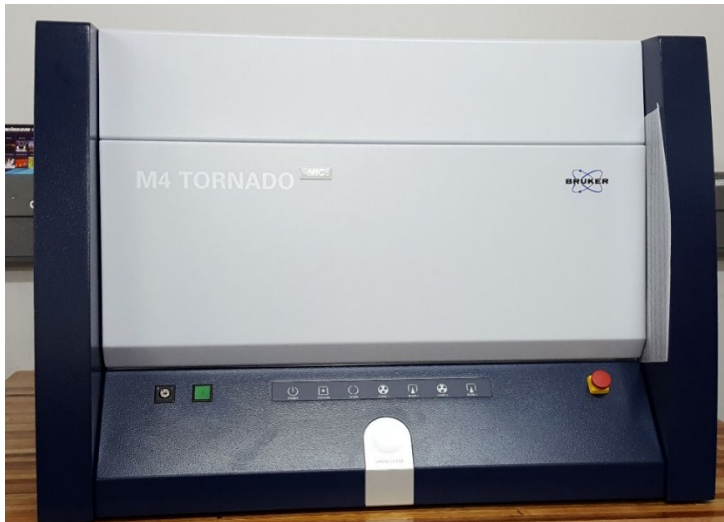
Fig 11. Bruker μ -XRF instrument at Mintek, South Africa

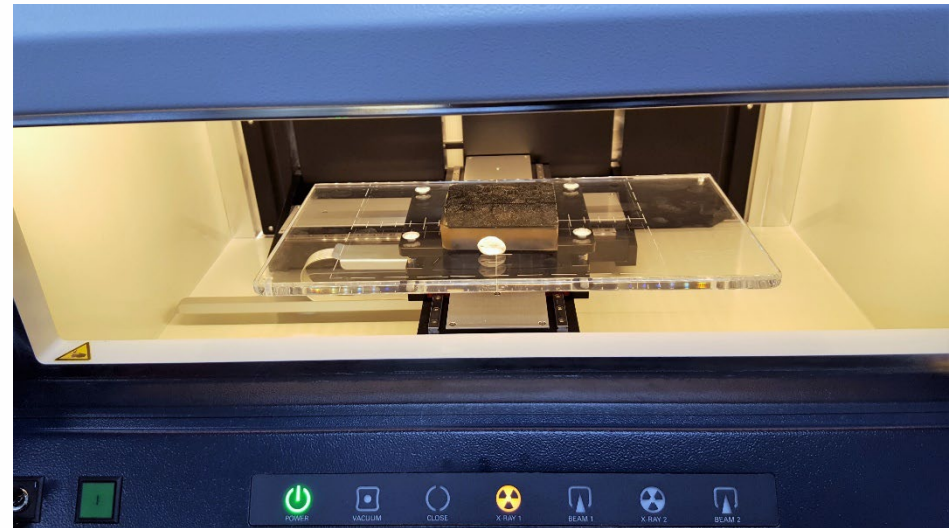
Fig 12. μ -XRF interior showing the sample stage/holder

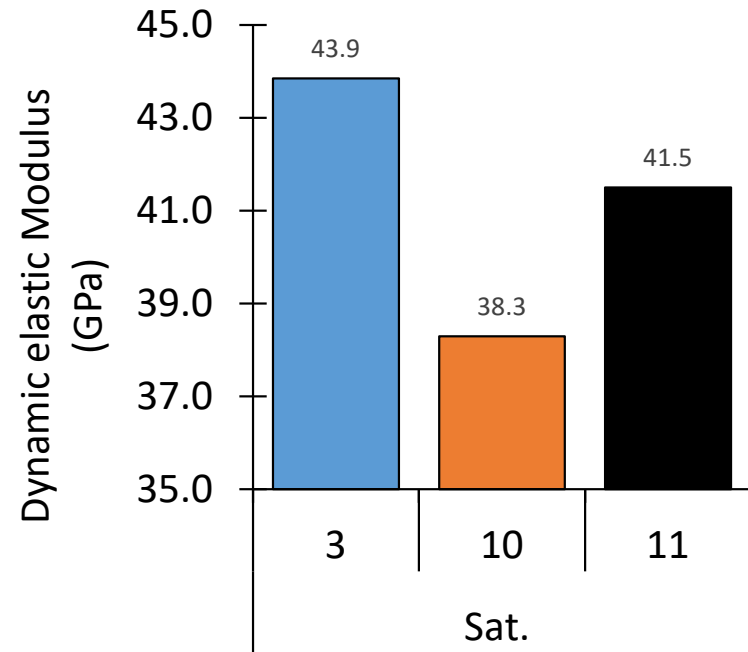
Fig.20: Dynamic elastic modulus based on pulse velocity results

Specimen	UPV (GPa)	Stiffness damage (GPa)
3	43.9	18.0
10	38.3	12.4
11	41.5	14.0

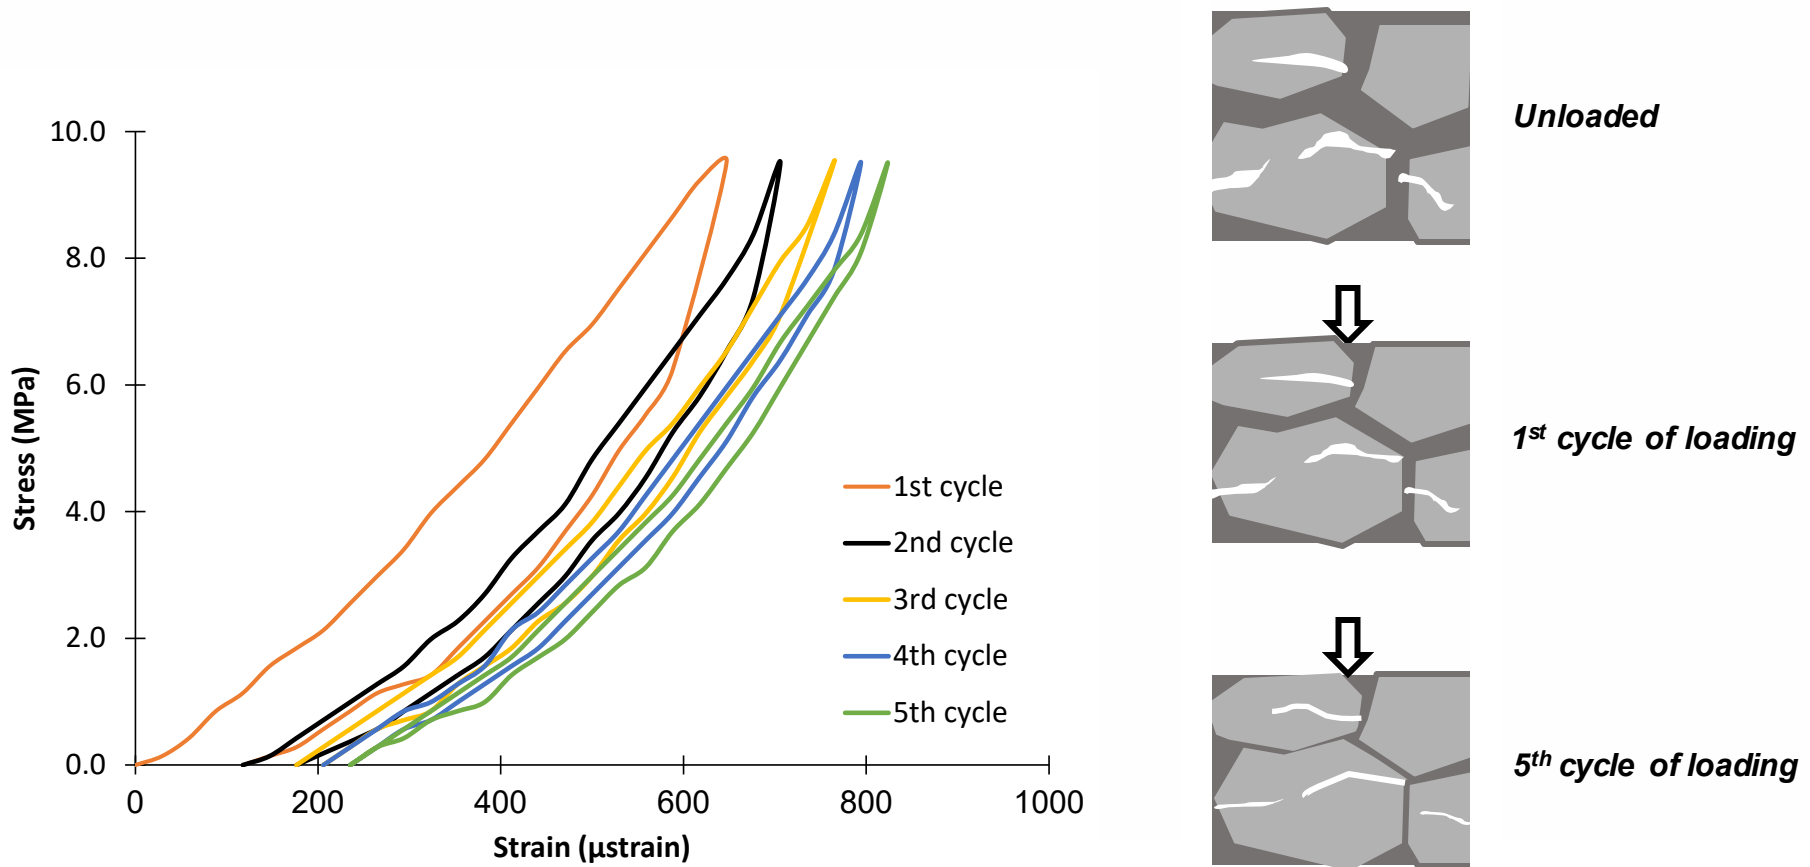
- Mechanical and cyclic test procedure, five compression cycles, Using percentage (40%) of the ultimate capacity (compressive strength) of the concrete

Fig. 21: Typical stress–strain behavior curves obtained for test specimens 3

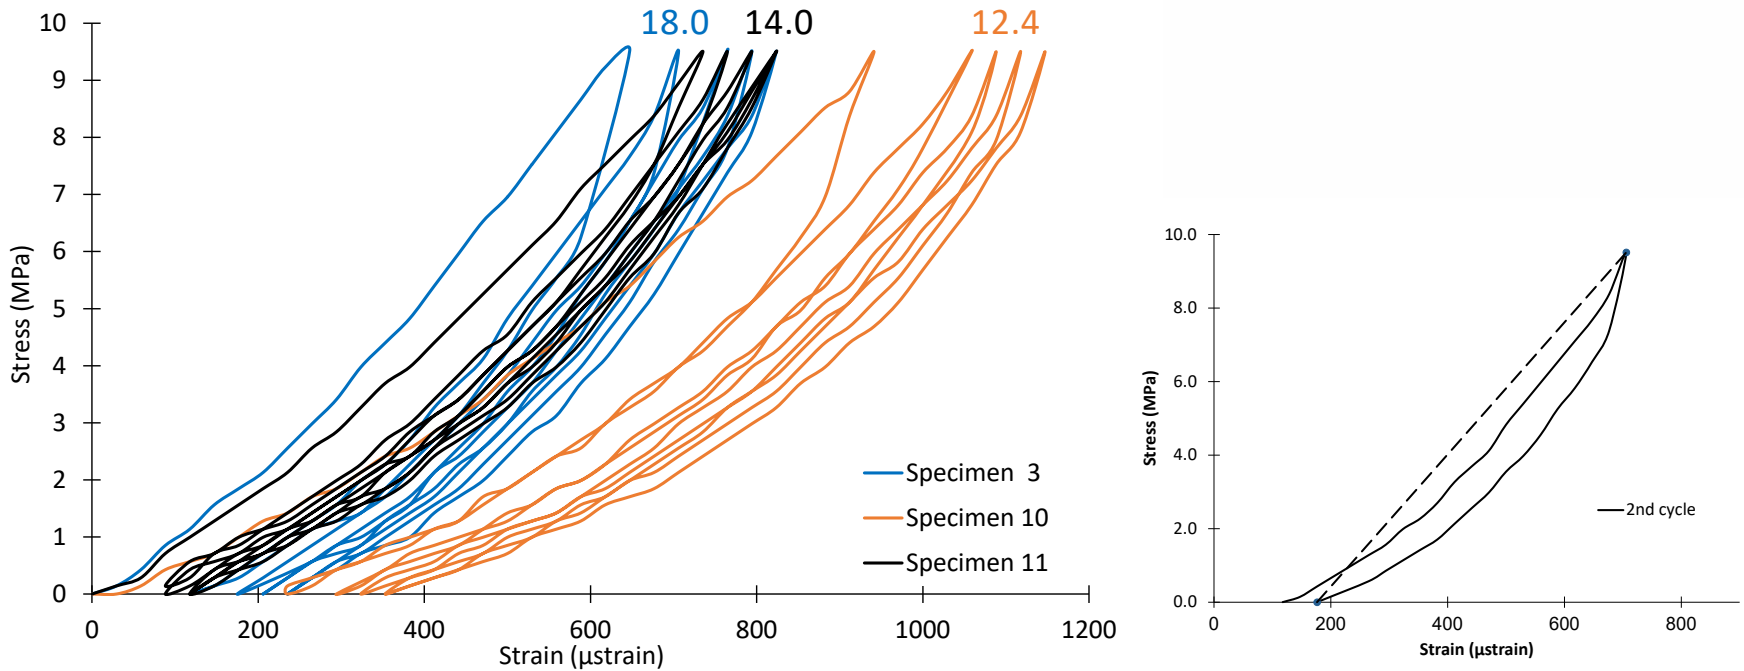
Fig. 22: Typical stress–strain behavior curves obtained for test specimens taken from various location of RC railway bridge
