# Msikaba Bridge Inclined PT Grouting

# Grouting Requirement

## PT in Anchor Blocks

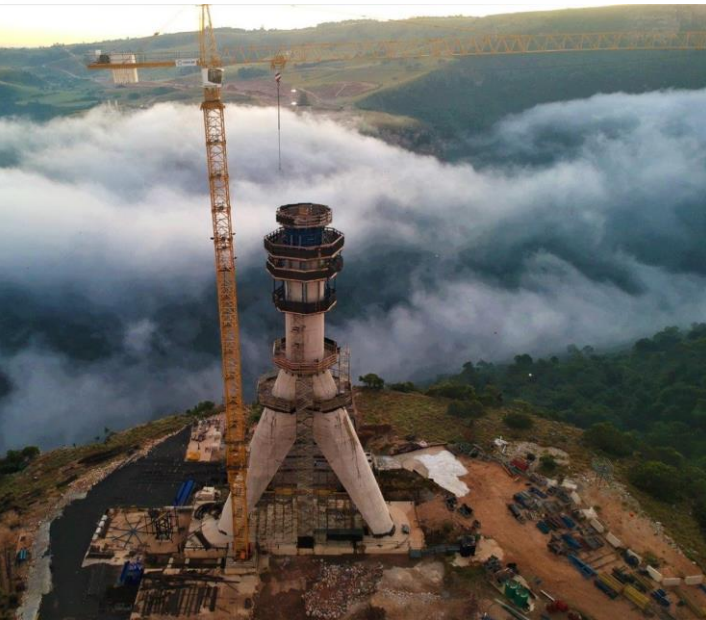
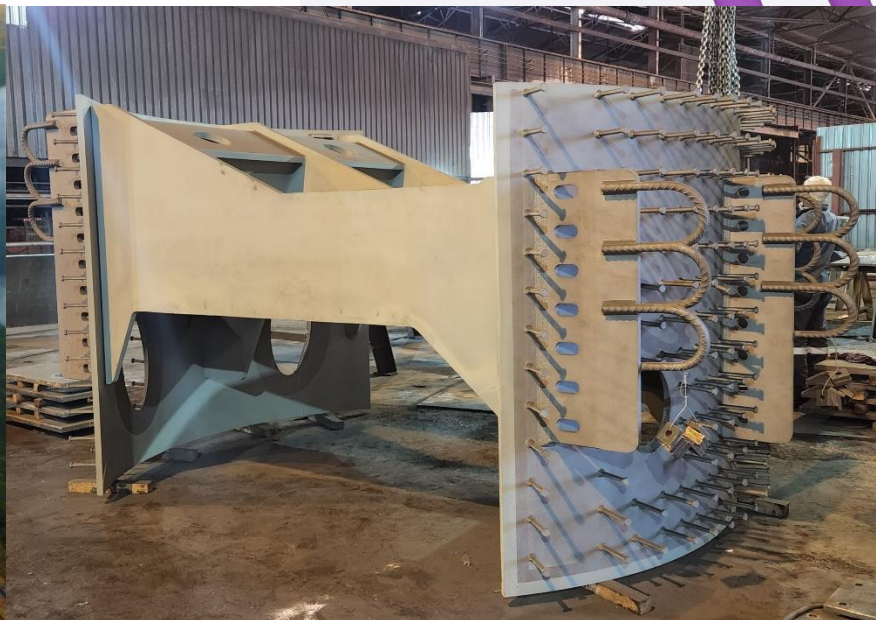
## Pylons

- Two identical inverted Y shaped concrete pylons 127 m High
- Taper from 4.5 m diameter at the pylon head to 6 m at the top of the inclined legs.

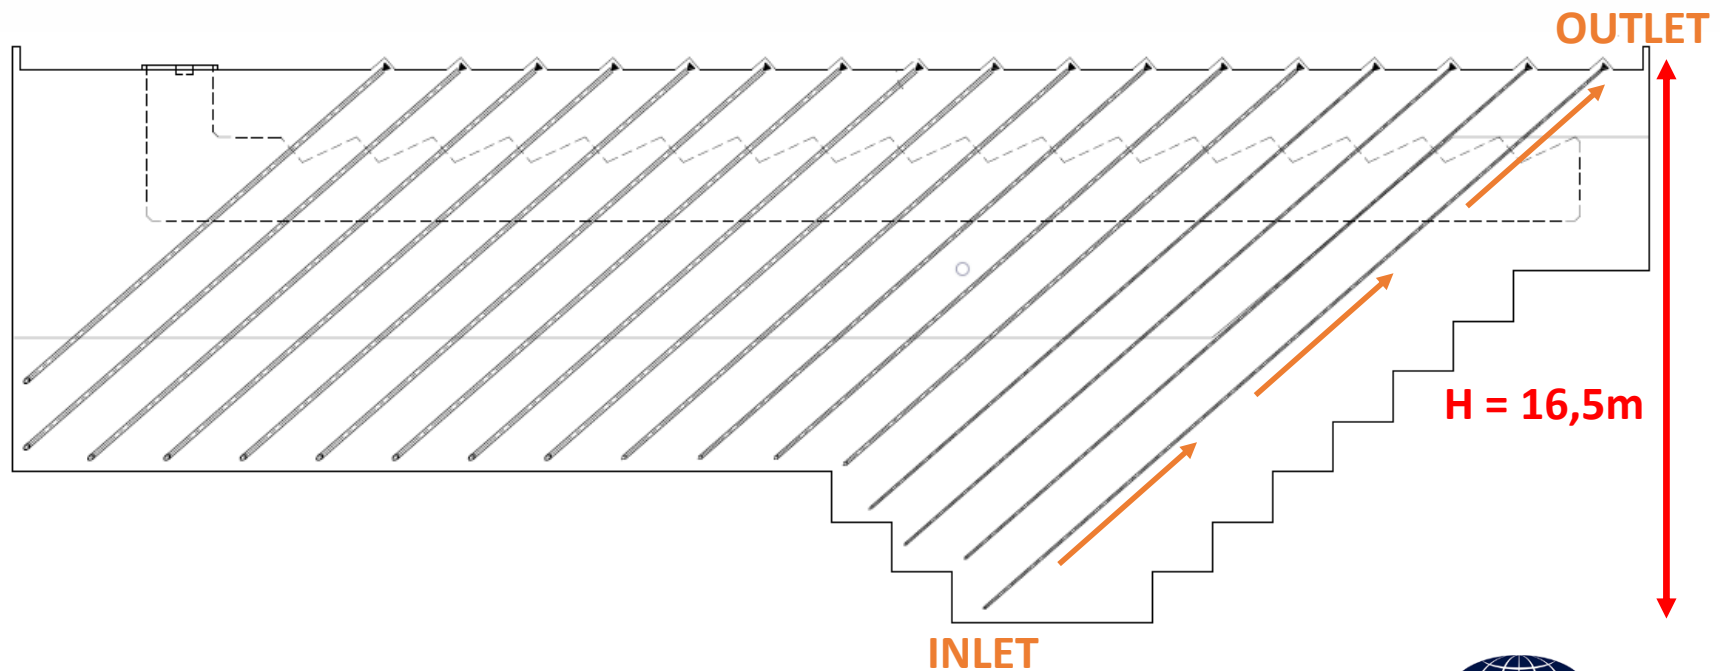
## Msikaba Tendons

- Unconventional structure and PT in SA
- Significant elevational changes (h) in tendon profiles
- Significant differential hydrostatic pressure in uncured grout (Settlement, bleed)
- Grout properties and testing not conforming to EN 445 and EN 447

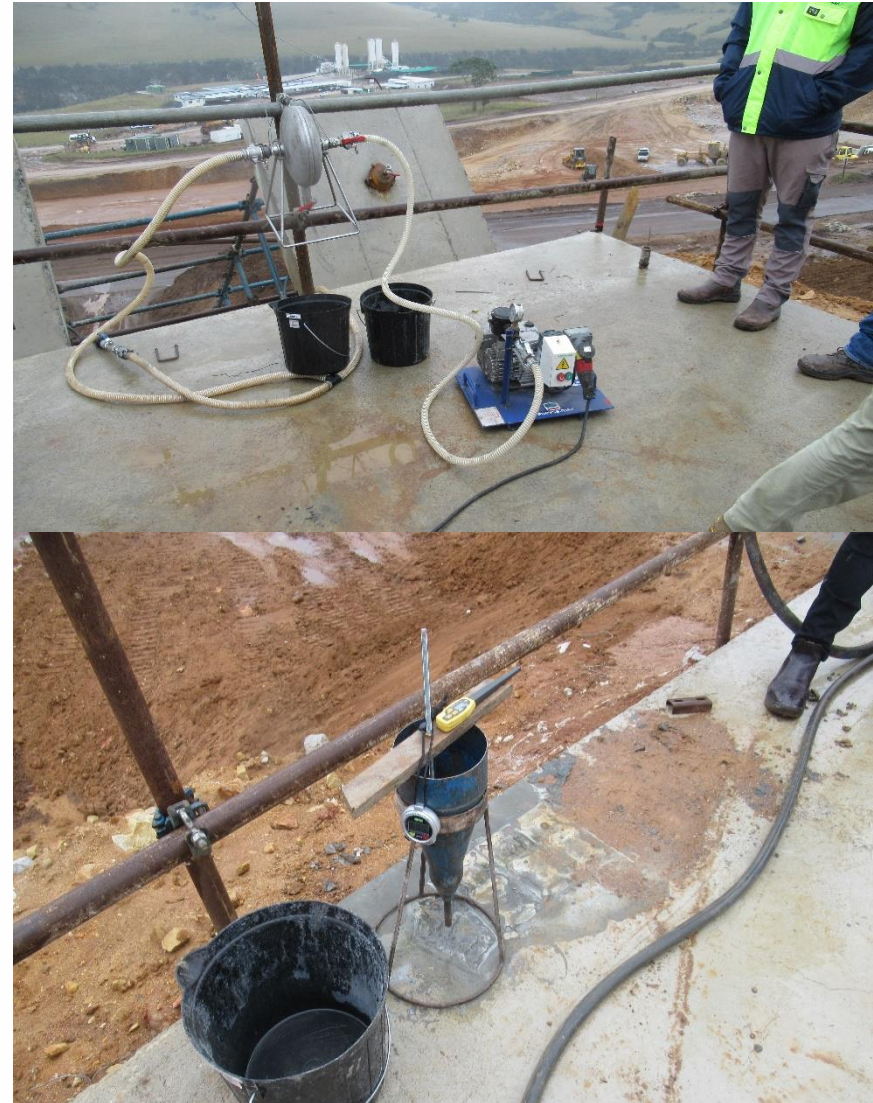
# Grouting Requirement Msikaba Tendons - Challenges

- Bleed water control/management?
- W/C Ratio?
- Pressure gradient – effect?
- Lack of reabsorption of bleed water
- Workability vs setting time
- Repeatability/robustness
- Compressive strength

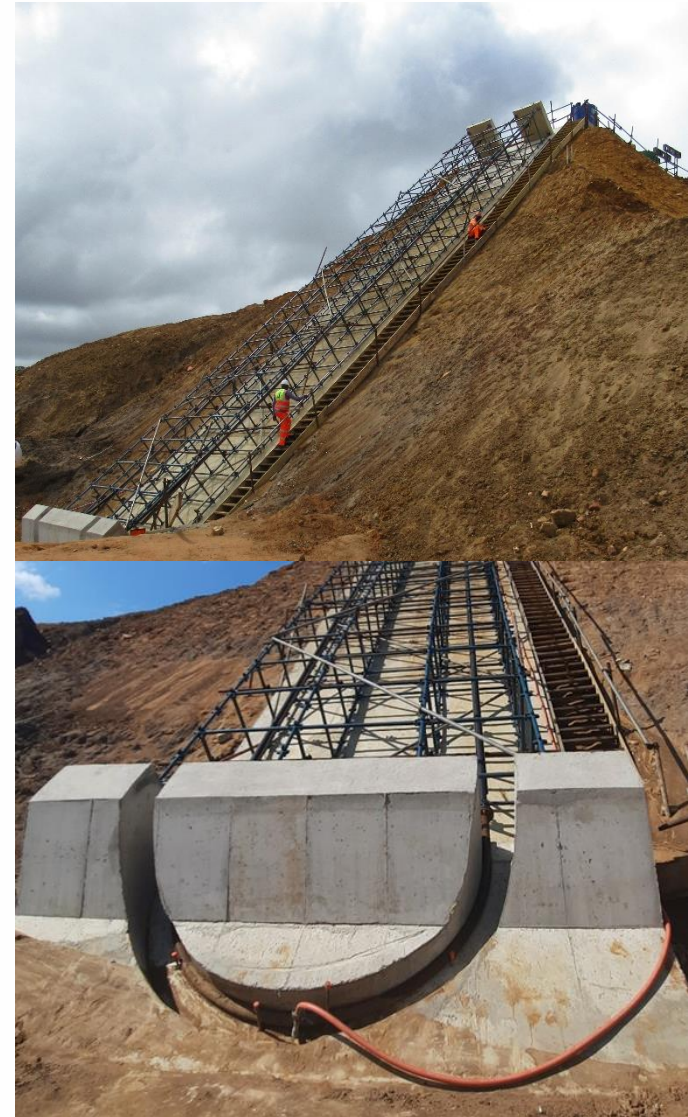
## Basic Overview

- Earth fill embankment constructed
- Grout mixed and pumped from above inlet.
- Grout injected from lower end of tendon.
- Smooth duct vs Corrugated duct
- 7 strand anchor – stressed to 10ton
- After curing, samples cut and assessed.
- Findings used to refine methodology.

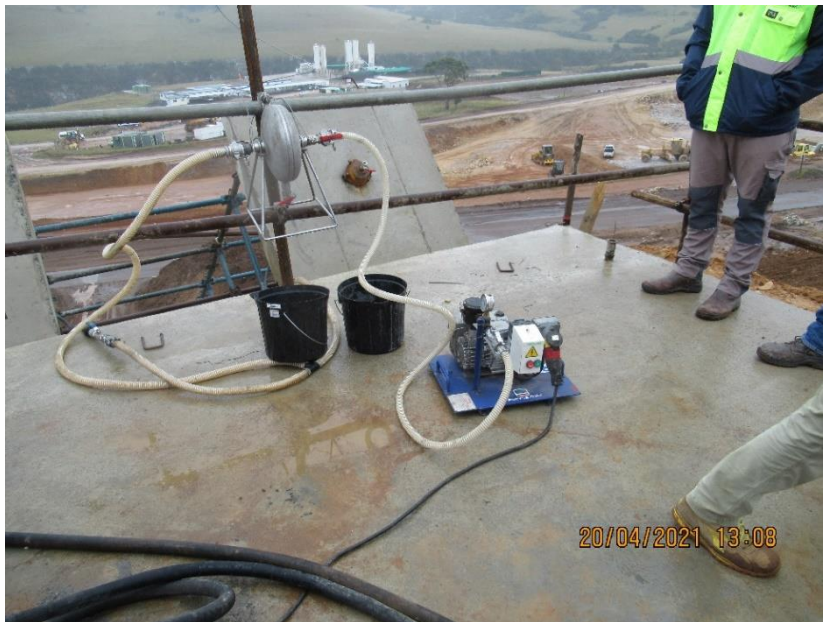
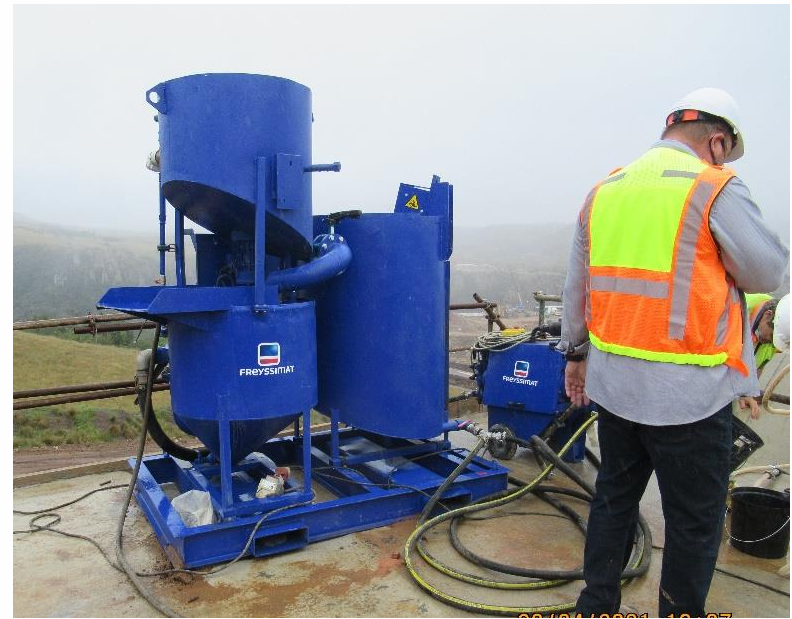
## Material vs Methodology

- Bleeding phenomena - Control or manage
- 2 ways: material performance and/or methodology

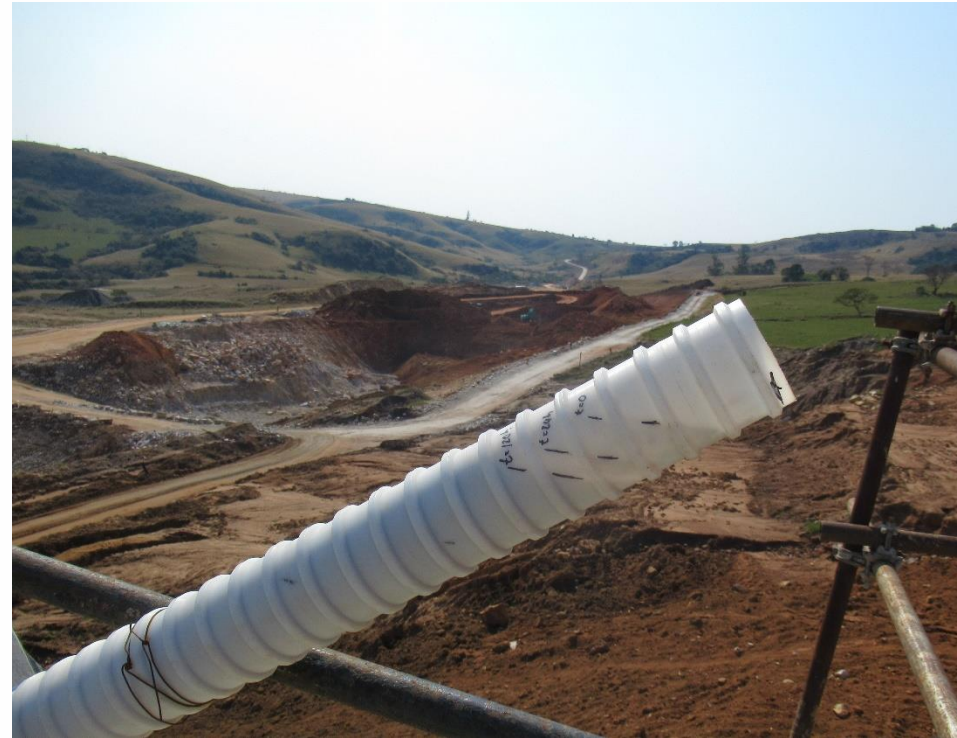
## Material

- W/C ratio
- Position of pump - grout flow in direction of pressure gradient
- Reduced W/C ratio possible
- Reduced flow times possible
- Independent grout material trials conducted
- Measure bleed affected grout

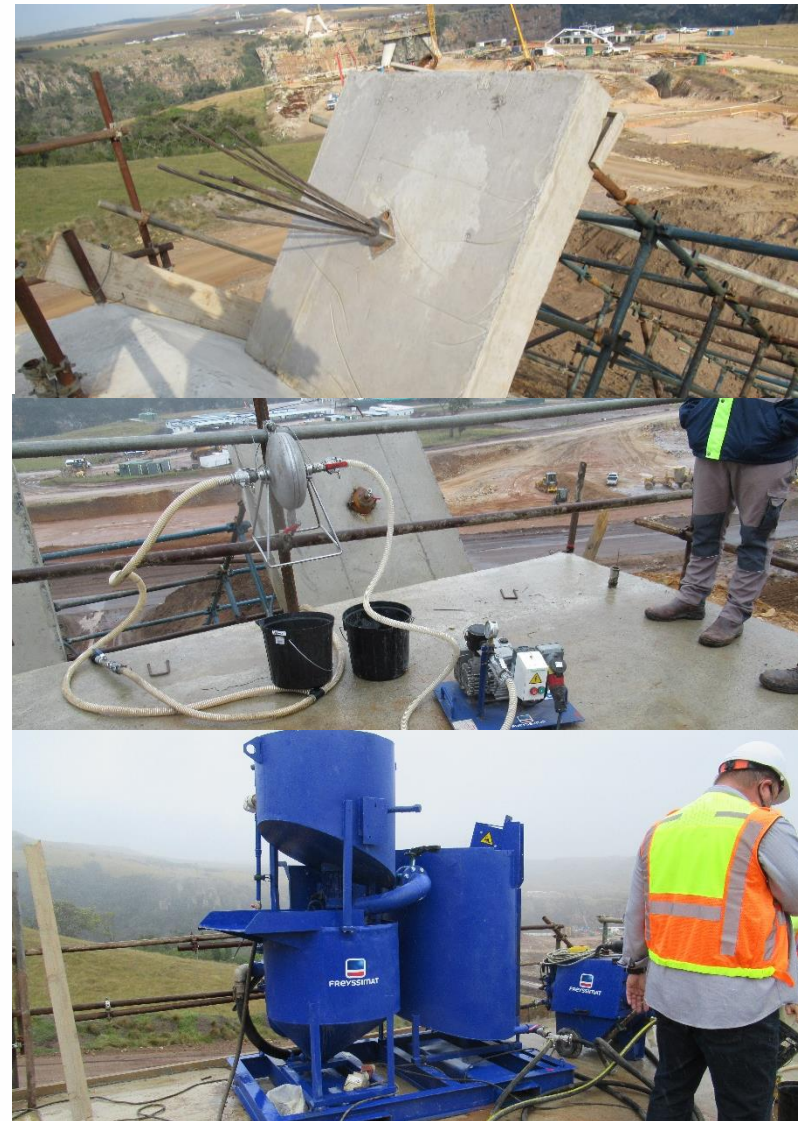
# Grout Trials

## Methodology – Trial 1

- 7 strand anchor fully occupied
- Reinjection valve added below anchor
- Inject grout
- Apply vacuum pump (1 hour)
- Apply air at grout cap to evacuate grout via reinjection pipe
- Cure 24 hours
- Blow out
- Re-grout

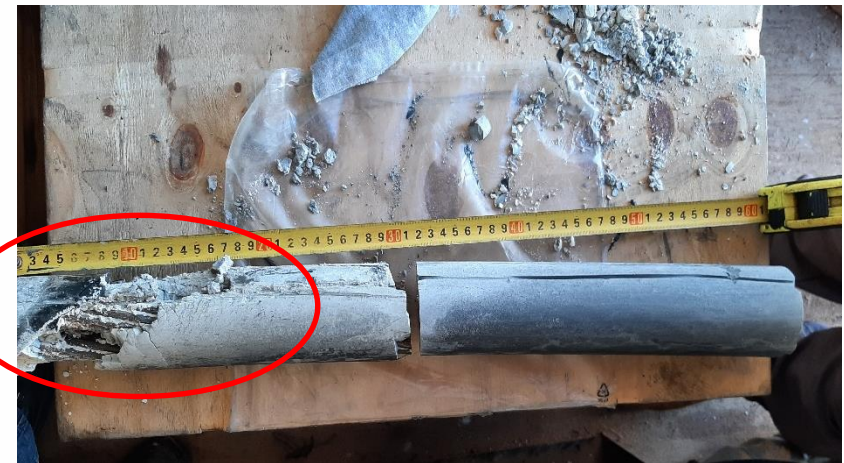
## Methodology – Trial 1

- Injection
- Evacuation
- 24 hours curing
- Blow out
- Reinjection

**FAIL:**

Blow out cannot eject bleed affected grout

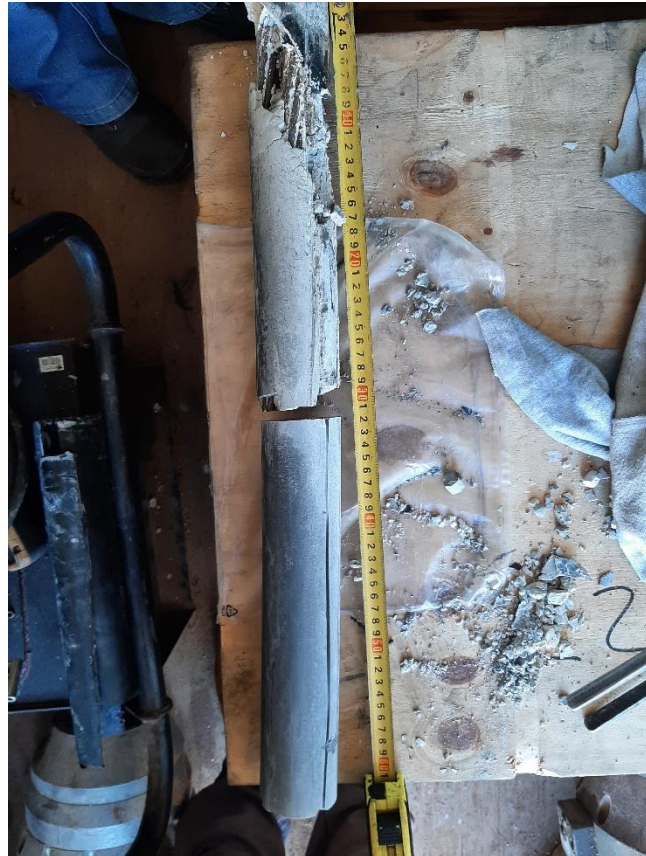
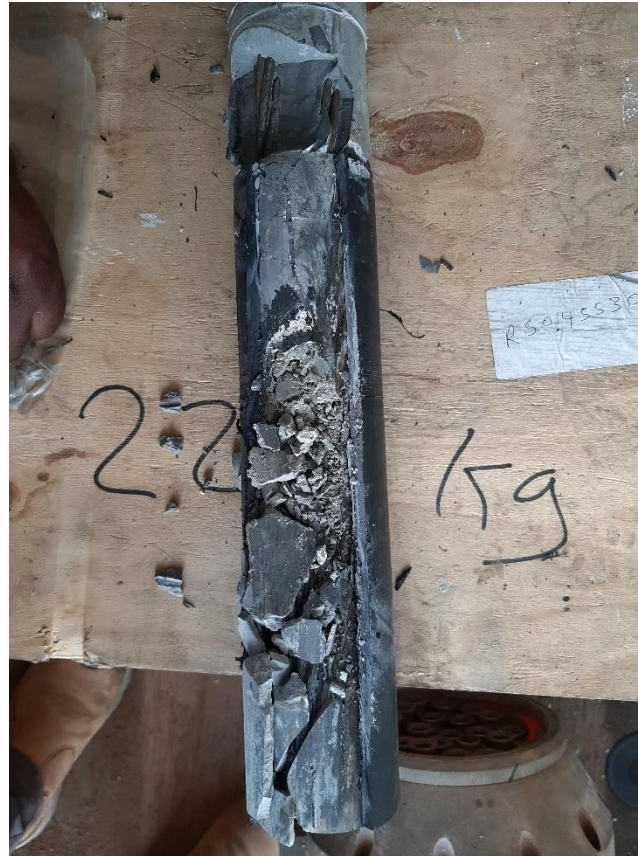
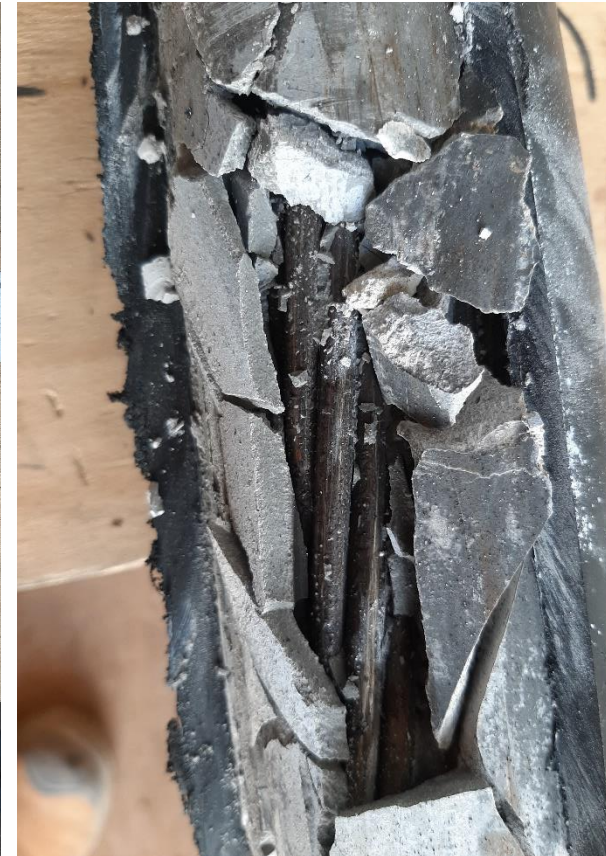
## Methodology – Trial 1

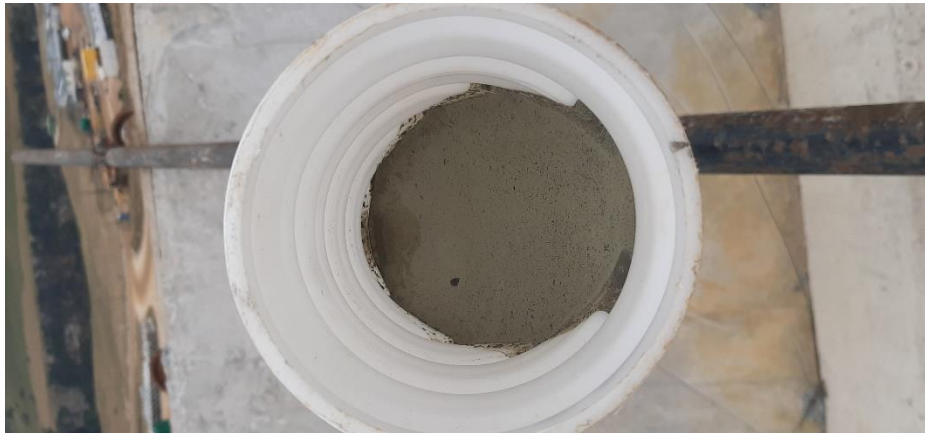
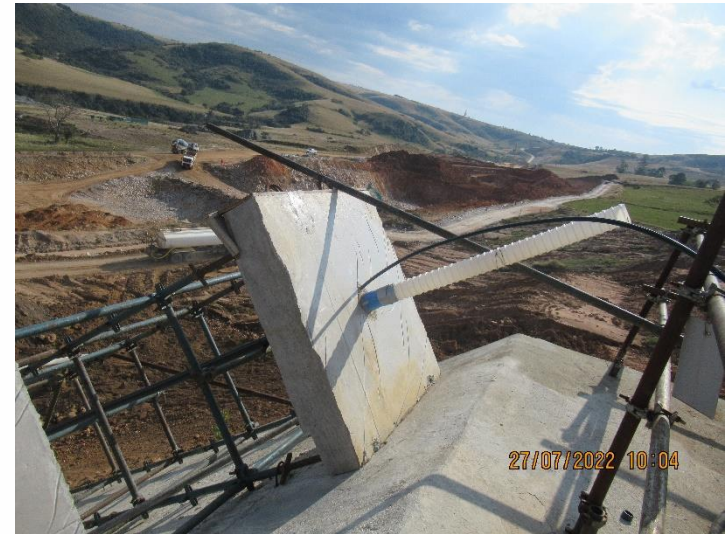
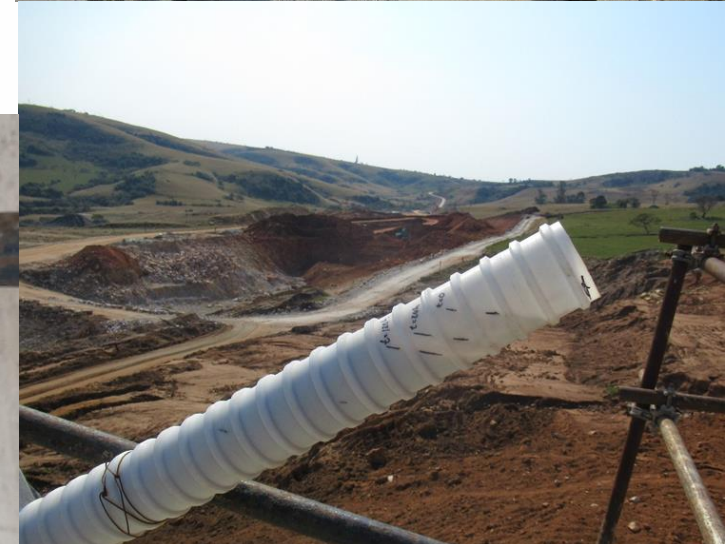
## Methodology – Trial 2

- 7 strand anchor fully occupied
- Add reservoir to accommodate bleed affected grout
- Inject grout
- Cure 24 hours

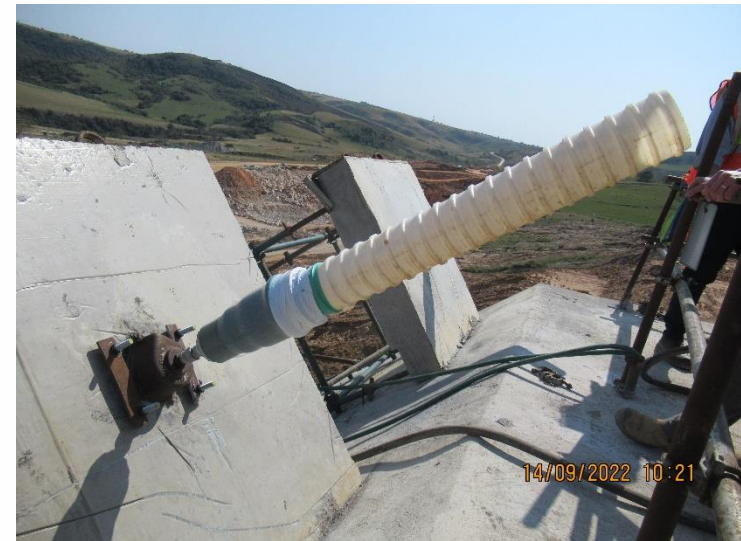
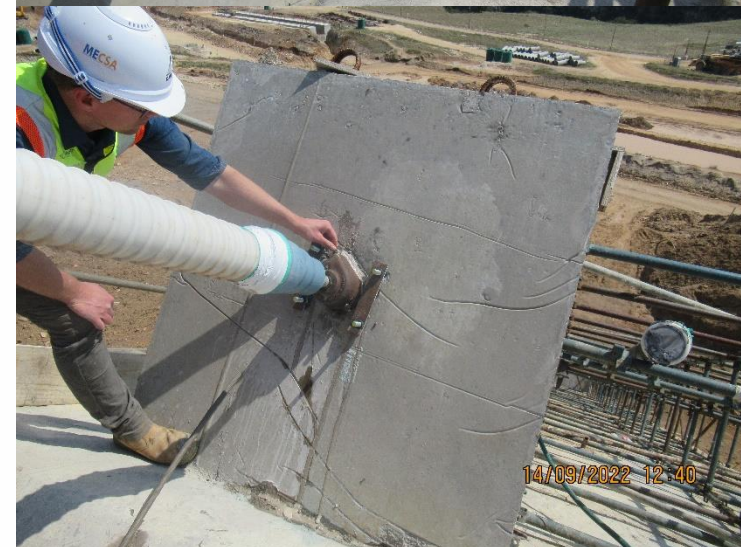
## Methodology – Trial 3

- 7 strand anchor fully occupied
- Add reservoir to accommodate bleed affected grout
- Add grout cap for clear bleed water migration path
- Inject grout
- Reinject after 2 hour period
- Cure 24 hours

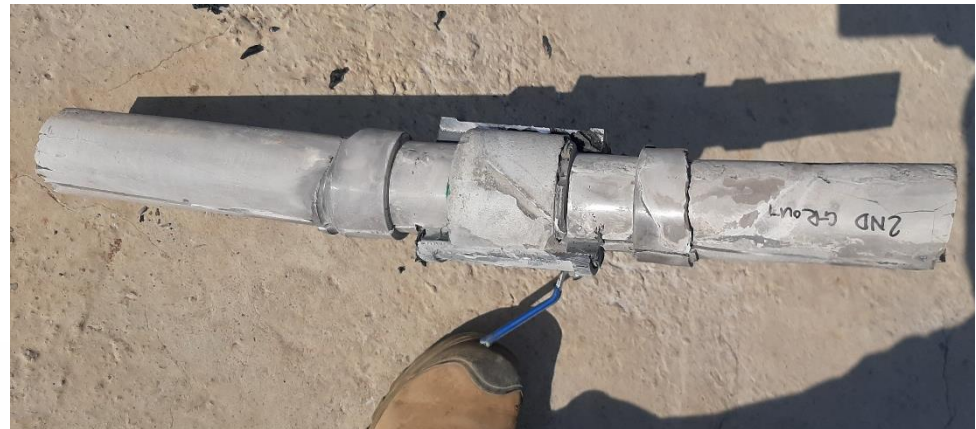
- Injection
- Wait 2 hours
- Reinject
- 24 hours curing

**SUCCESS**

- Bleed water can be managed by both material and methodology
- Clear migration path for bleed water through anchorages vital
- Reinjection at top of tendon before initial grout sets.
- Workability not affected by lower W/C ratios.
- Slower flow times had no effect on quality and filling ability
- Success through local products combined with local experience
