# Aging concrete on our dams

Frank Denys - 22 February 2024

CONCRETE WORKING FOR WATER – FEBRUARY 2024

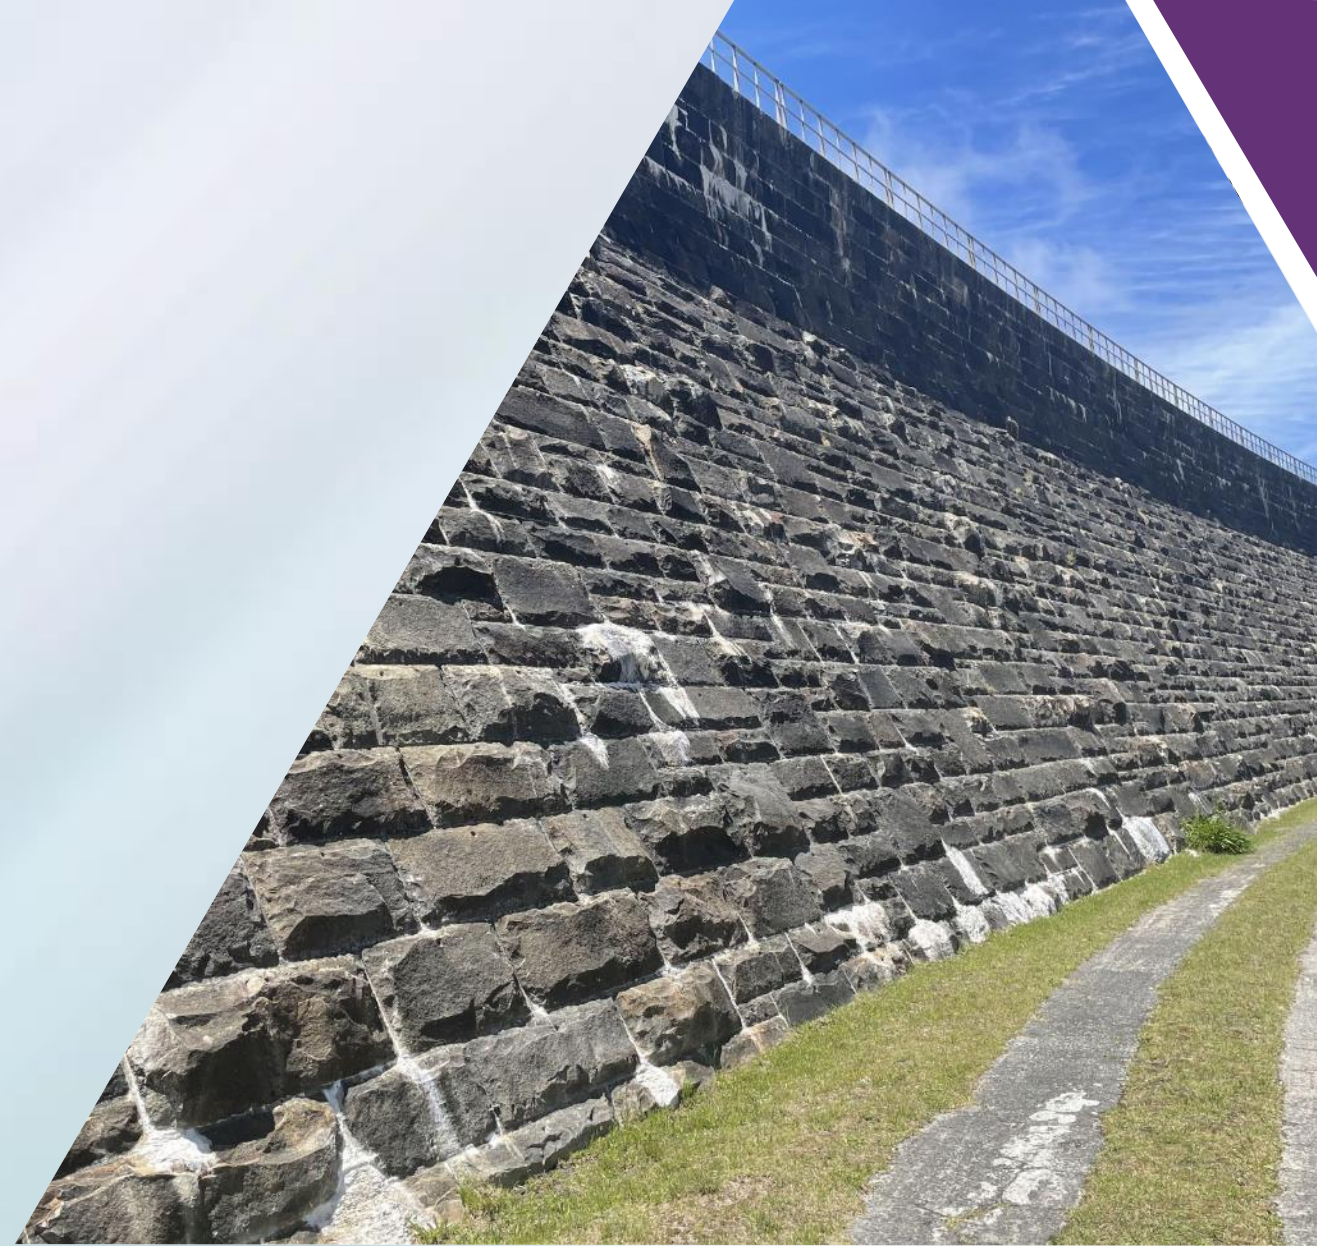
# Hely Hutchinson Dam

16 m high masonry gravity dam

- One of original water supply dams to City of Cape Town – located on Table Mountain
- Built from 1889 to 1904
- Design consists of sandstone masonry blocks with an internal zone of plum concrete
- Empties annually
- Outdated design

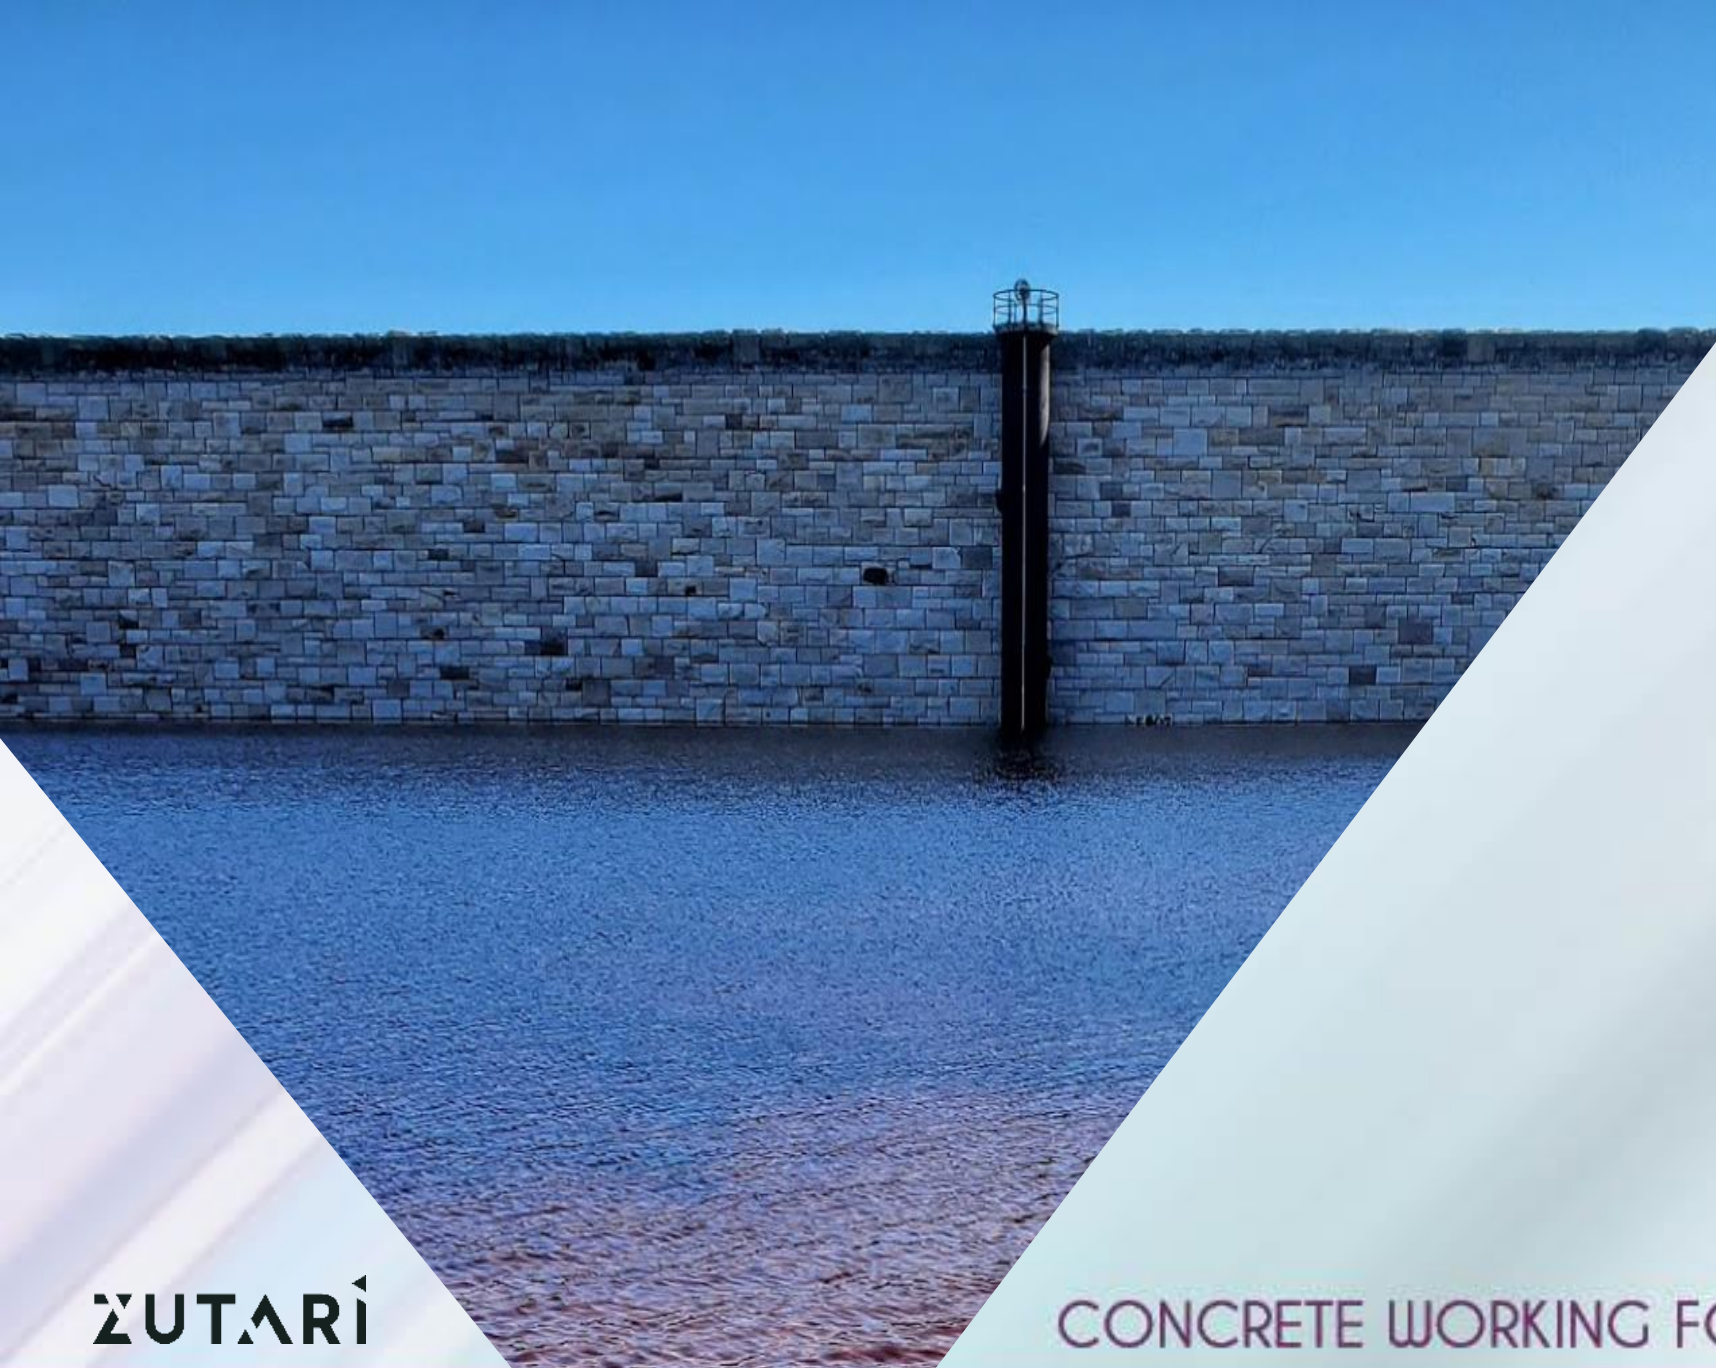
# Leakage and seepage

Repairs?

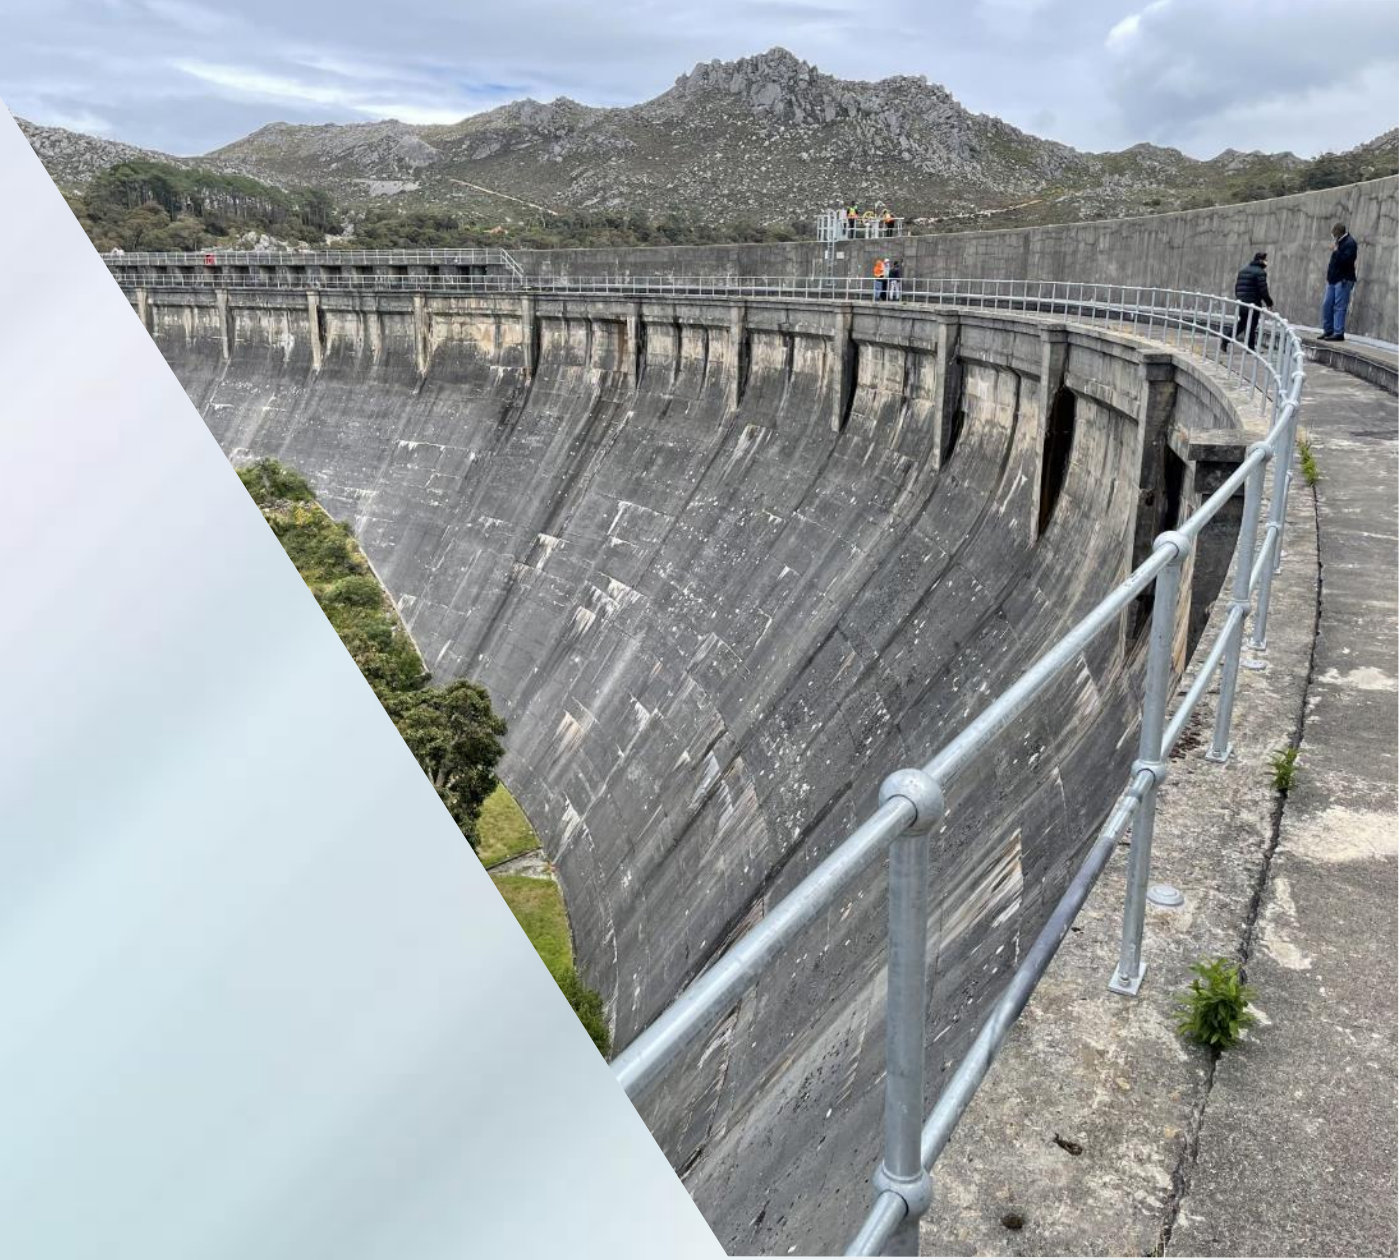
# Steenbras Lower Dam

28 m high concrete gravity and arch dam

- Originally built in 1921
- Raised in 1927 and again in 1954
- Concrete gravity structure with outdated design
- Strengthened in 1954 with post-tensioned steel cables
- Significant AAR concerns

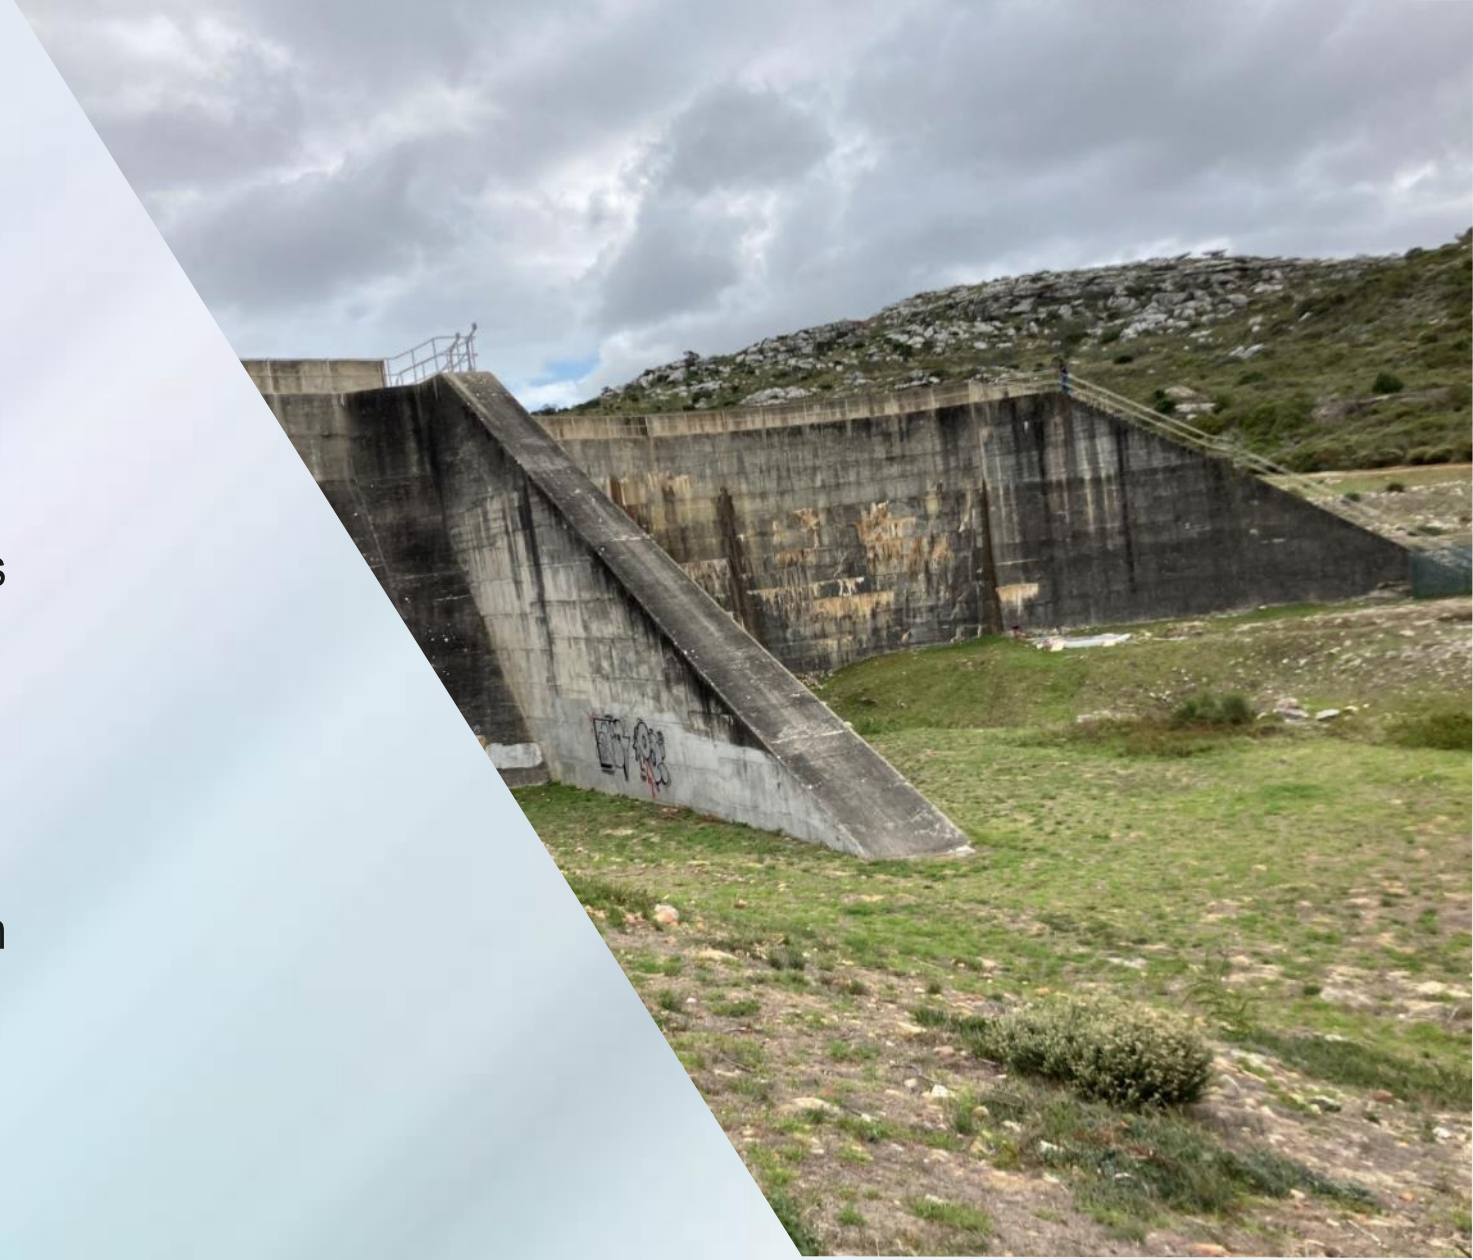
# Lewis Gay Dam

16 m high concrete arch with gravity flanks

- Built in 1951
- Concrete arch dam supported by two buttresses
- Flanked by concrete gravity walls
- No expansion joints in arch section
- Only movement joints at buttress supports
- Severe vertical cracking and leakage in the arch

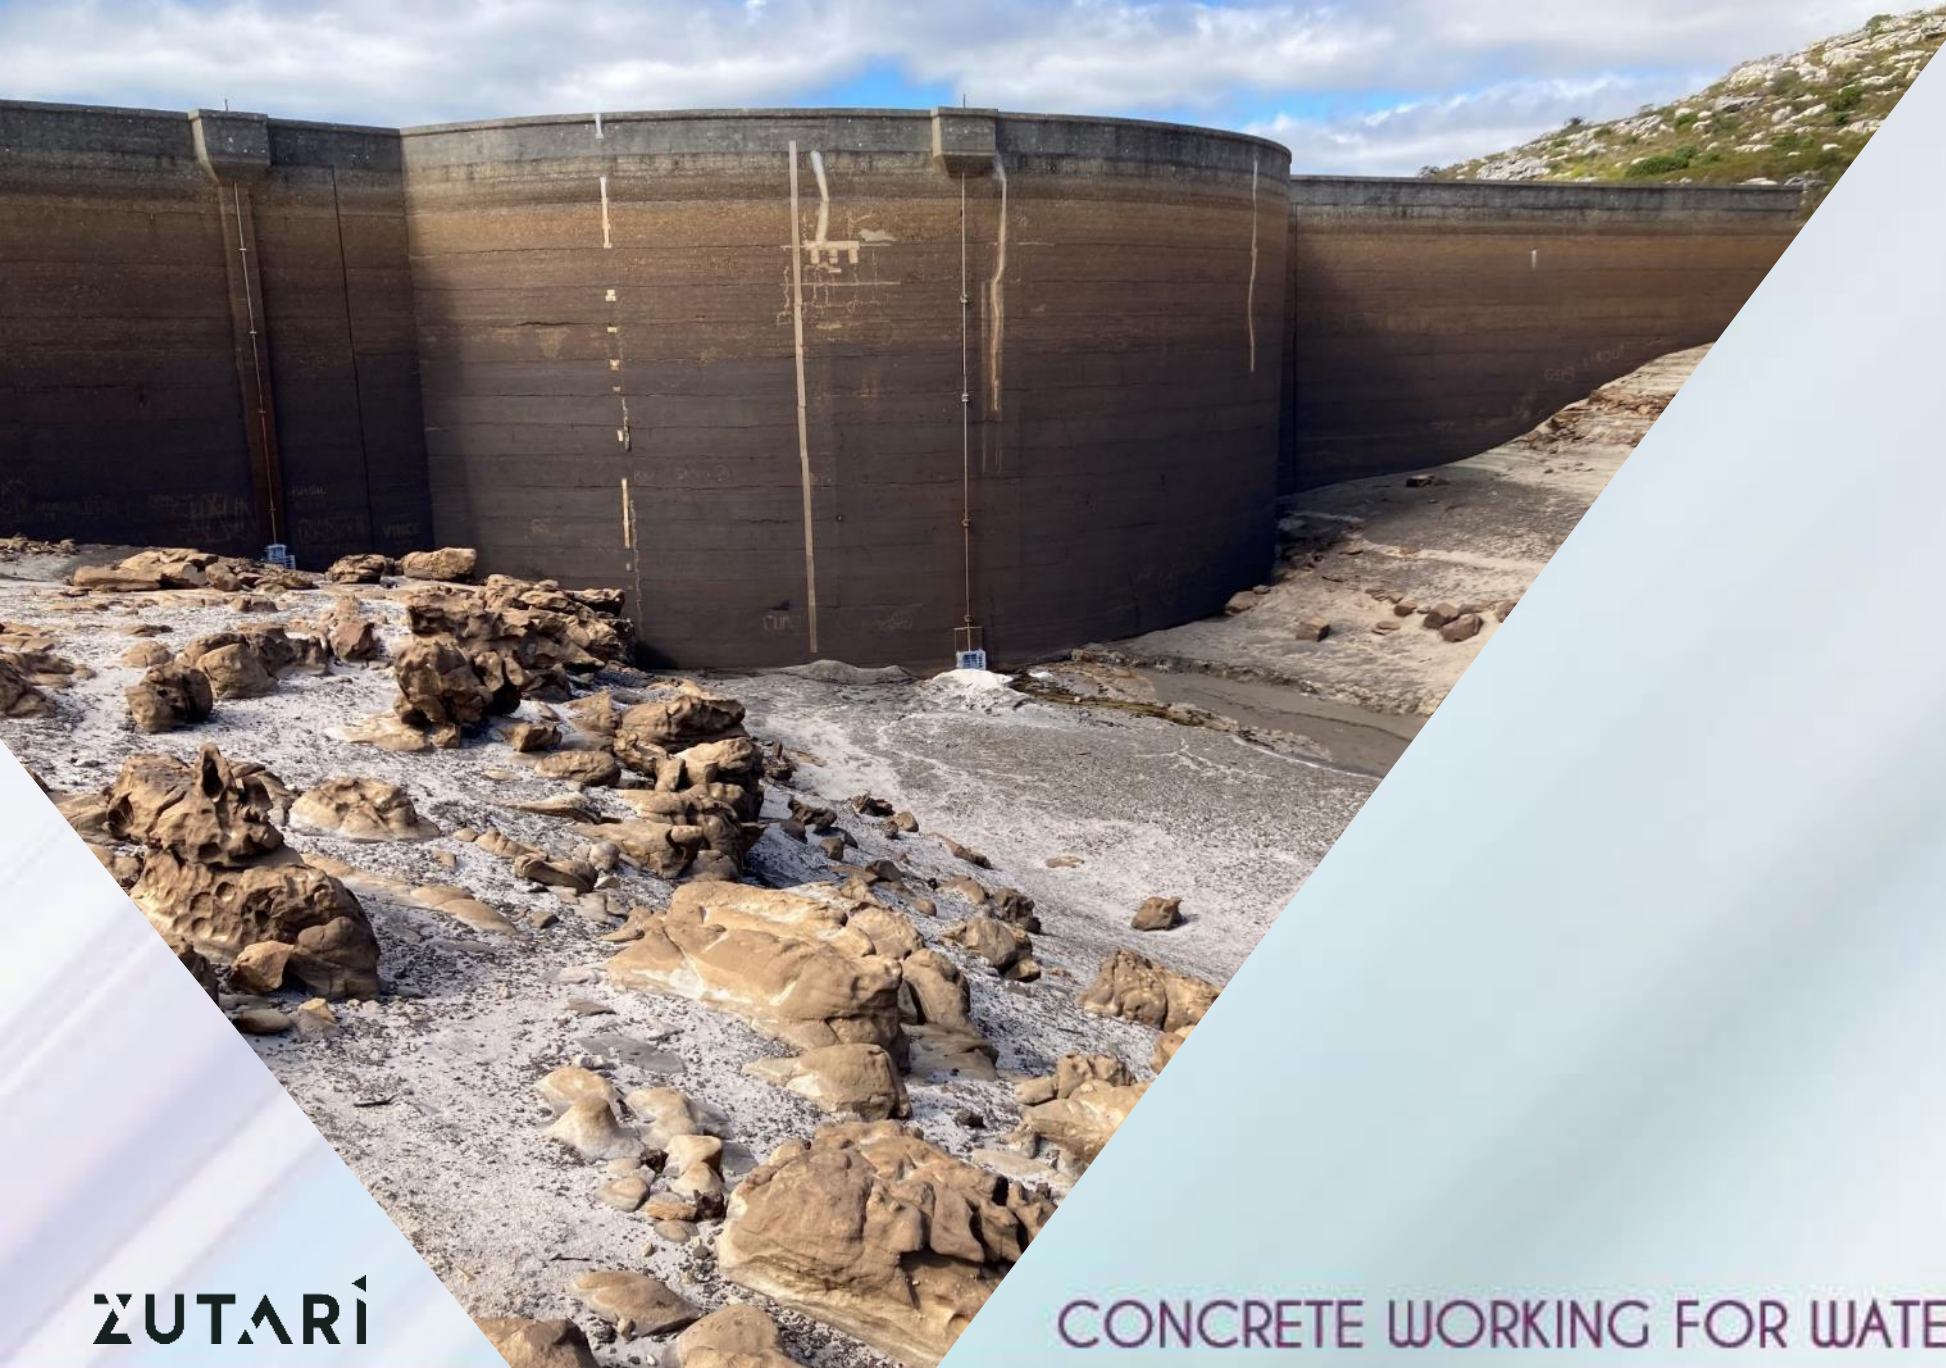
# Cracking and leakage

Repairs?

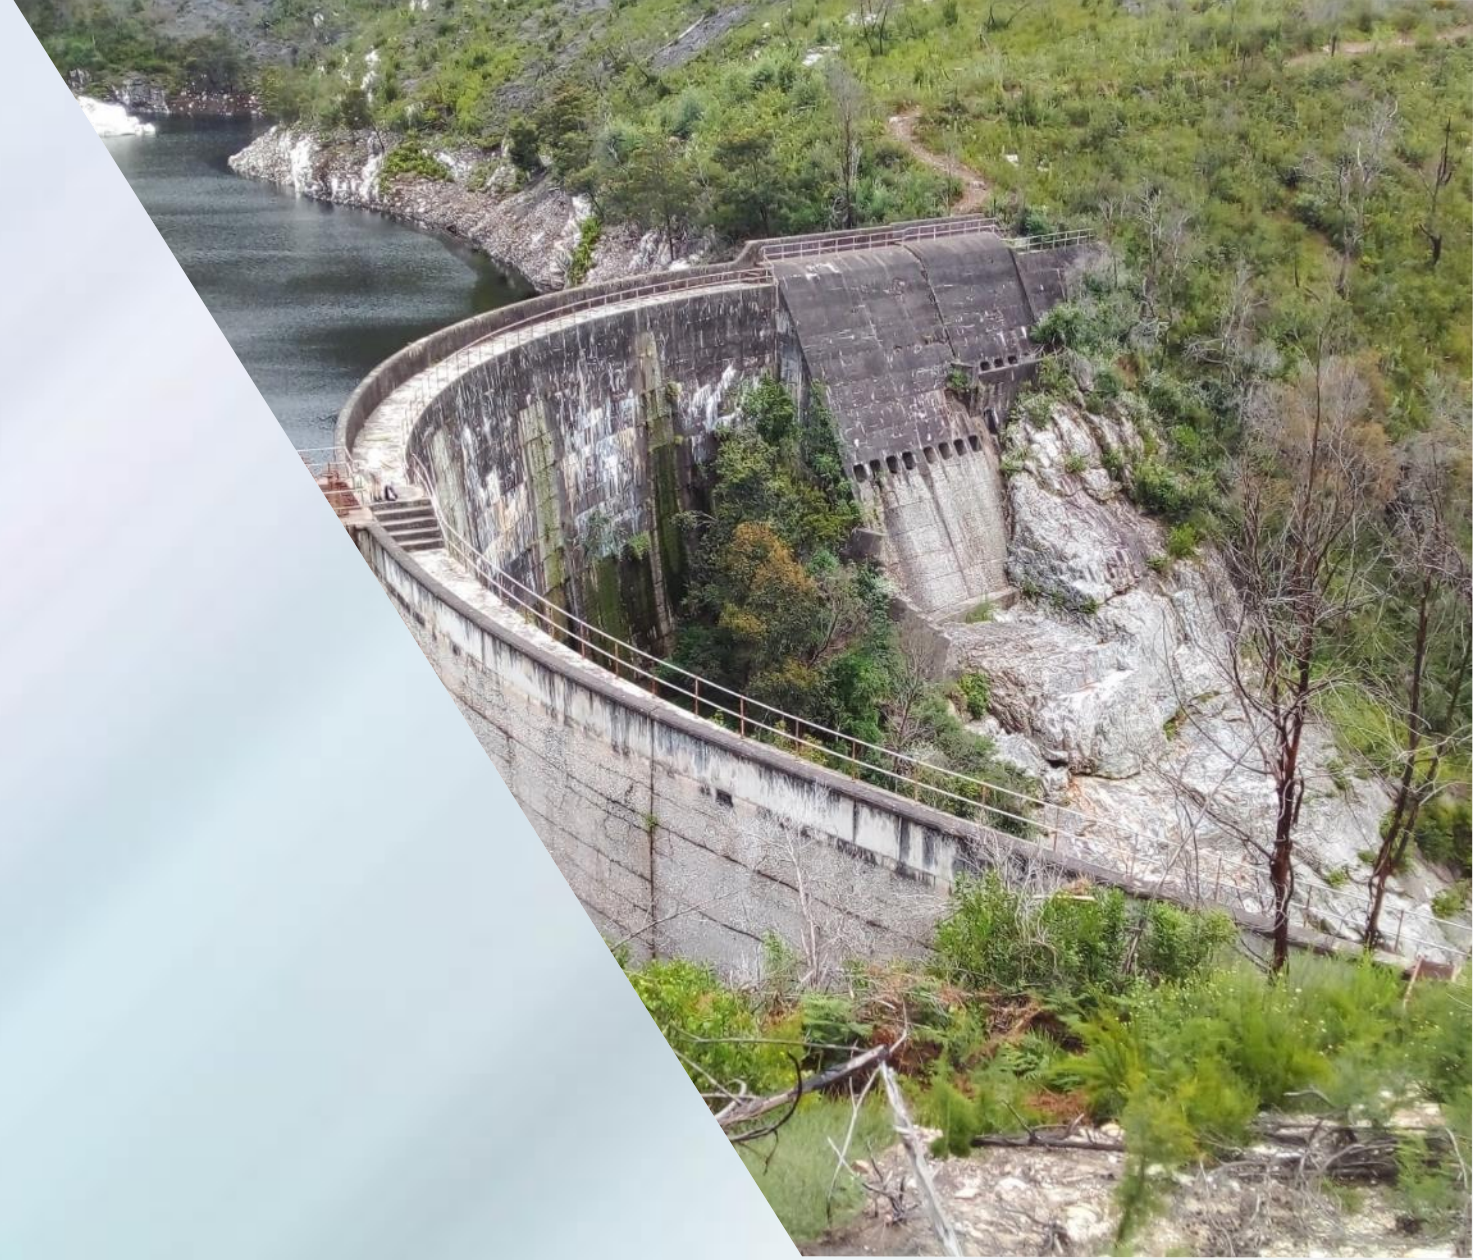
# Swart River Dam

34 m high concrete arch dam

- Originally built in 1940 and raised in 1954
- Severe leakage
- Not able to store water
- Still structurally sound

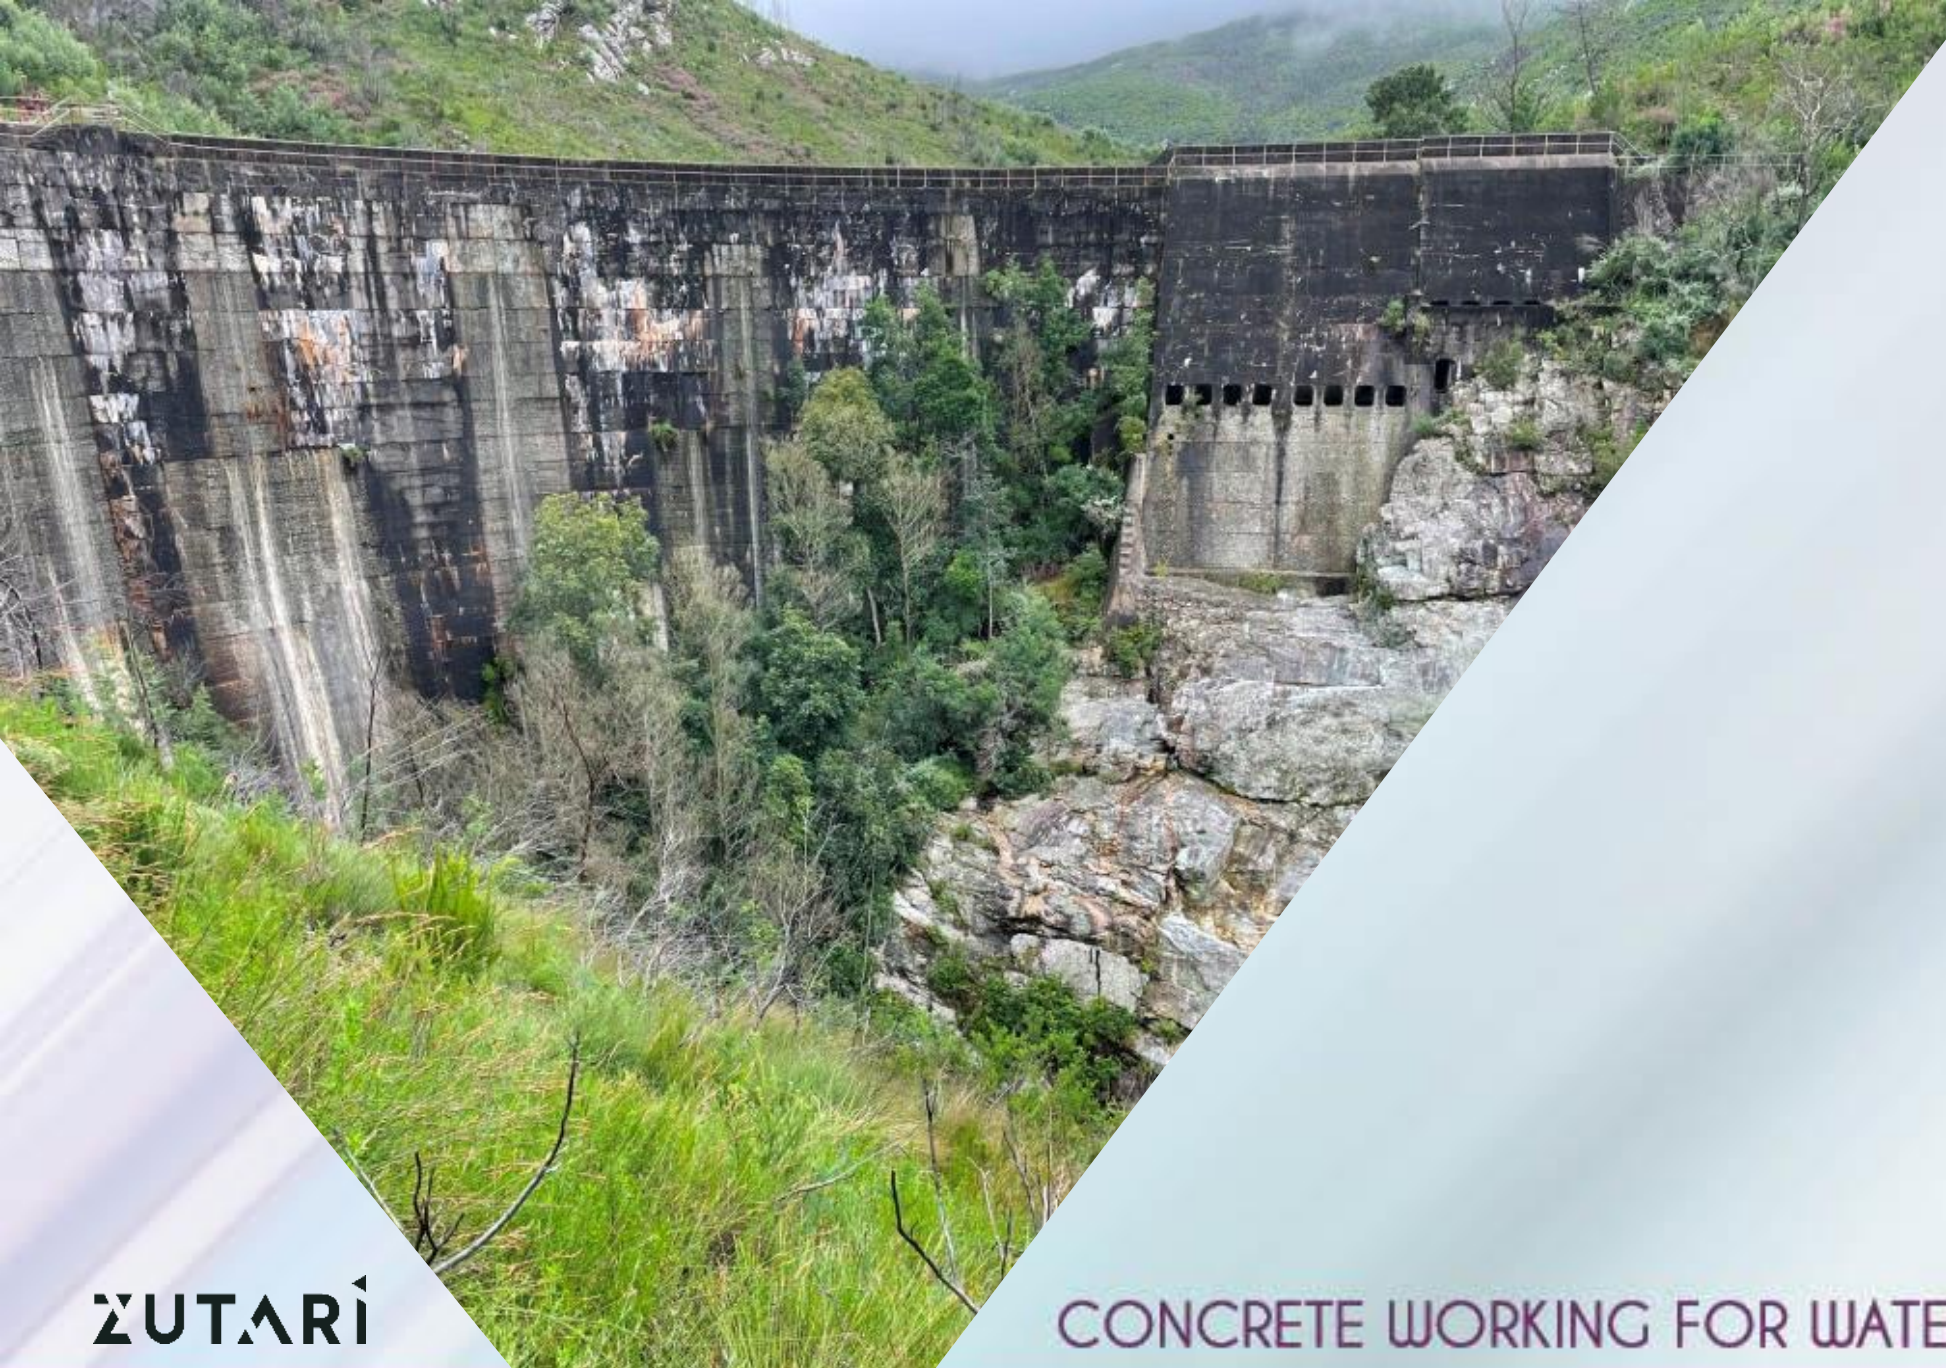
# Siphon up close

Repairs?
