# Case Study – Fire Damage Repair of the Sarnia Road Bridge

Thobekile Ngcobo Graduate Engineer and  
Kevin Volmink Pr Eng

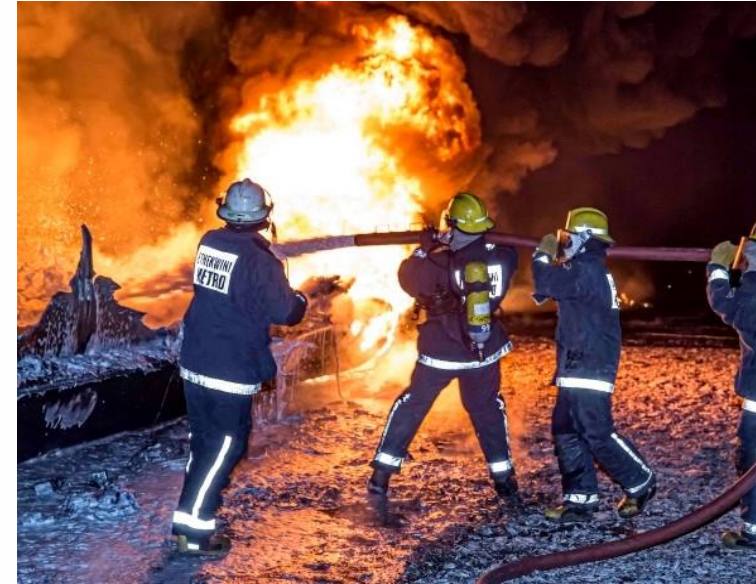
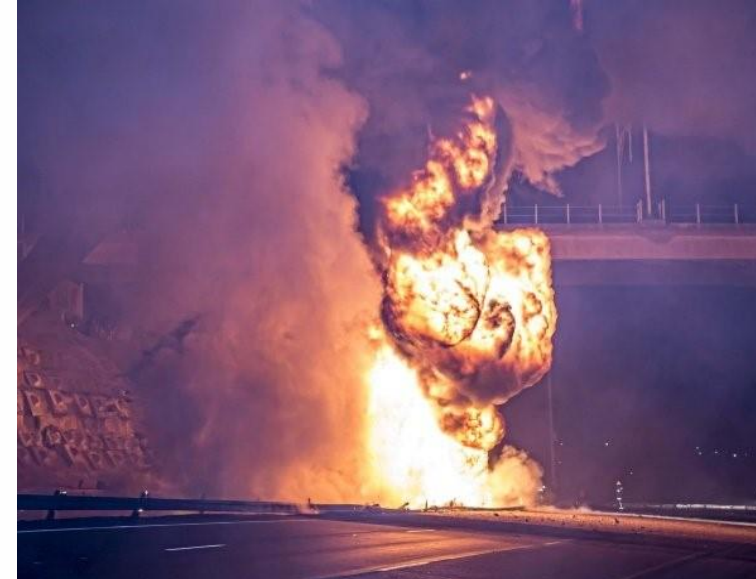
- Fire - a threat to infrastructure.
- Tankers transporting flammable fuels are the cause for most bridge fires.
- Damage to B112 – Sarnia Road Bridge

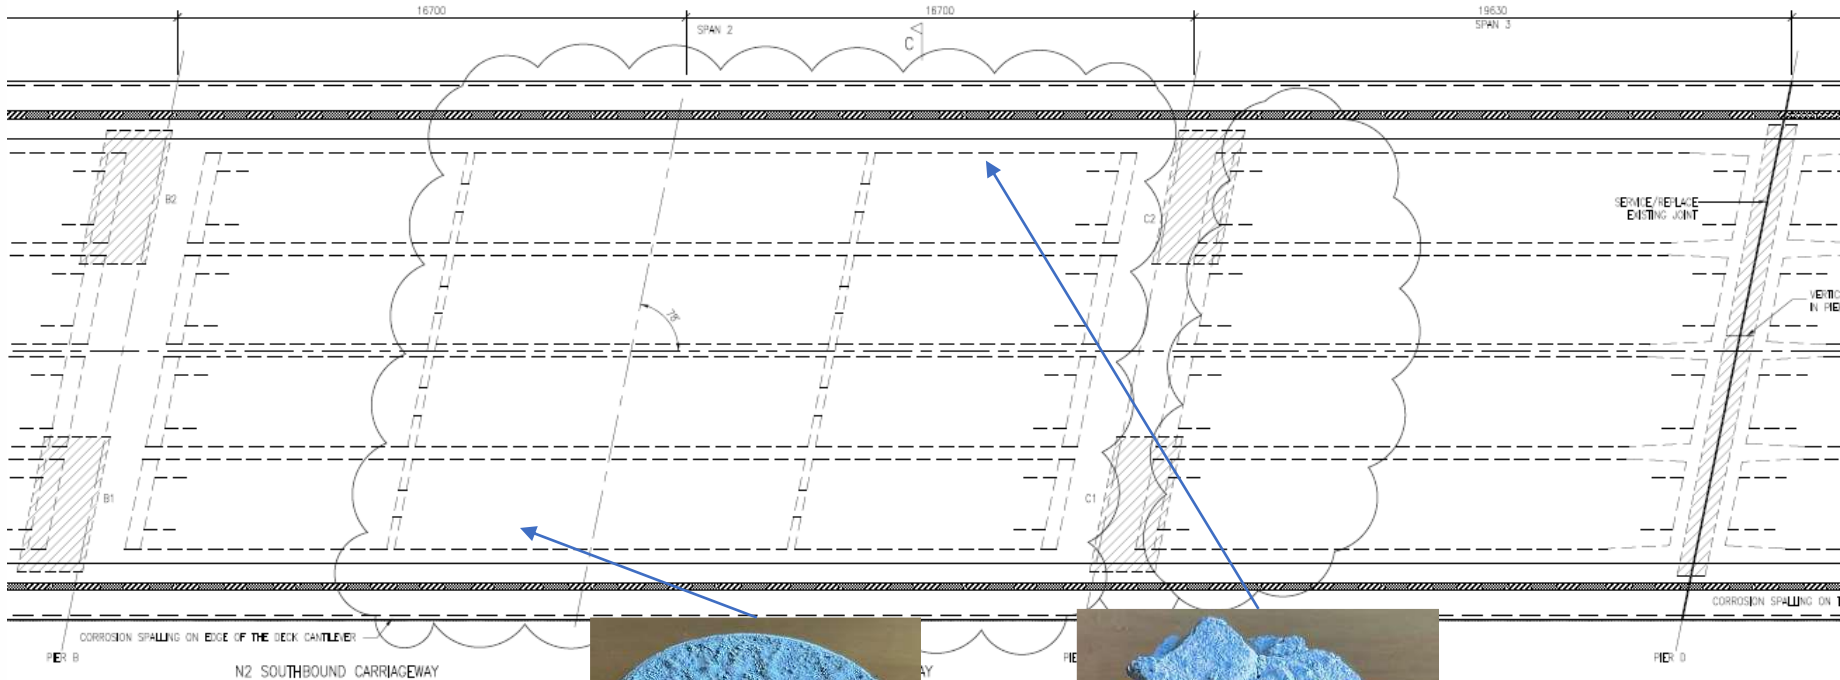
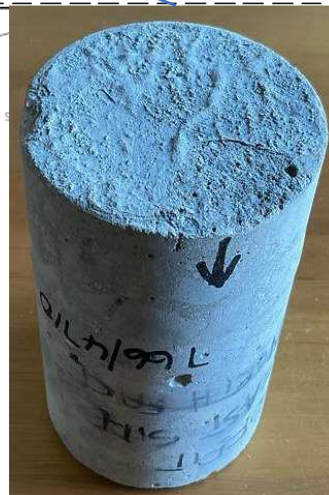
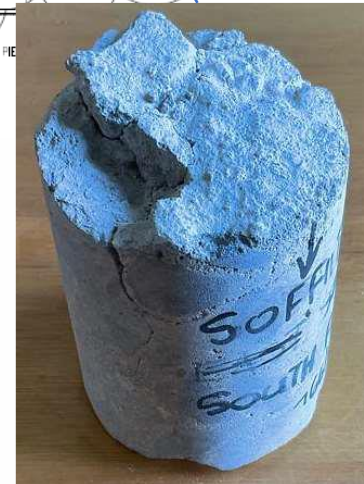
# Concrete Core Testing

- Concrete remained unaffected beyond the depth of 35mm.

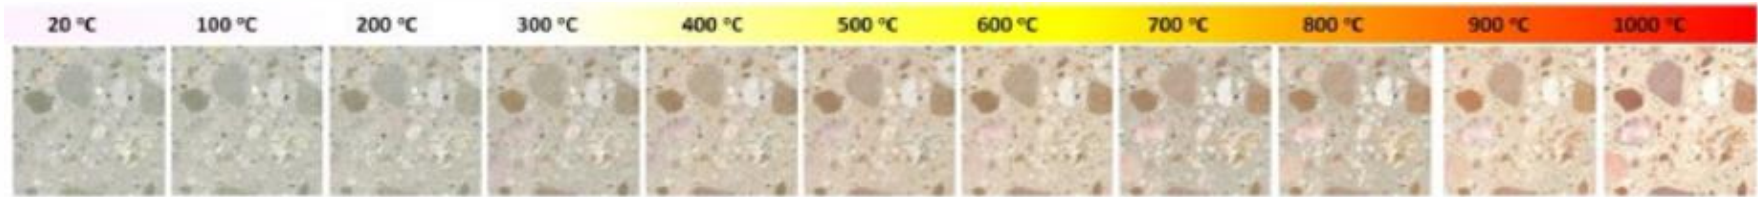
# Fire Impact on Concrete Colour

- Change in colour due to chemical and physical changes when exposed to high temperatures.
- Quartz-containing concrete turns pink/red between 300°-600°C.
- Discolouration near fire's location suggests exposure above 300°C.

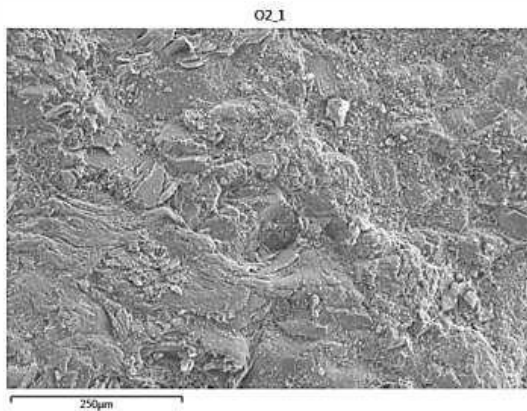
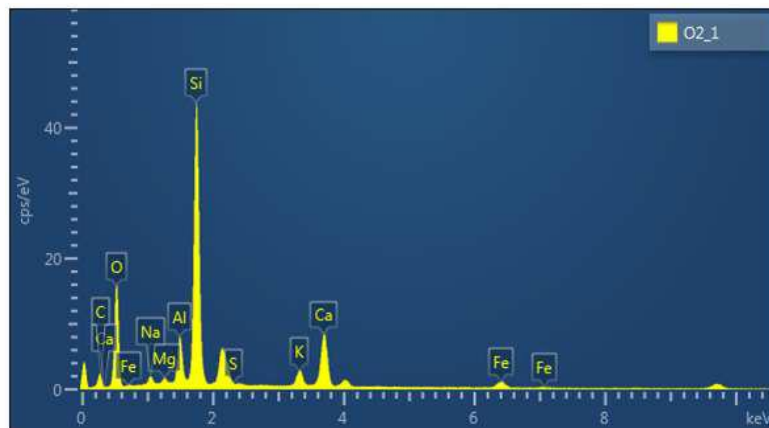
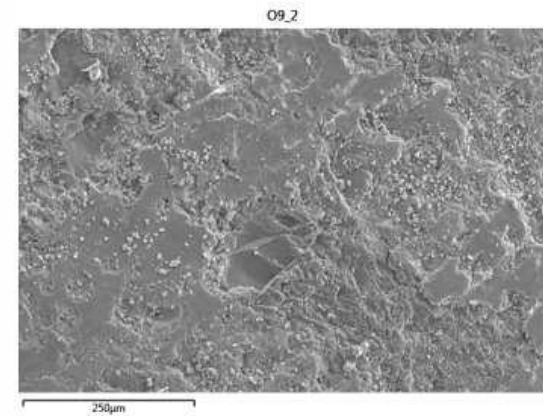
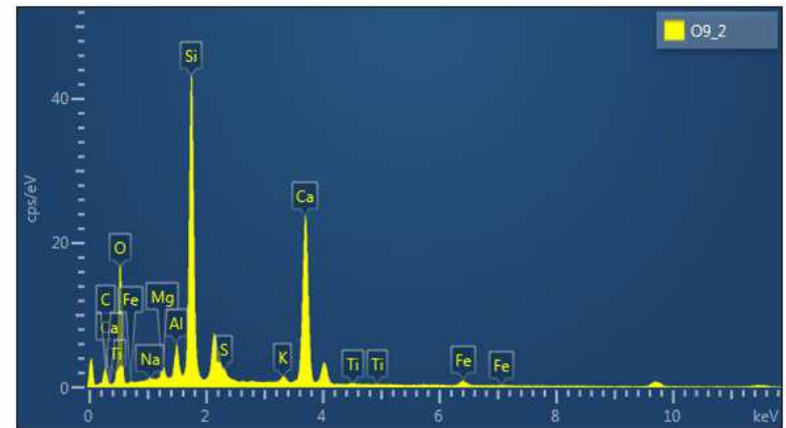
# Microstructural Analysis

- Scanning electron microscopy (SEM) and energy dispersive spectroscopy (EDS).

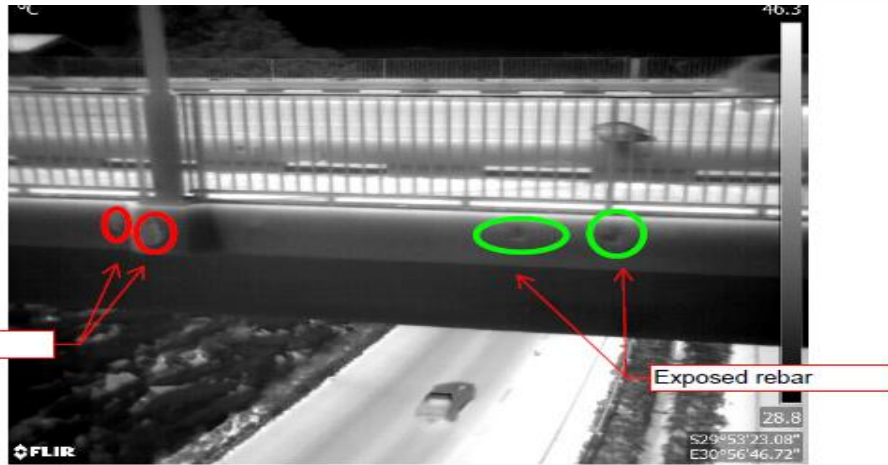
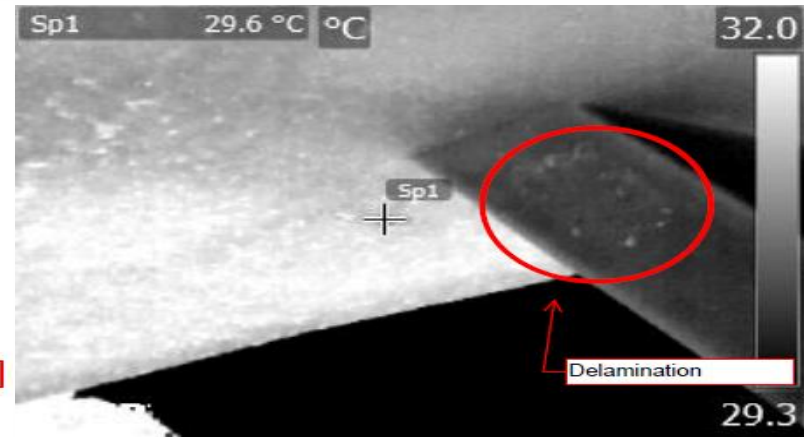
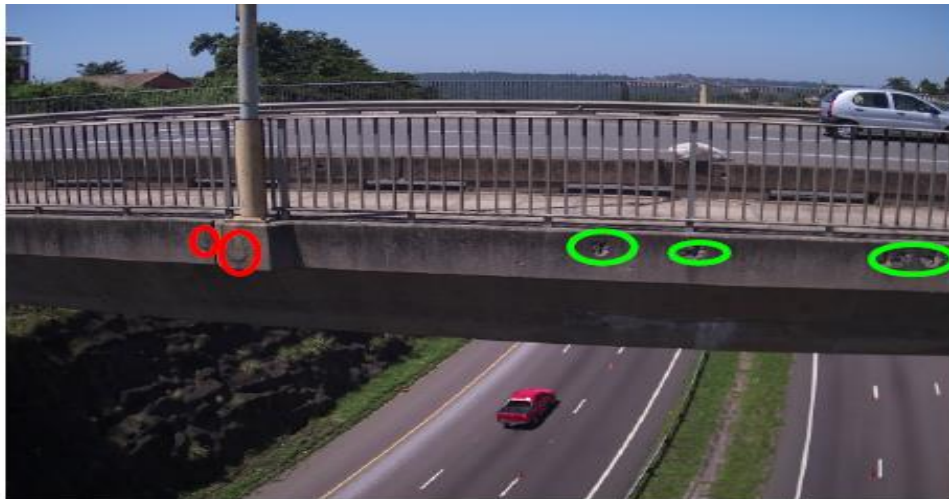
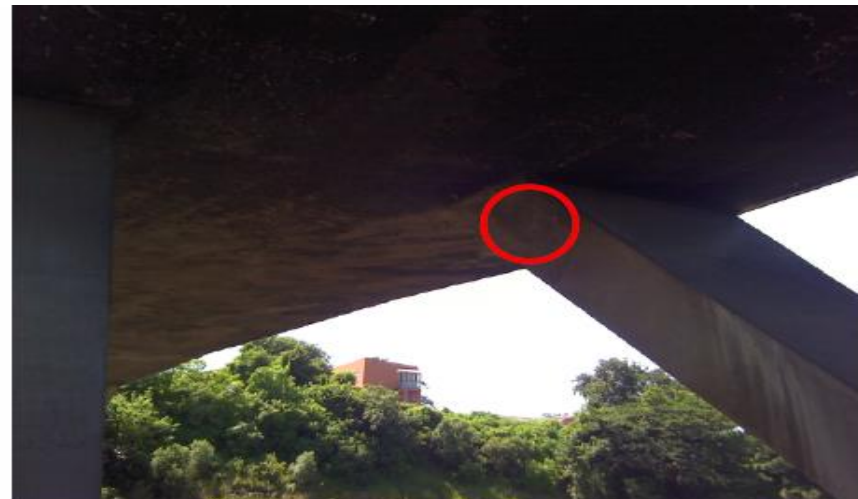
# Thermal Imagery Defects

- Digital twinning
- Other defects: concrete spalling/exposed rebar, potential delamination, cracking and failure of existing repairs were identified.

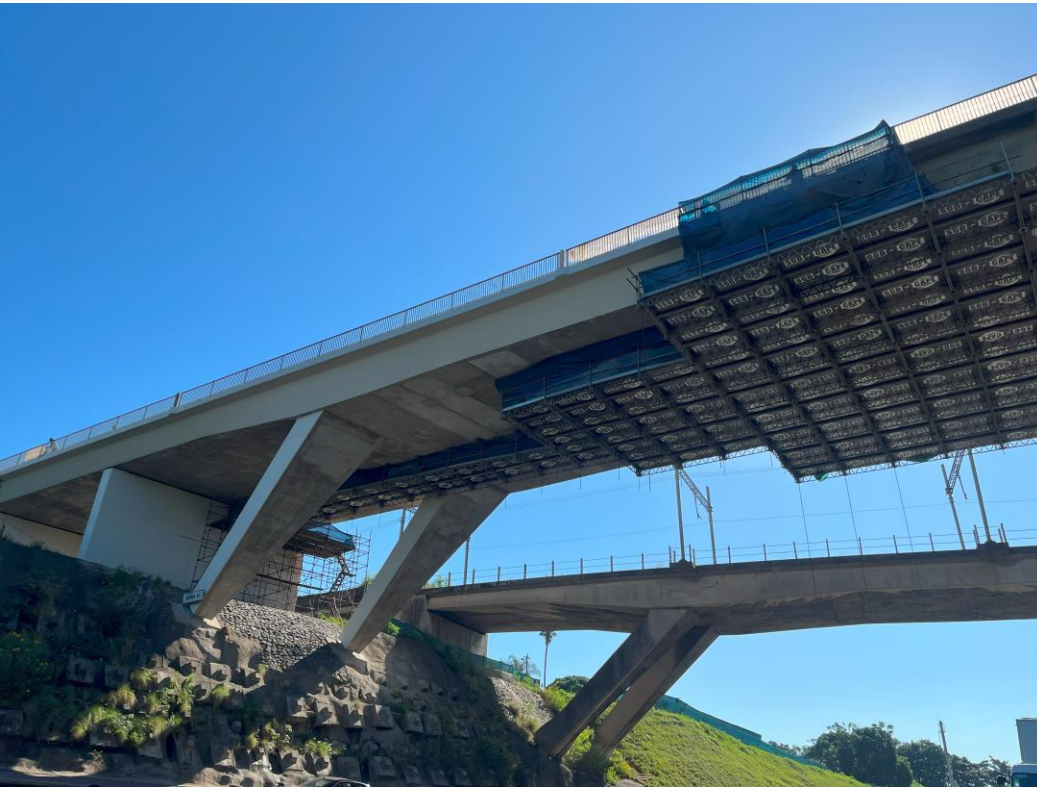
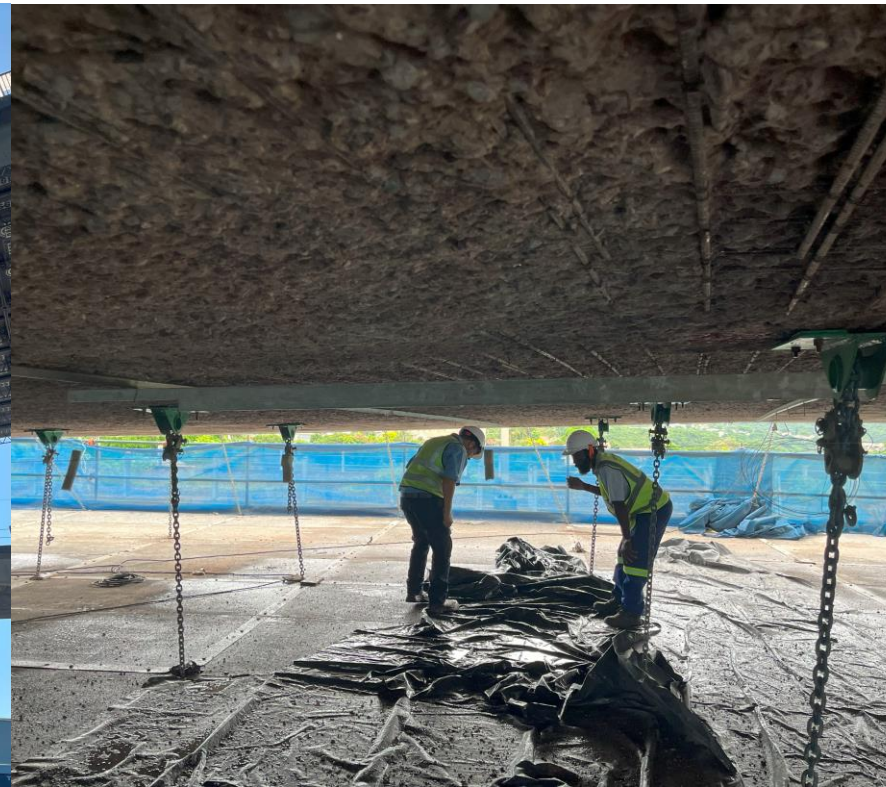
# Access and Pre-construction Testing

- Suspended Access System
- Preconstruction Testing
