# Towards an improved behaviour of CRCP thanks to active crack control

Luc Rens

Consulting Engineer – FEBELCEM

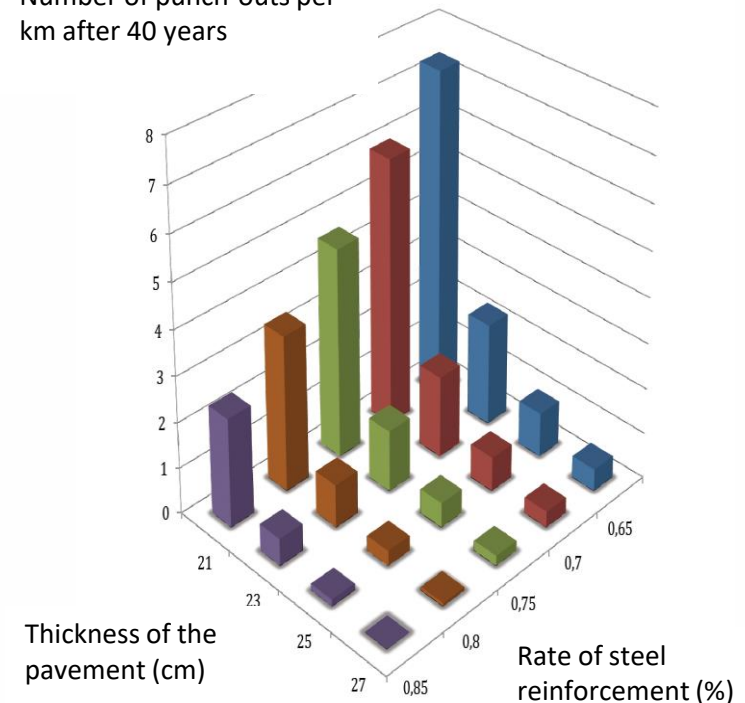
- Various dissertations and doctoral theses
  - Monitoring of CRCP behaviour
  - Study of the influence of parameters
  - Simulation with MEPDG, using Belgian conditions
- Slab thickness and longitudinal reinforcement are determining parameters
- Decision to keep the 0.75 %

Number of punch-outs per km after 40 years

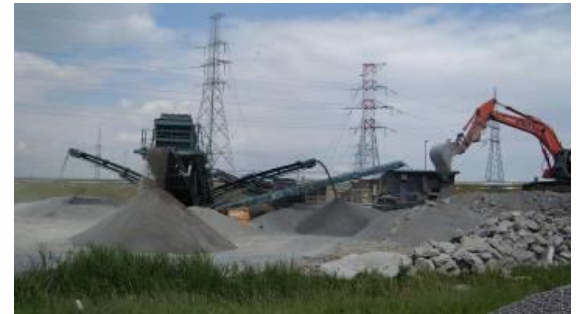
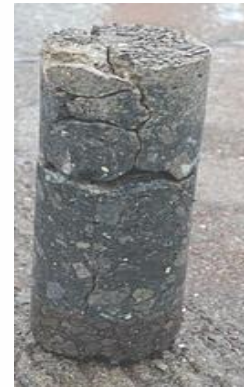
- 2007 WB-2008 EB
- CRCP + 2lift + use of RCA in bottom layer
- 2011: fragmentation in WB – no damage in EB (hydrophobic impregnation?)
- Cores + MIRA: HC + corrosion
- Overlaid with bituminous wearing course – relatively good performance

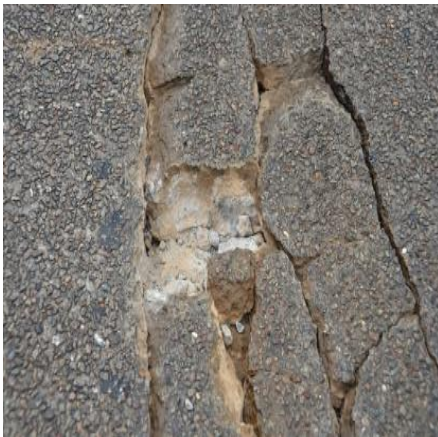
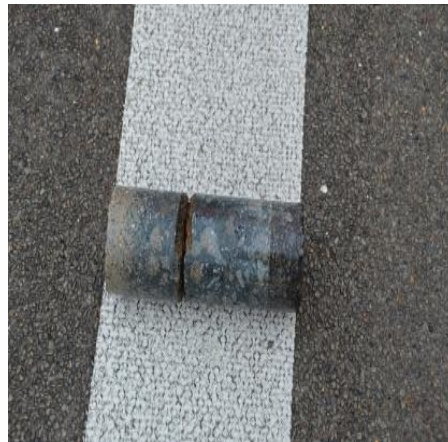
- Damage after only 3 years : fragmentation between closely spaced cracks in the middle of the lane in combination with horizontal crack
- Horizontal cracks at the height of the steel reinforcement (not between the concrete layers !)

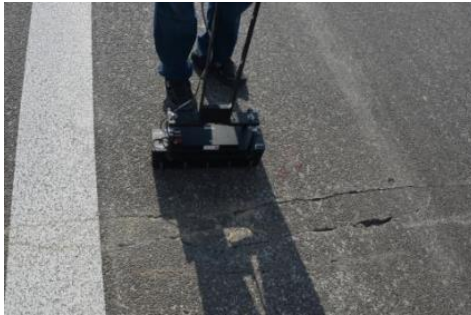
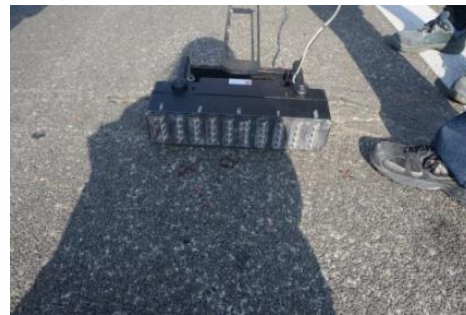
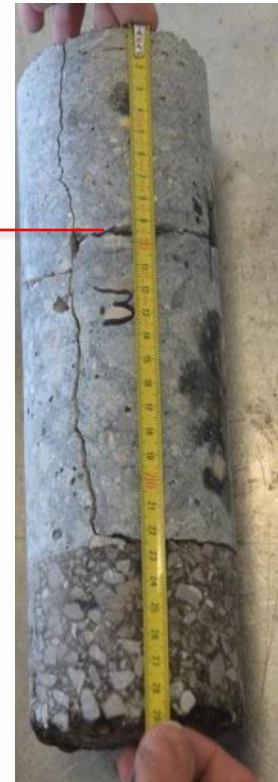
- Investigation with ultrasonic tomography (MIRA)

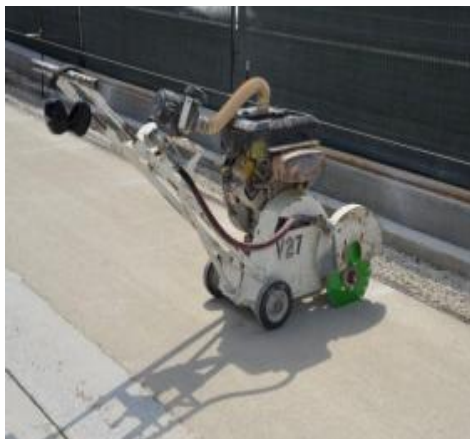
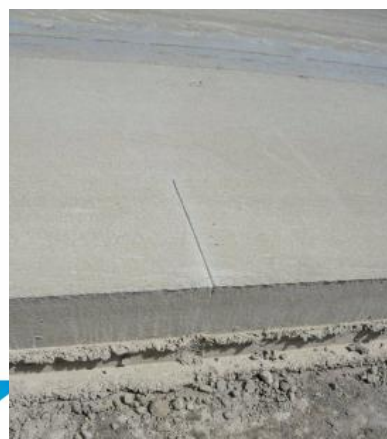
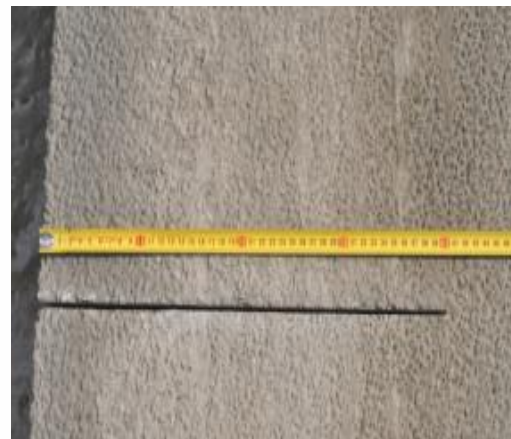
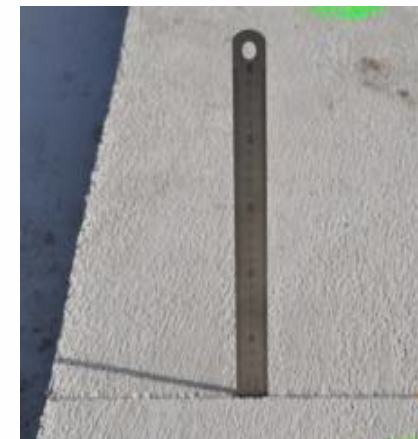
- Proposal for the E313 Worksite in 2012
- Sawcut at the edge of the concrete strip :
  - 40 cm long
  - 3 to 6 cm deep
  - spaced at 1.20 m (= average crack spacing)
  - within 36 hours after concreting (when brushing off the concrete mortar for exposed aggregate finishing)

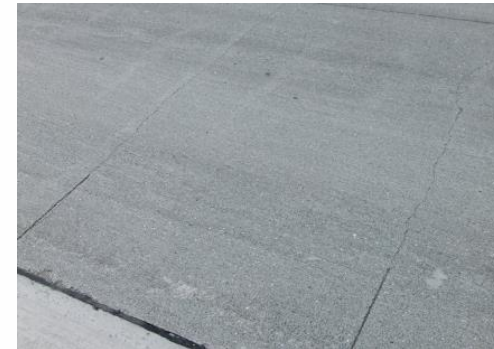
- Monitoring in framework of doctoral thesis – D. Ren, 2015, Delft University
- Results (after first winter)
  - 67 % of the notches were effective, thus initiated a crack
  - Of all cracks, 56% for 30 mm depth and 78% for 60 mm were located at notches  
(Remark: in case of 60 mm, also earlier sawcut - within 24h)
  - Reduced risk of clusters of closely spaced cracks

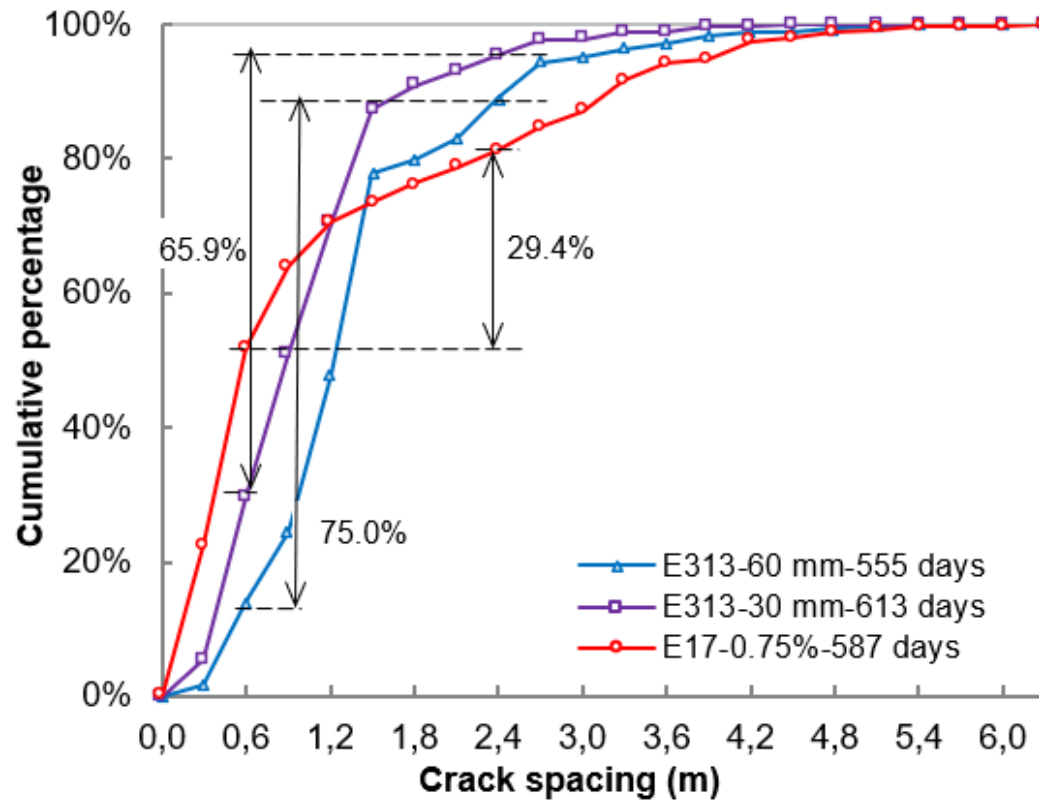
Figure 5-- Comparison of cumulative crack spacing distribution at the test sections on E17 and E313 after about 20 months, including 2 winters; the arrows represent the percentage of the crack spacings in the preferred range 0.6--2.4 m (Belgium) ¶

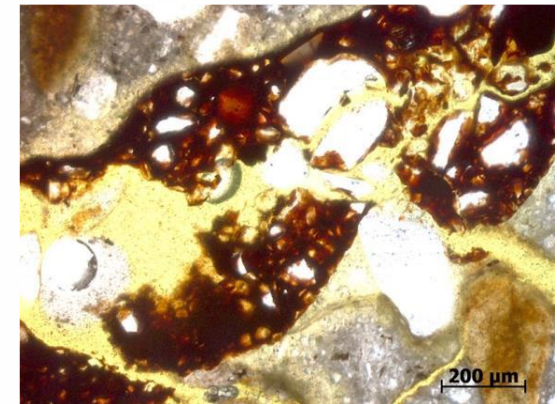
Microscopic image of horizontal crack filled with corrosion particles

- Use of RCA was assumed cause of HC and related damage of N49, Zwijndrecht, 2007
  - Higher shrinkage
  - Wide open cracks
  - Water infiltration
  - Corrosion

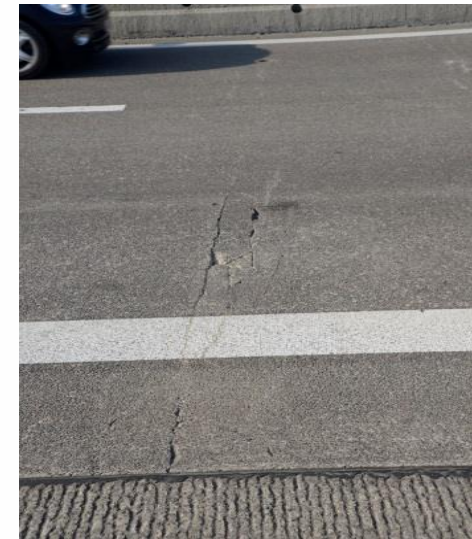
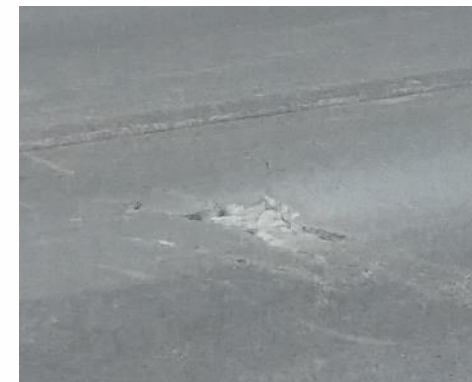
- New type of CRCP distresses
  - Observed at other BE worksites, following all best practices
    - Horizontal cracking at level of steel reinforcement
    - Similarities with punch-out
      - Between closely spaced cracks
    - But also differences with punch-outs
      - In wheel track
      - Not only in heavy duty lane
      - Only upper part of concrete layer is fragmented
  - How is this caused??
  - Which are influencing parameters??

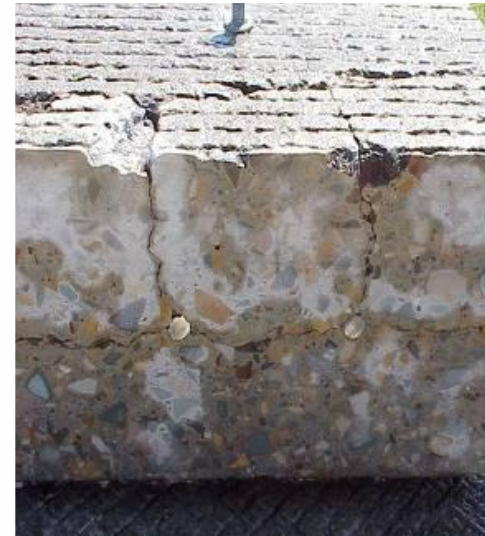
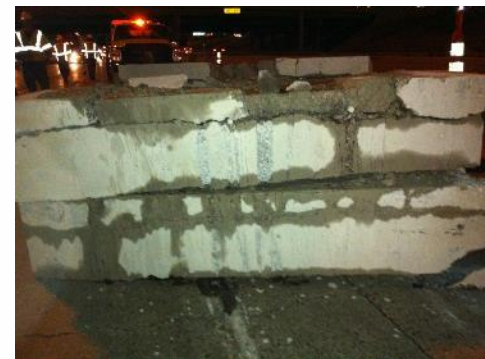
- A. Texas, U.S.
  - Ref: Prof. Moon Won
  - HC observed since 1999
  - Research & recommendations
    - Concrete: low E, low COTE
    - Steel: amount + 2 layers of reinforcement for thick CRCP
    - Construction: curing effectiveness, temperature variations through slab depth, consolidation of concrete

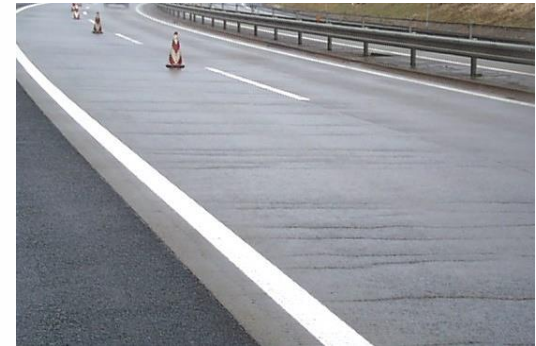
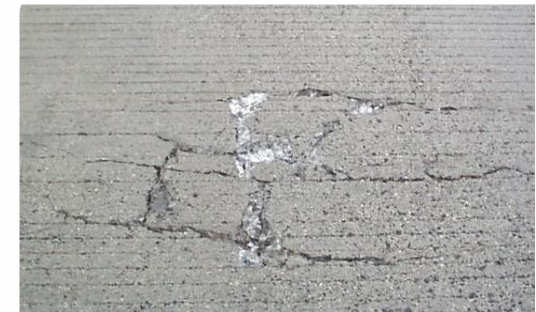
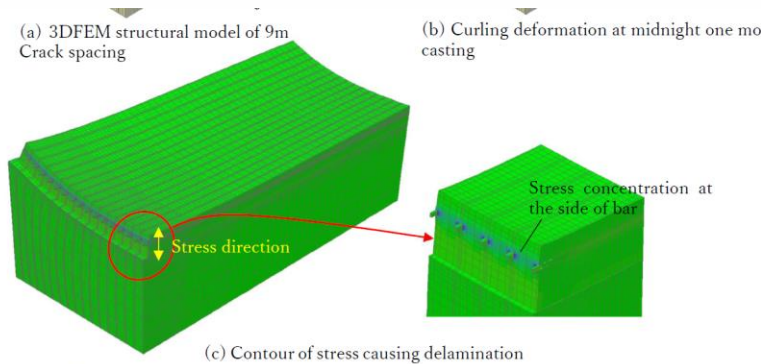
Fig 1 3DFEM analysis

- B. Japan
  - Ban-Etsu expressway
  - Study by T. Nishizawa
    - Transverse curling of CRCP
